An archaeological survey of Broad Lane farmhouse, North Curry, Somerset

BROAD LANE FARM, NORTH CURRY: THE DEVELOPMENT OF A SIXTEENTH-CENTURY FARMHOUSE

RICHARD PARKER, COLIN WAKEHAM AND GARY YOUNG

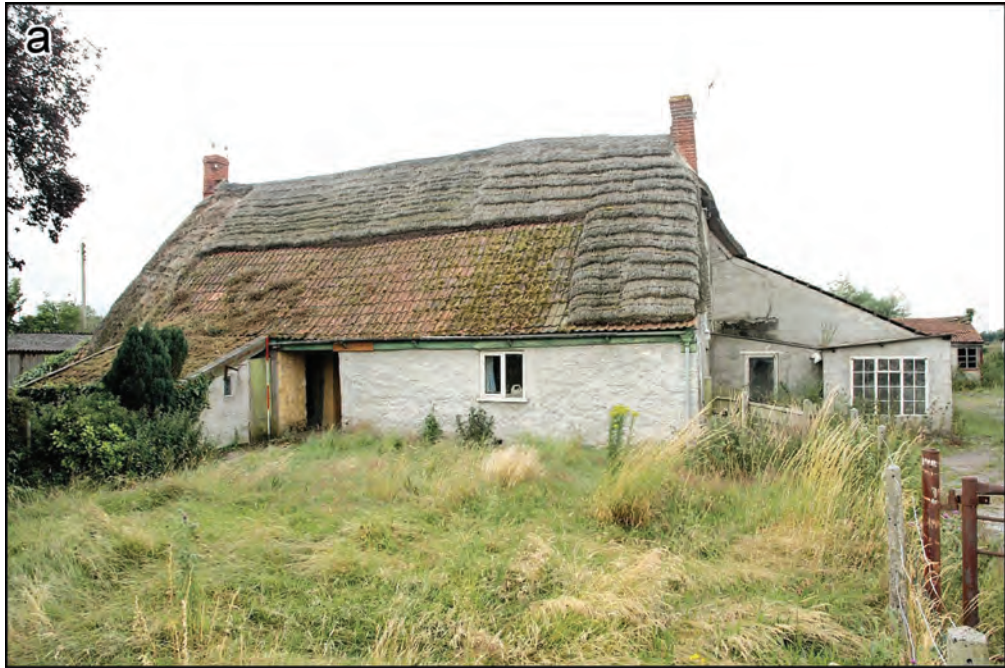
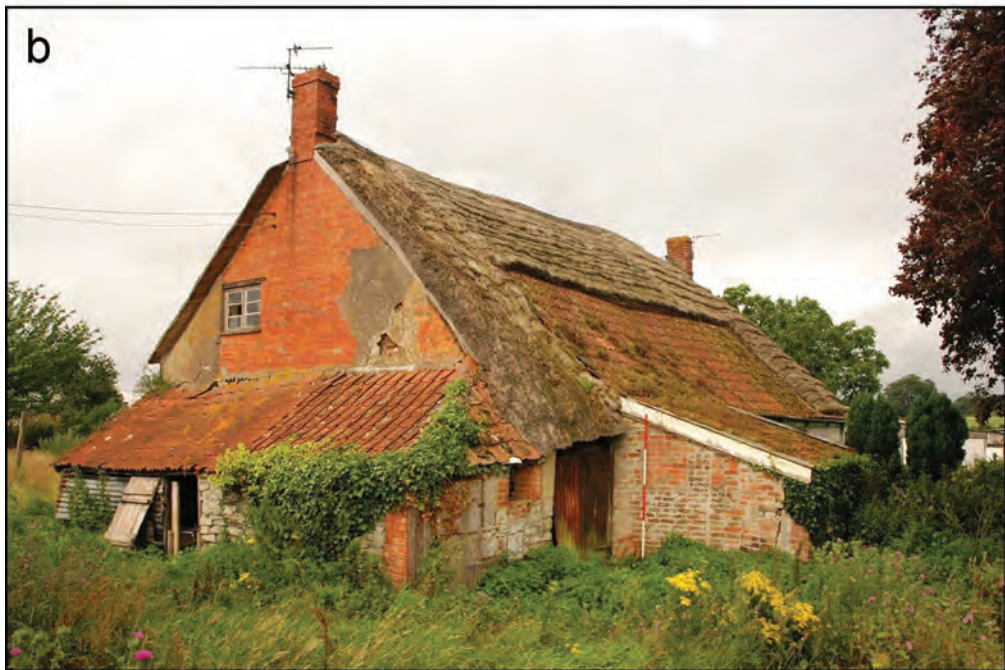
The south-western elevation of the house is its principal façade (Fig. 1a); this has a central doorway to the cross-passage, flanked by ground- and first-floor windows, the latter under eyebrow dormers in the thatch and offset to the south-east. A large concrete raking buttress supports the south-eastern end of the main house, which is collapsing. A single-storey porch masks the doorway and the window of the central room, and provides a covered passage to the rear-wing. This wing has long been alienated from the domestic accommodation, and has few windows. Much of its south-western wall has been demolished and rebuilt in concrete blocks, and its south-eastern wall is also collapsing. No historic farm buildings survive near the main house; its sheds and outbuildings are of 20th-century date.

Fig. 1 Broad Lane Farmhouse. (a) From the lane to the north, showing the extent to which the early house is concealed by later outshuts and extensions. (b) From the south-east, showing the gable end rebuilt in brick (photos: Gary Young)

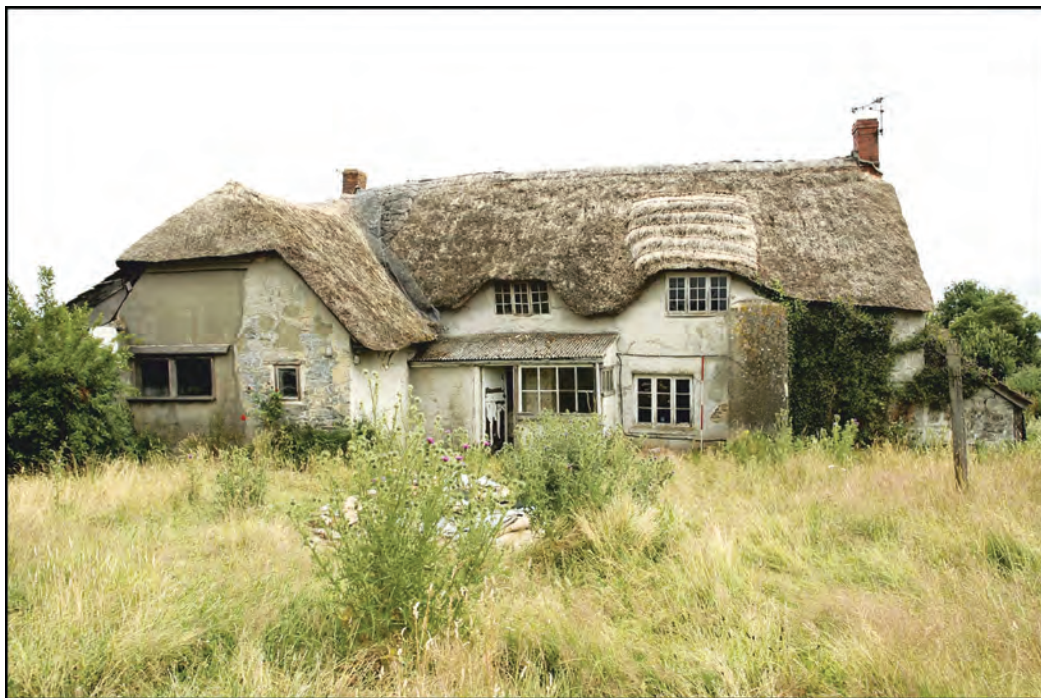
Fig. 2 View of the south-western (rear) elevation, with the rear-wing (left) and the modern buttress supporting the collapsing south-west wall (photo: Gary Young)

In the later 20th century the south-west wall of the rear-wing, which may have included a chimney, was demolished and rebuilt in concrete. A raking buttress was added at the southern corner of the building, which had continued to move outwards, and many props were added to support the floors and roof timbers throughout the building. Despite these precautions, the structural integrity of the building has continued to deteriorate and parts of the building are even now on the point of collapse.

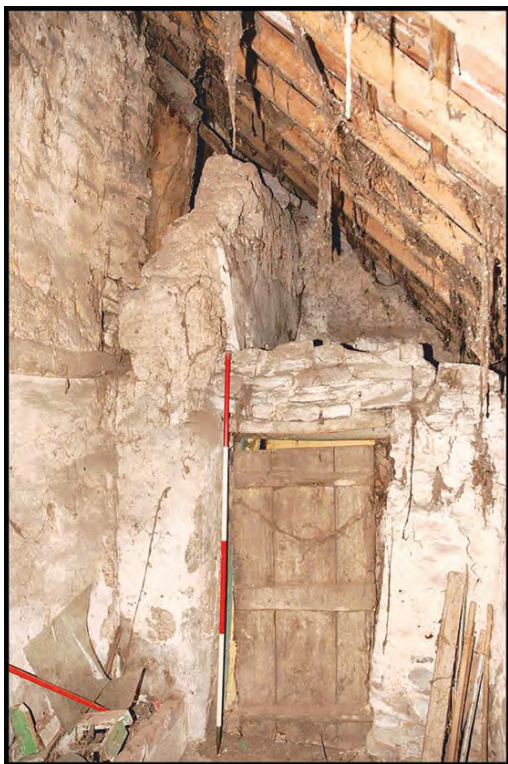
Fig. 4. View within the lean-to 'wood shed', looking west, showing the remains of the early cob front wall and the later timber partitions to the west (photo: Gary Young)

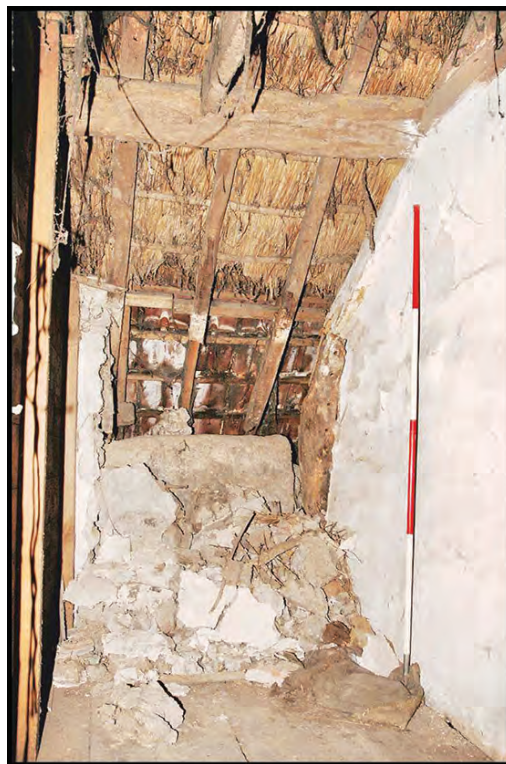
Fig. 5. View within the central first-floor room, showing the relationship of the roof and the original front wall, revealed by the demolition of the later timber partition to the outshut (photo: Gary Young)

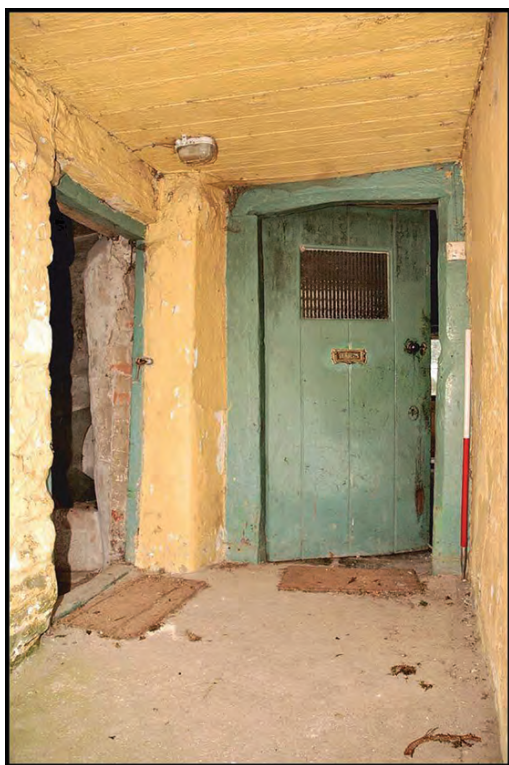
Fig. 7 The door frame of the main doorway within the cross-passage, showing the crude character of the early joinery (photo: Gary Young)

The main doorway to the inner part of the cross-passage, lying within the original front wall of the house, has a timber door frame with a triangular arched head and chamfered jambs with straight cut stops (Fig. 7). Unusually, the chamfer between the jambs and the arched head is not continuous; the arch has curved run-out stops which do not respect the chamfers of the jambs. This device gives the

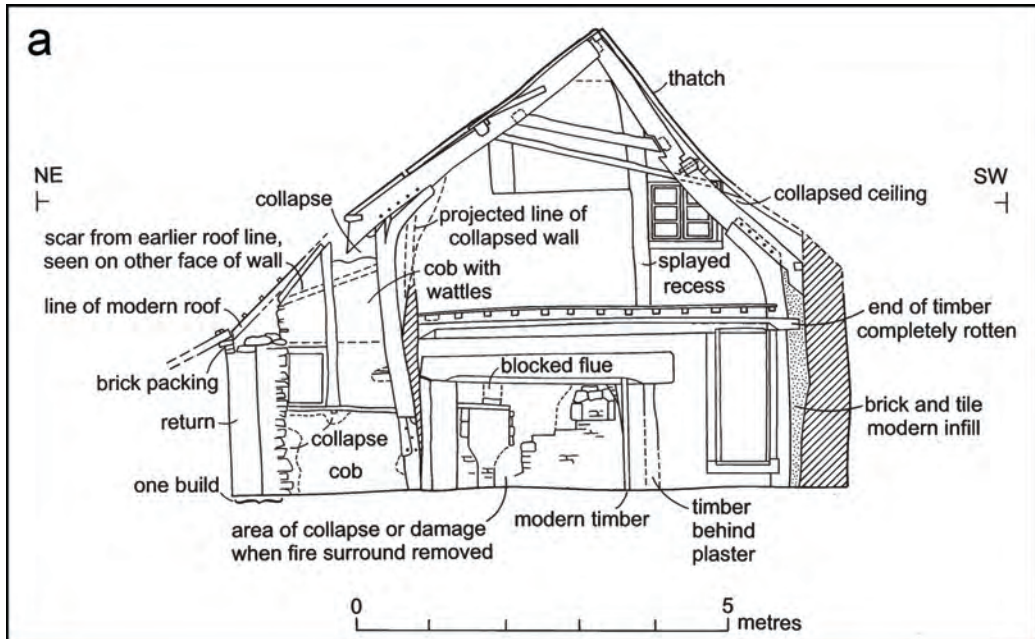
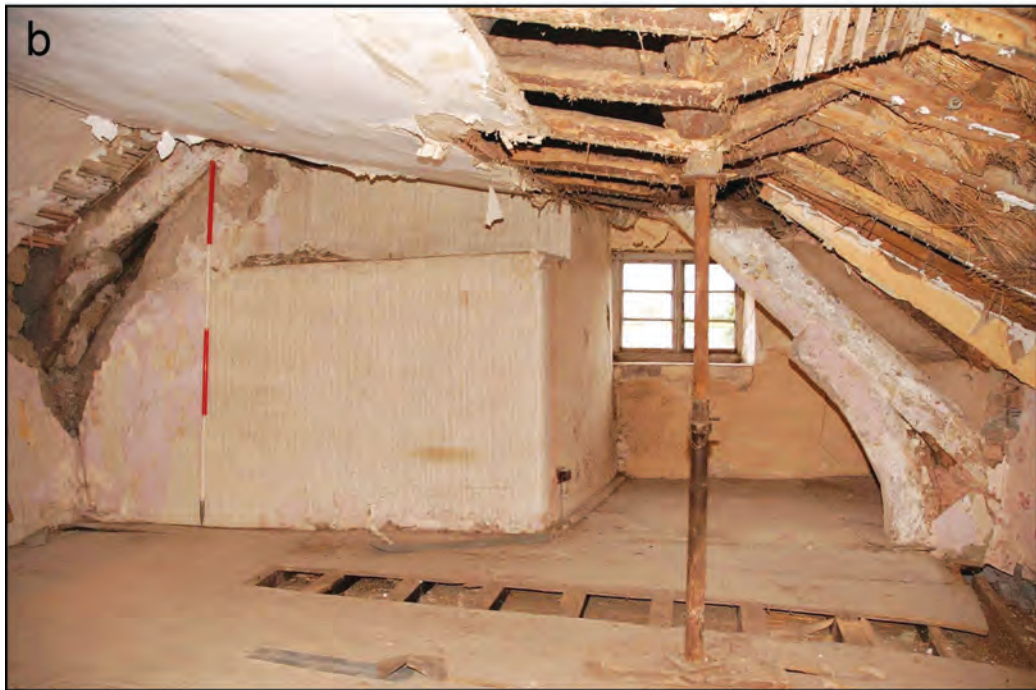
The roof structure at the south-western end of the farmhouse is supported on two massive cruck posts with curved, jowled heads (Fig. 8). The cruck posts extend almost to the ground, the north-eastern one in the end truss being slightly raised by means of a short length of timber scarfed and pegged onto its foot. This has now almost entirely perished. The opposite post formerly had a similar arrangement but the extra timber scarfed to its foot has vanished, and the truss has consequently dropped by as much as 1m. The building is now astonishingly crooked and the south-western corner of the room is collapsing. The ceiling beams were fortunately not fixed to the cruck posts (perhaps because they were inserted and are not part of the primary structure) and therefore they did not move with the collapsing truss. If this had been the case the result would have been even more disastrous for the house. Nonetheless neither beam end has any real bearing in the south-western wall, and the central beam has had to be propped with an additional post.

Fig. 8 (a) Section I: the south-eastern end of the house, showing the character of the roof truss over the hall, the inserted fireplace behind it and the extent to which the roof has sagged (based on hand-measured survey by Exeter Archaeology). (b). View at first-floor level (photo: Gary Young)

The foot of the most southerly cruck post, which was formed by a separate timber scarfed to the foot of the post, seems to have completely disintegrated, causing the leg of the truss to drop by around a metre. The roof and the ceilings in the upper rooms have thus descended to a crazy angle. Fortunately for the house, the ceiling beams in the hall were not connected with the cruck posts and the first-floor structure remained (broadly) horizontal. If this had not been the case it is likely that much of the house would have had to be demolished. The decision seems to have been taken to repair the house as it stood rather than trying to correct the distortion. The south-eastern gable end was thus rebuilt in red-orange bricks, and a new chimney in the same material was inserted into the north-western gable, with a small cast iron fireplace of early 20th-century type. Similar red bricks were utilised as 'beam filling' along the wall tops on the south-western side of the house, perhaps in the belief that this would stabilise the roof. The staircase adjoining the hall chimney may have been rendered useless due to the lowered ceiling levels; it seems to have been abandoned and the stair turret converted into a cupboard. A new staircase was inserted within the central room, cutting through the ceiling and the chamber above seems to have

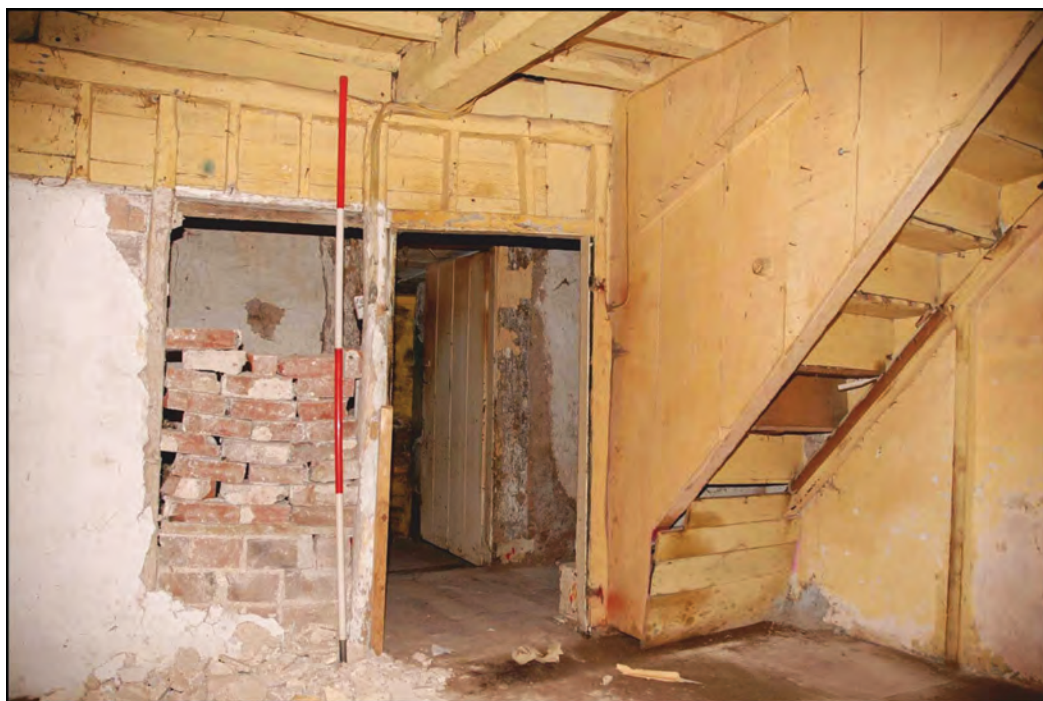
*Fig. 9 The central room looking east, showing partition and well-made joists
(photo: Gary Young)*

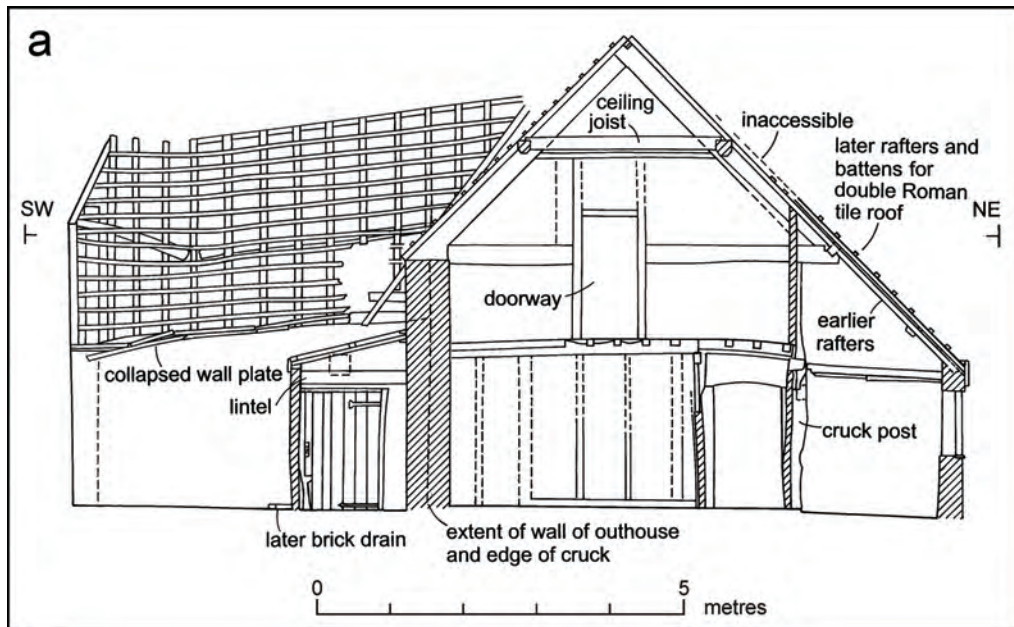
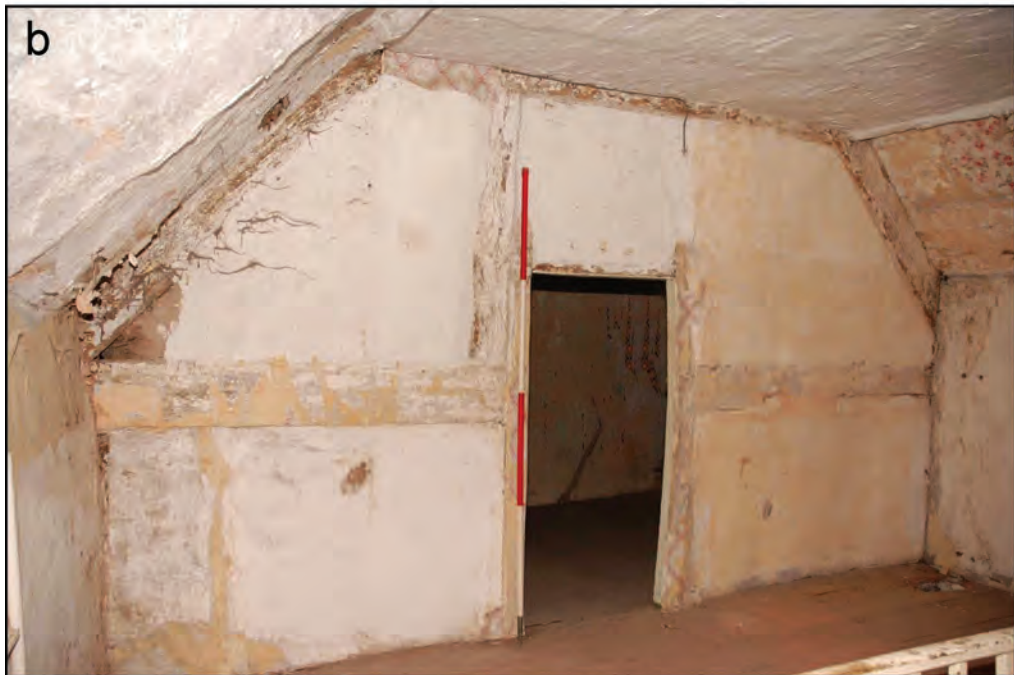
Fig. 11(a) Section 3, through the north-western end of the house, cut through the central room, showing the structure of the timber-framed partition defining the end room and the south-eastern elevation of the rear-wing (based on hand-measured survey by Exeter Archaeology).
 (b) View of the partition at first-floor level (photo: Gary Young)

The north-western wall of the central room is a further timber-framed wall (Fig. 11). This is also contrived between the legs of one of the trusses supporting the roof. In this case, however, the truss is not a jointed cruck like those to the south-east; instead, the wall-posts rise on either side and support a horizontal tie (now interrupted by a doorway) crossing the building at eaves level, from which the principal rafters spring. The lower and upper parts of this partition are not exactly aligned vertically, the upper part being offset slightly to the south-east, resting on the chamfered beam terminating the ceiling joists. The lower part of the partition appears to contain six rather closely-spaced vertical studs of rather irregular sizes forming six panels. The thickest of these studs in fact relates to a partition in the adjoining room, which explains its larger size. The upper part of the partition appears to have larger panels; however it is possible that the studs are simply concealed by plaster.

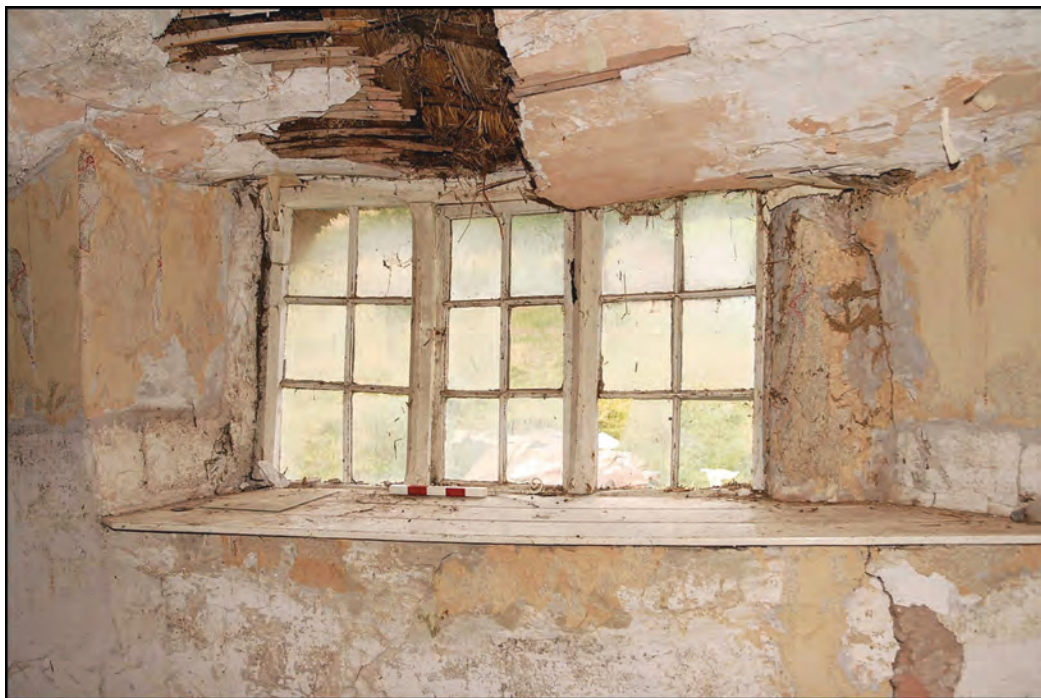
Fig. 12 Detail of the window lighting the central chamber on the first floor (photo: Gary Young)

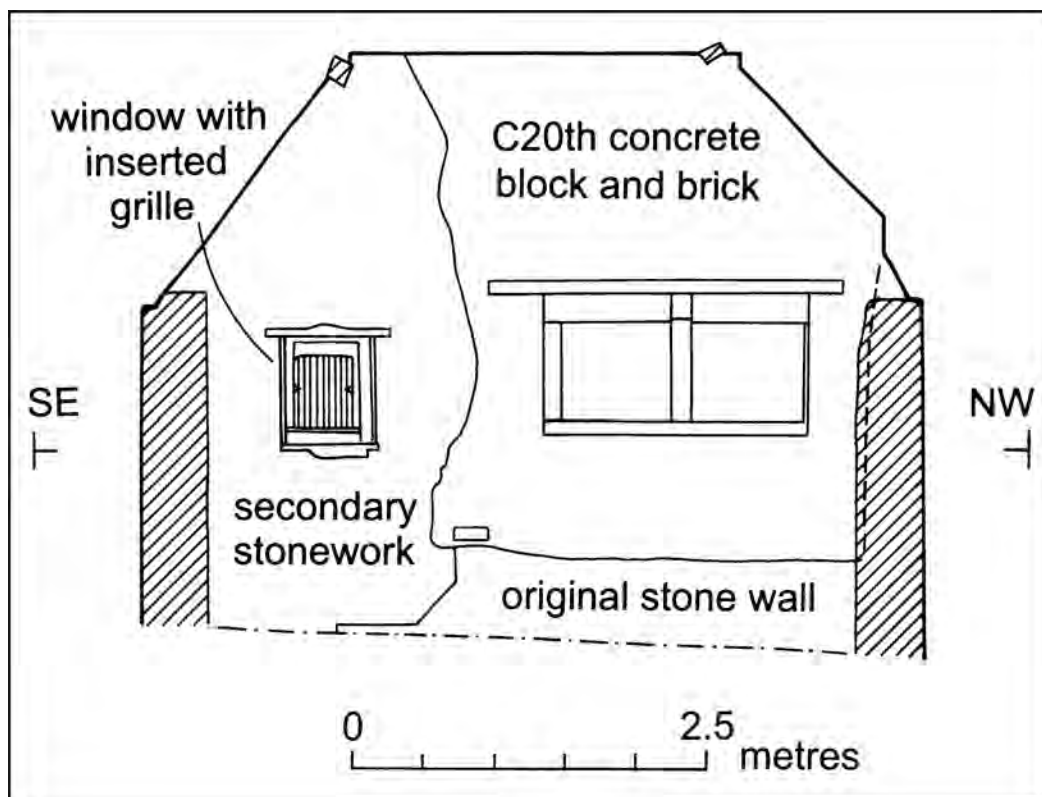
Fig. 13 Elevation of the south-western wall of the rear-wing, showing the rebuilt section of wall, which may represent the site of a demolished chimney (based on hand-measured survey by Exeter Archaeology)

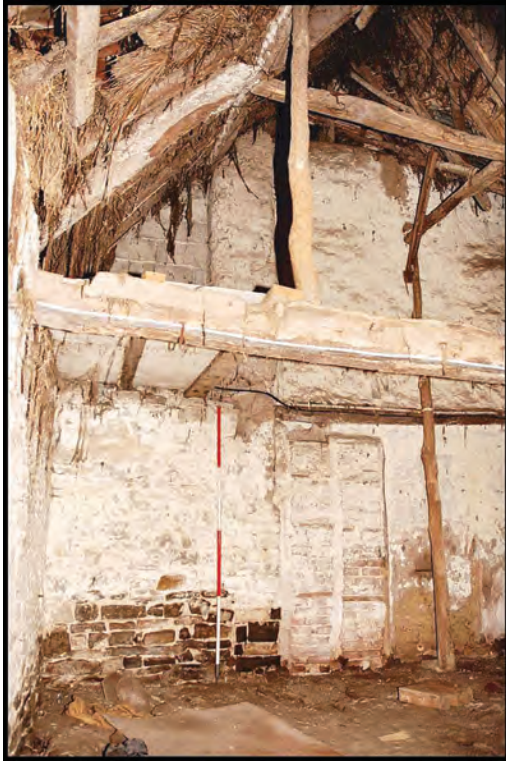
The roof of the rear-wing is of three bays supported by two rather crude 'A'-frame trusses, now in a dreadful state of disrepair (Fig. 14). The southern principal rafter of the easternmost truss has wholly vanished and the truss has had to be propped upon softwood poles. The corresponding principal rafter in the adjoining truss has completely fractured at its junction with the collar beam; this has also been braced by an additional timber applied to the north-eastern side of the truss, the foot of which is now pushing the south-eastern wall over at the eaves. Both trusses have slender

Fig. 14 Interior of the rear-wing, showing the blocked doorway to the house, the north-eastern truss and the baulk of cob beyond it which may represent the truncated primary gable of the original house (photo: Gary Young)
