Restoration of the Tower of Taunton Saint Mary Magdalene.

*At a Meeting held at the Market House, Taunton, May
14, 1852, to consider the state of the Tower of the
Church of Taunton St. Mary Magdalene.*

SUMMARY OF THE REPORT.

TOWER OF ST. MARY MAGDALENE'S CHURCH
TAUNTON.

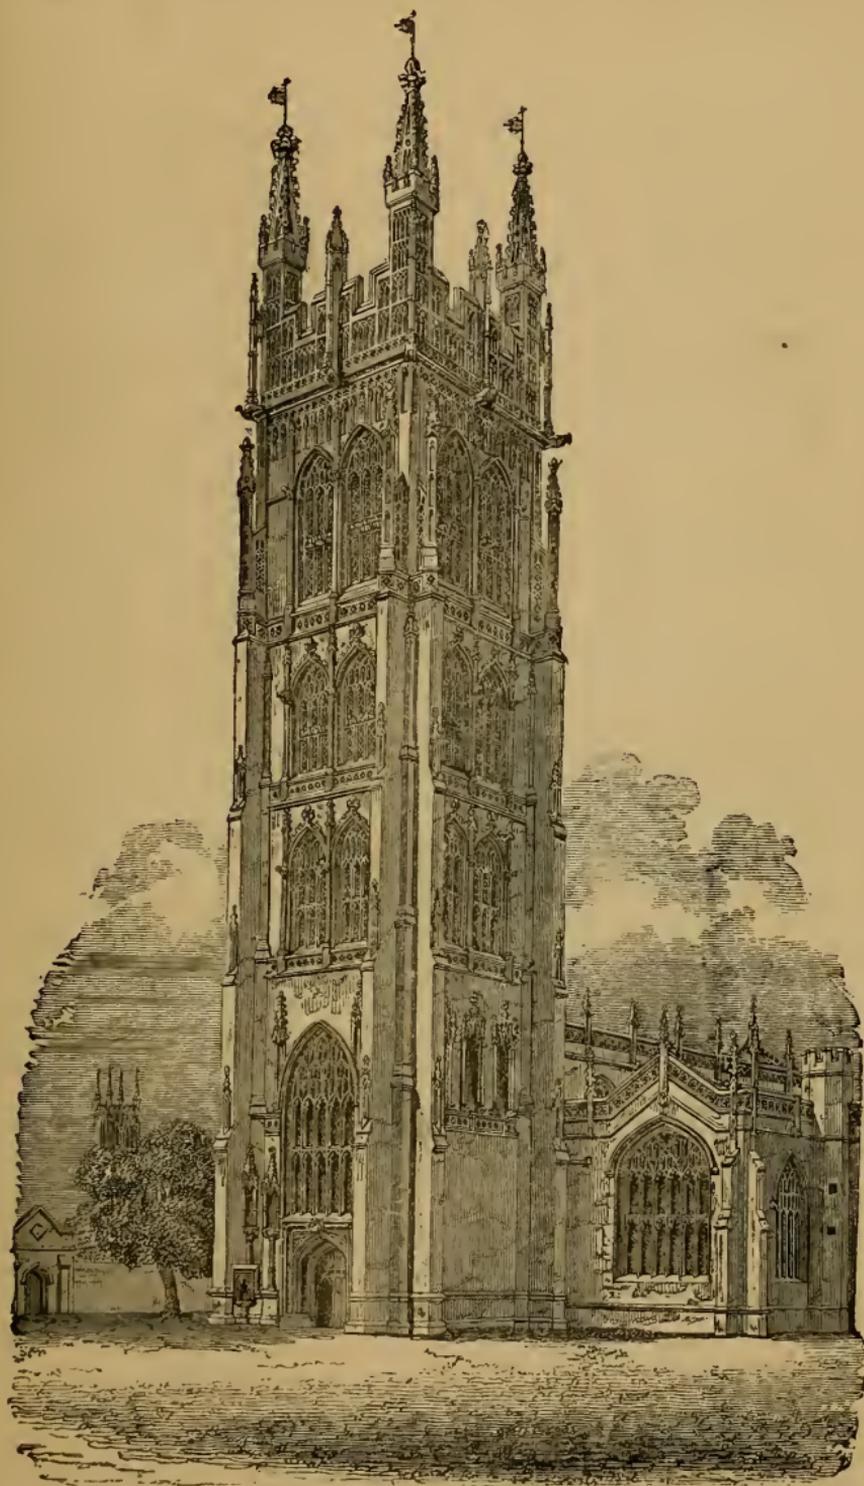
Portions of the battlements of the stair turret, weighing more than 2 cwt. are in imminent danger, being quite detached and overhanging the wall.

At the north eastern angle of the parapet, the small pinnacle projecting from the larger one, and overhanging the north aisle, rests entirely on a very decayed and dangerous gargoyle. This pinnacle weighs probably nearly 10 cwt. and is disjointed, crooked, and at its centre shattered so much, as to render it extremely dangerous.

The great pinnacle at the north eastern angle of the parapet is falling apart. The finial is splitting asunder, and many fragments are likely soon to be precipitated on the roof of the church.

At the south eastern angle of the parapet, the small pinnacle is in a dangerous state, and portions of the great pinnacle are quite loose.

At the south western angle of the parapet, the small pinnacle is quite unsafe, and several cwt. of stone may fall at any time. A stone weighing about eight or nine pounds has fallen, and has been caught by the projecting neck of the decayed gargoyle, where it is just balanced, and overhangs the corner at which the school children play between school hours.

The great pinnacle at this corner has also many very dangerous portions.

The great pinnacle and the small overhanging one at the north western corner, are in a similar condition with the preceding.

The pinnacle in the centre of the parapet on the north side has portions quite loose which would fall at a touch, the small shaft in connection with it, depends for support on the legs of the gargoyle, which are worn away and reduced to the diameter of an inch.

All the great pinnacles surmounting the buttress are dangerous. Four of them are in a frightful state and will fall before long, they weigh more than 10 cwt. and two would fall on the church.

The buttresses on the north side of the west front is undermined and separating from the wall. A great portion now rests on about eight inches of masonry much decayed. Above two tons of masonry will probably slip at once when this stone gives way.

There are many hundreds of smaller features and fragments of stone, scattered over the entire surface of the Tower in a falling condition, and on the west front are several iron cramps and ties, weighing about 15 lbs. each, which must fall soon, one is particularly threatening, and one has lately fallen weighing 9 or 10 lbs.
