**Some older houses in West Street, Dunster**

*Mary Ewing*

Extracted from the Proceedings of the Somerset Archaeological and Natural History Society for 2020.

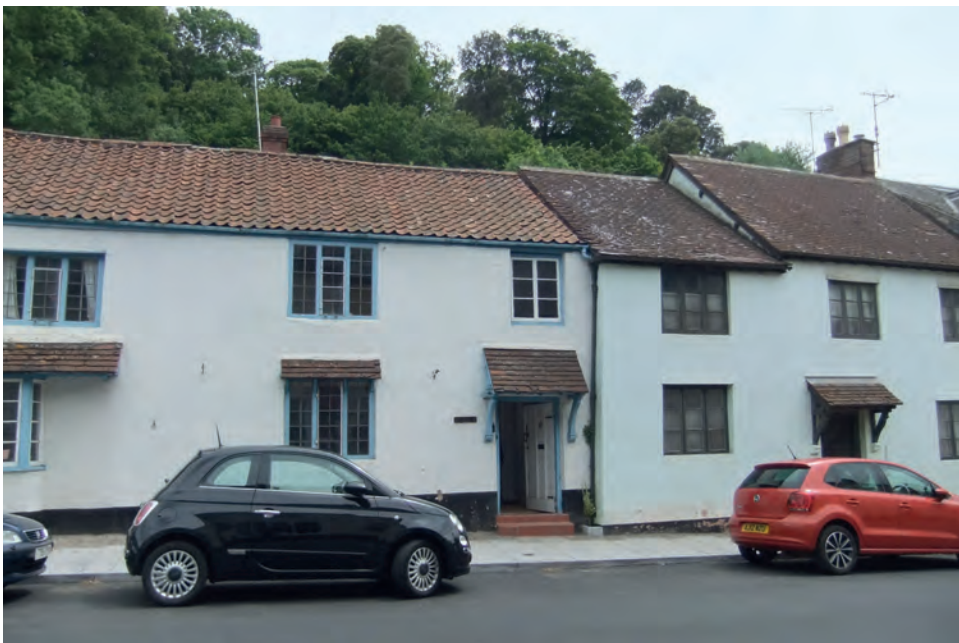
*Fig. 8 Line of roof extending south under a different roof finish (at right of photograph)*

The extended roof is also apparent externally with a difference in roof height at the position of t6b, although no. 13 extends beyond (Fig. 8) with a rear range containing more jointed cruck trusses. The evidence suggests that this part of no. 13 was originally an outer service room to no. 11. The jointed crucks of the rear wing at no. 11 are similar to those in the front range and are heavily smoke blackened, but they are built over the roof structure of the front range and so are assumed to be of a later date.

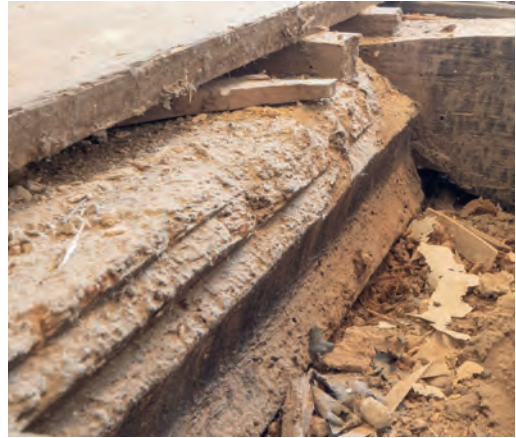
Fig. 10 Profile of assumed jetty beam b3

Another feature revealed was the top of beam b3 which was found to be elaborately moulded (Fig. 10). Below the ceiling, it is similar to b2 with simple chamfers but may possibly have been plastered over concealing any lower moulding. In the floor above, joists laid flat between this beam and the wall separating the hall from the cross-passage were chamfered on the lower edges (17cm wide x 13cm deep and at c. 46cm

spacing). Together with the moulded beam this would have given an impressive effect to the overhang when built. In providing a partial ceiling to the hall below, another chamber was housed above this and the cross-passage together. Nothing was seen to suggest what form the wall or balustrade would have taken above the beam.
