A mid 18th-century kiln of the ‘pottery house in the old park’, Dunster (HER PIN MSO9466)

David Dawson, Oliver Kent and Bill Stebbing

Extracted from the Proceedings of the Somerset Archaeological and Natural History Society for 2019.

The pottery kiln surviving behind the Exmoor National Park Authority Visitor Centre at Dunster is a remarkable scheduled ancient monument (number 1020409 at SS

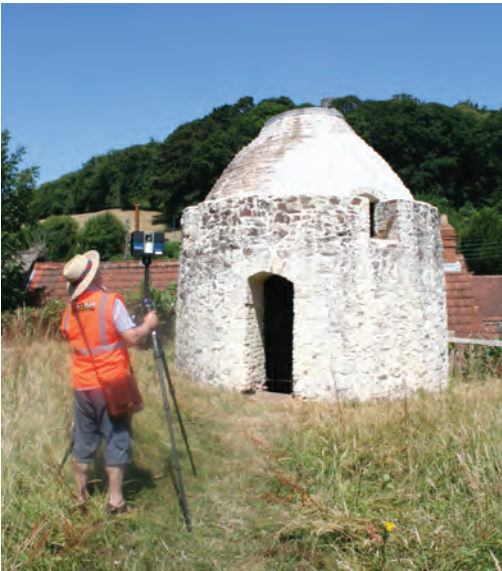
Fig. 1 Bill Stebbing surveying the kiln using a Faro Focus laser scanner

The kiln stands as an isolated structure, basically a cylinder 3m overall in diameter and about 3m high with walls 0.9m thick (Fig. 1). The drip courses of the building that once adjoined the kiln and linked it to the Pottery House to the west can be clearly seen on the east and west sides (Fig. 2). The appearance of these buildings is recorded in an oil painting of the park by William Tomkins commissioned in 1768 and still in the Dunster Castle collection (National Trust DC/P/34). The ware chamber is roofed with a shallow domed brick vault surmounted by a conical chimney (Fig. 3). The two opposed fireboxes and labyrinth of flues below the original floor survive, essentially intact though lowered and originally packed with unfired pottery when the kiln floor was removed and the sill of the ware

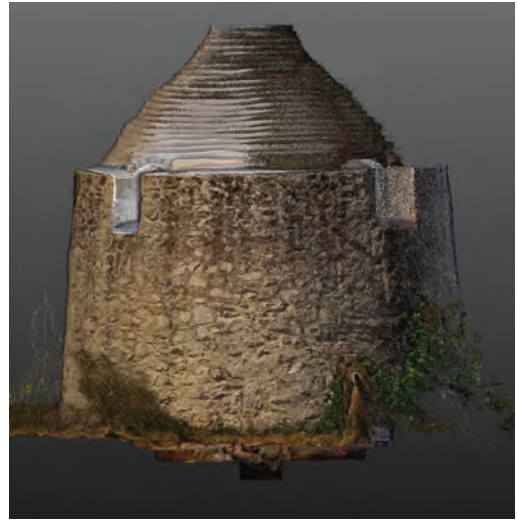
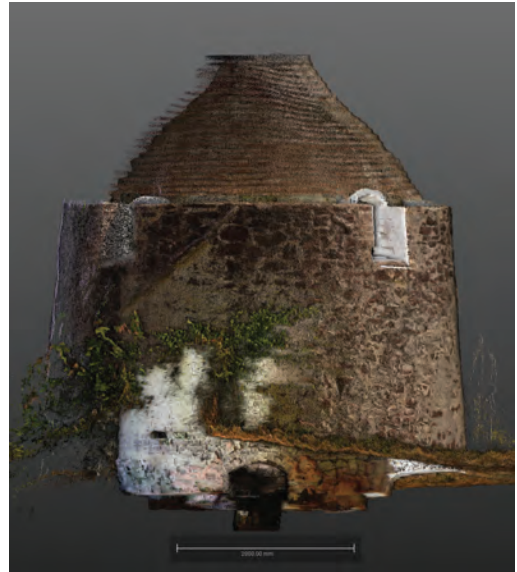
Fig. 2 East (a) and west (b) elevations showing the drip courses of the adjoining rooflines.

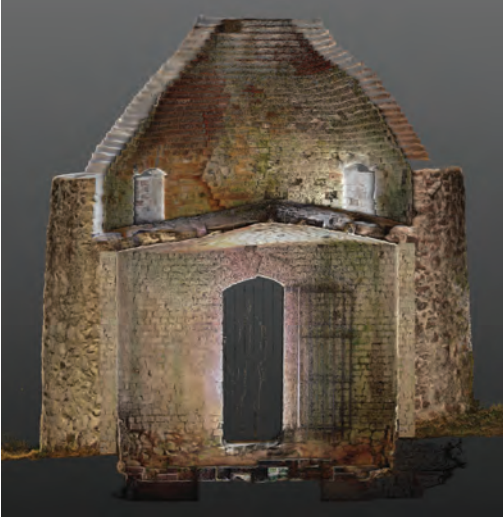
Fig. 3 Section east to west. Note the change from stonework to brickwork marking the position of the original floor. The eastern firebox has been blocked with stonework but the western only partially with roof-tiles and domestic rubbish.

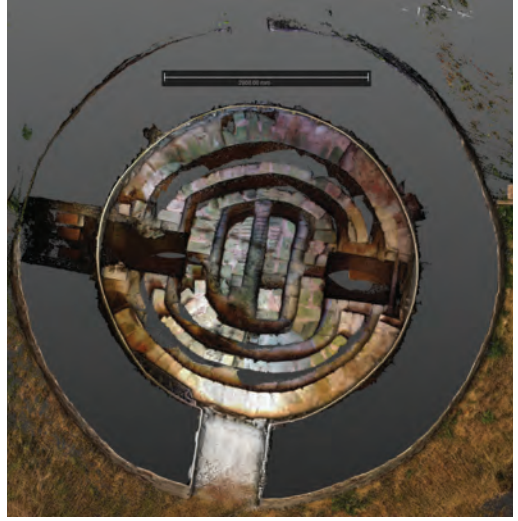
Fig. 4 Plan of the fireboxes and labyrinth of flues beneath the original floor (north at the top). Note the meltdown of the brickwork of the westernmost flue.

chamber door was lowered (Fig. 4). This remodelling happened in the mid-19th century in conjunction with extensive building and landscaping works including raising the external ground level, conversion of the kiln into a shed and probably the demolition of the rest of the pottery buildings. The western firebox was blocked with mortared stone after the kiln went out of production but the eastern firebox was left open and blocked with roof-tiles of a similar pattern to those used on the nearby

range of buildings which now house the visitor centre. It can be clearly seen that the fireboxes extend under the floor of the ware chamber but that on the west has suffered a meltdown of the brickwork on the north side blocking the end of one of the flues (Fig. 4). The original level of the dismantled floor of the ware chamber is clearly marked by the change between the stonework of the substructure and the brickwork of the lining of the ware chamber walls (Fig. 3). The kiln has suffered from subsidence probably consequent on the building of the new road and outbuildings to the Luttrell Arms c. 1850. Hence the distortion of the chimney and the probable loss of its upper courses of brickwork. The pierced vault over the ware chamber has similarly distorted (Fig. 5). The tile repairs carried out to the cracks in the ware chamber wall during conservation work in 2009 can be seen in Fig. 6.

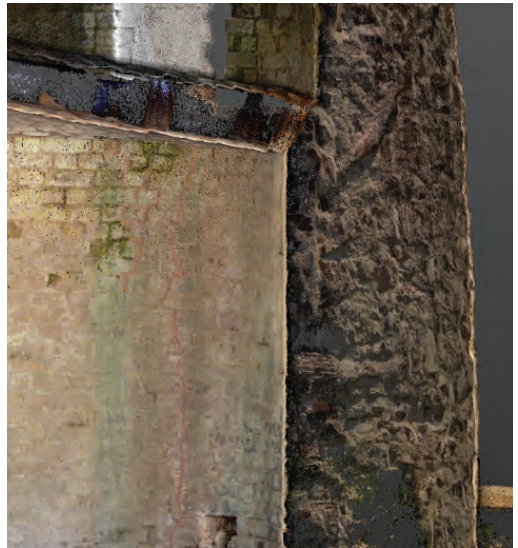
Fig. 6 Tile repairs to cracks in the ware chamber wall during conservation work in 2009
