PROCEEDINGS
OF THE
SOMERSETSHIRE ARCHÆOLOGICAL AND
NATURAL HISTORY SOCIETY
DURING THE YEAR
1907.

Shepton Mallet Church: its Architectural History.

BY F. J. ALLEN, M.D. CANTAB.

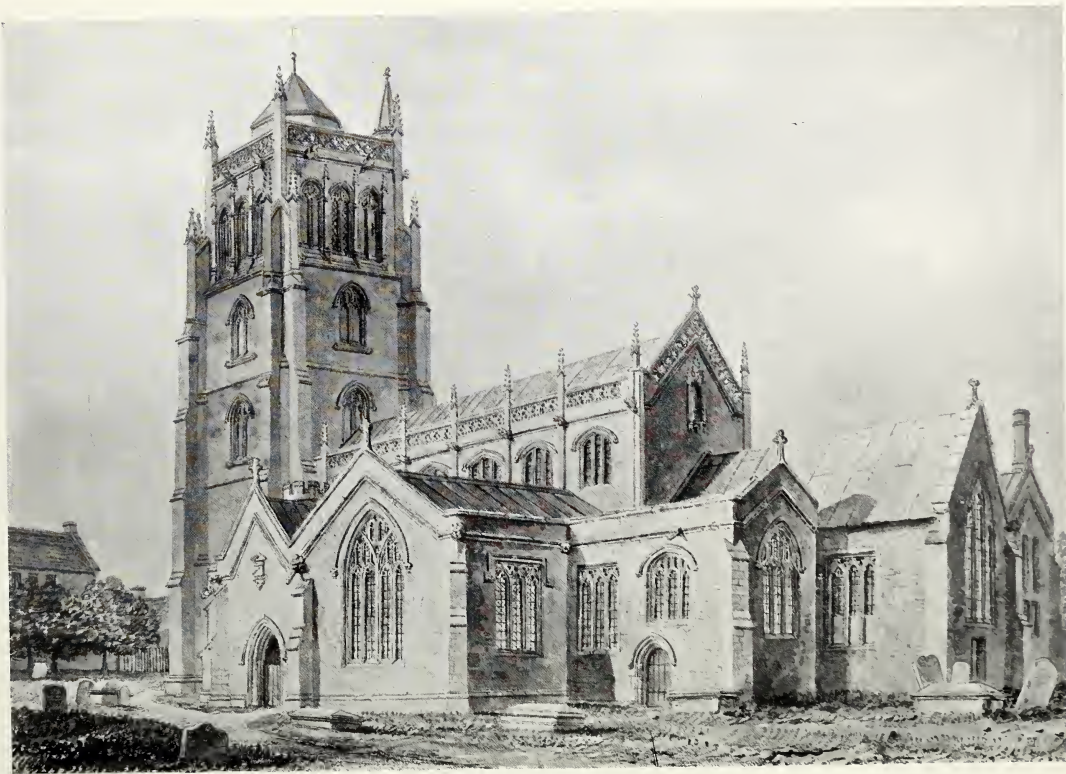
SHEPTON MALLET CHURCH FROM THE S.E., 1833.

In Plate I, which is from Buckler's drawing made in 1833 for the Smyth-Pigott collection, now in our Museum at Taunton, it may be seen that the south side had an aile, a porch, a transeptal wing, and a chapel on the south of the chancel. A plan of the old church, made at the time of the

In the 14th century some additions seem to have been made to the church, for Buckler's drawing (Plate I) shows windows of 14th century character in the chancel, south chapel and south transept. But these have all been destroyed, and the only relics of the Decorated period are the corbels which support the roof of the chancel.

These “munnells,” which were plain mullions without tracery, remained until 1880 or later, when the present tracery was substituted: but the stumps of the “munnells” still remain at the bases of the new mullions (see Plate I).

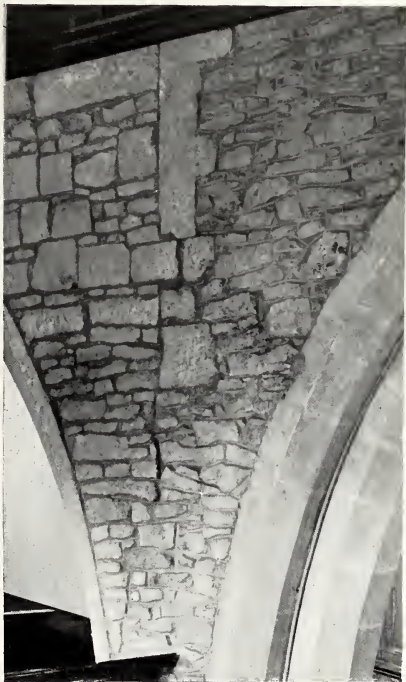
FIG. 1.—EARLY QUOINS IN S. AILE.

The oldest portion consists of the eastern two-thirds of the nave, with so much of the ancient chancel as has escaped rebuilding. On entering the church one may notice that the nave arcade consists of three very large arches on each side ; and that these are of two periods, the two eastern bays on both sides being of the Transition-Norman period, and the western bay being a later rough imitation (Plate II). The span of the Transitional arches is nearly 17ft., which is much wider than the nave itself (14ft. 5in.), and even wider than the arches of the arcade in Wells Cathedral. Such excessively large and disproportionate arches are not likely to have been designed when the very narrow nave was planned ; and the writer had suggested years ago that the arches may have been inserted into a previously existing wall. The recent removal of the plaster has provided confirmation of this hypothesis, by bringing to light the quoins of the original building, which are visible on the aisle side of the wall between the second and third arches, both north and south. These quoins (Fig. 1, Plate III) are unmistakably *external* ; i.e., there were no aisles, and consequently no arches. Moreover, the end of the older wall is over the *middle* of the arch pier ; so that only half the width of the pier belongs to the older wall, and that would not have given sufficient abutment to the arch, or sufficient thickness for the west wall. (See Plan, page 14).

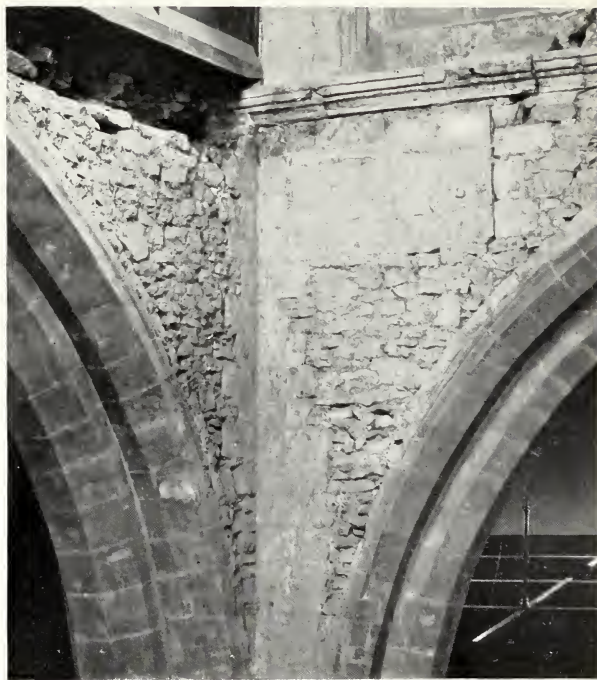
FIG. 2.—MARKS OF (?) ROOD-LOFT, S.E. CORNER OF NAVE.

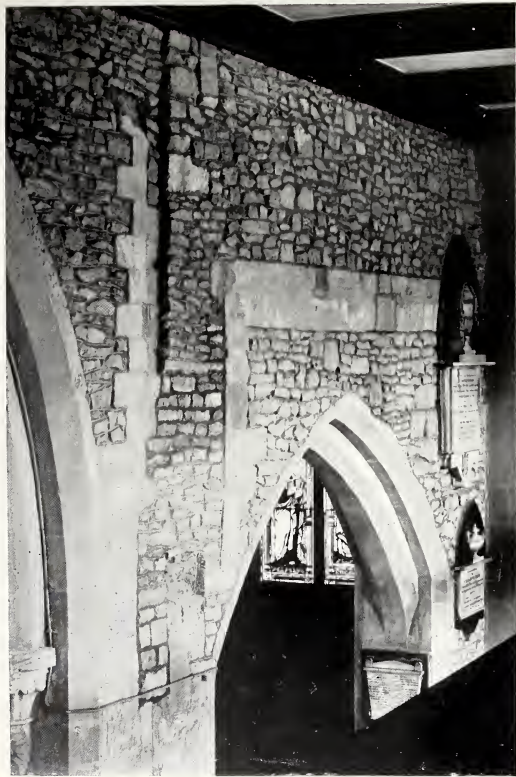
FIG. 1.—MASONRY AT E. END OF S. AISLE.

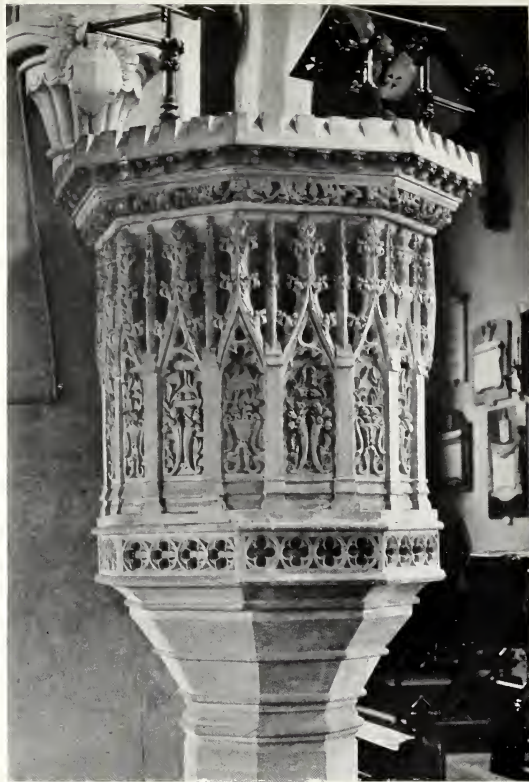
FIG. 2.—STONE PULPIT.

The Pulpit is, I believe, the finest stone pulpit in the county,

and one of the finest in England (Fig. 2, Plate IV): but it is a very late piece of work, belonging to the period when Gothic art had begun to feel the influence of the Classic revival. It has, mixed with Gothic details, the Roman *cornu copie* and *modillion*. Its date may be as late as 1550.

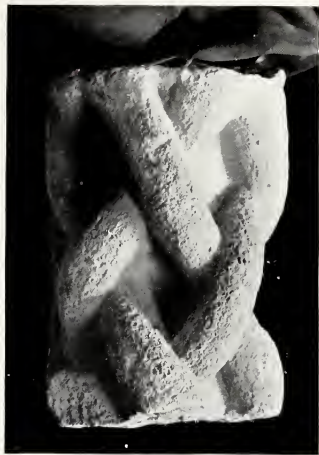
FIG. 1.—FRAGMENT OF EARLY
COLUMN.

There is no carving or characteristic masonry left *in situ*, by which the date of the original church at Shepton can be fixed : but in the course of the recent repairs a fragment of an engaged column was found, which had formed a part of an external doorway, if we may judge by its weather-worn state. It is 9in. high, and carved (Fig. 1, Plate V) with an interlacing pattern of early character, from which the date may possibly be guessed by connoisseurs of Norman and Saxon ornament. This pattern was frequently used in pre-Norman times for decorating flat surfaces, but it is unusual on a column.

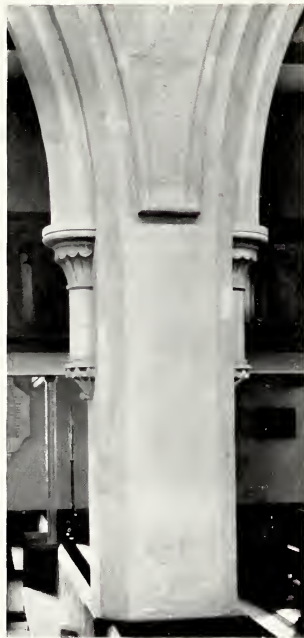
FIG. 2.—TRANSITION-NORMAN PIER.
SHEPTON MALLET CHURCH.

the arch. A second chamfered member arises from corbelled half columns or "responds" of characteristic form (Figs. 2 and 3, Plate V). Some of these have been restored with stucco (in 1837?), but three or four seem to be genuine. The capitals are of the form named "the pollard willow" by Mr. Francis Bond. The unusual form of the piers may be due to their consisting of portions of the original wall left when the arches were inserted.

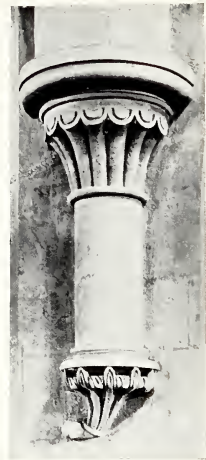
FIG. 3.
TRANSITION-NORMAN
RESPOND.

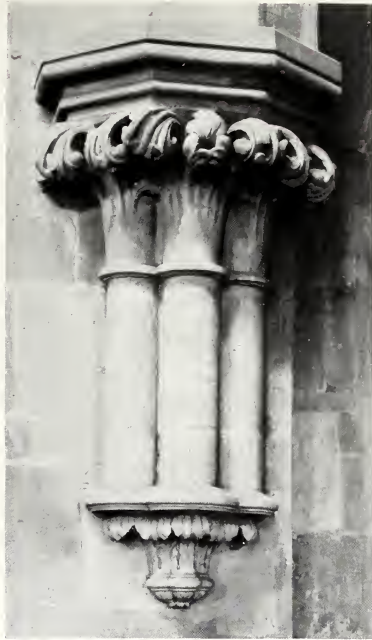
FIG. 1.—RESPOND OF CHANCEL ARCH.

The Chancel Arch at Shepton was doubtless inserted into a previously existing wall, in place of an earlier round-headed arch. It is distinctly more advanced in style than the nave arches, and may be called fairly mature Early English. The corbelled responds with foliage capitals (Fig. 1, Plate VI), of the highest quality of their period, are extremely like those in the eastern part of the nave at Wells, built between the death of Reginald and the accession of Jocelyn, *i.e.* about 1200.

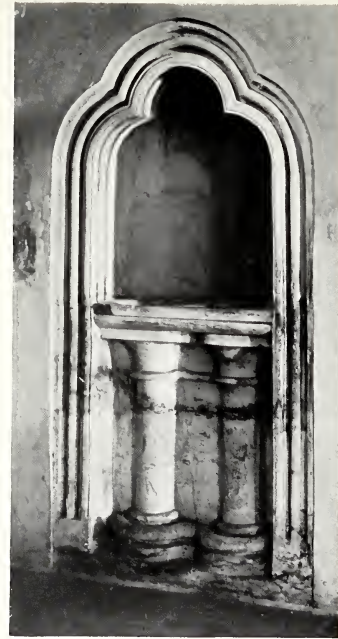
FIG. 2.—DOUBLE PISCINA.

The Piscina (Fig. 2, Plate VI) is double, under a single trefoil arch, and is a very graceful specimen of the middle Early English period, corresponding in mouldings to the W. front at Wells, which was consecrated in 1239.

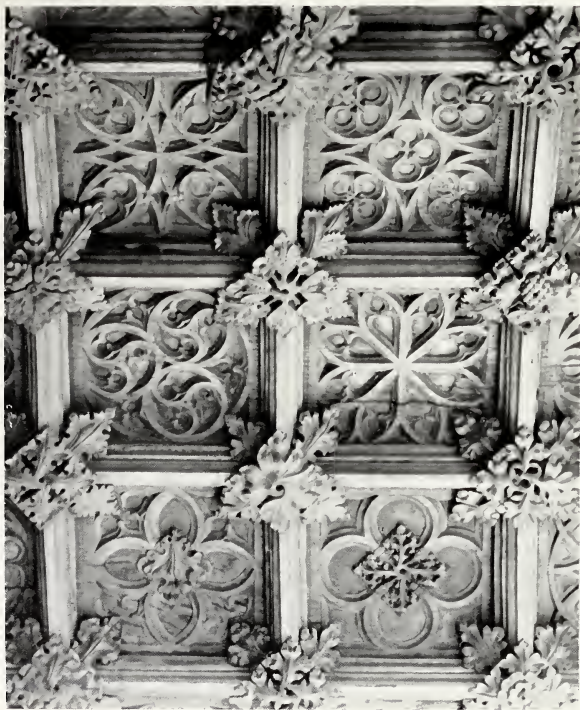
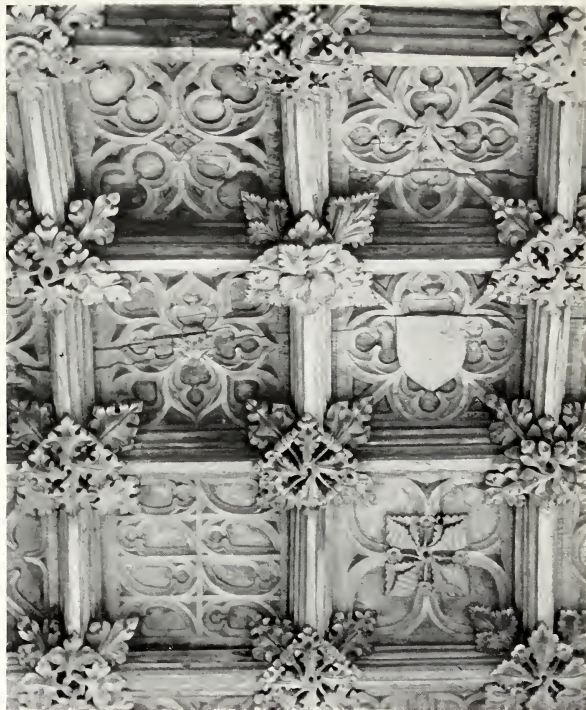
OAK CEILING, SHEPTON MALLET CHURCH.
Specimens of the 350 different Designs.

The clerestory, with its probable coloured windows, its canopied niches, and its many statues, was fitly crowned with the splendid carved oak ceiling, which is the most distinguished feature of our church. This ceiling is of the wagon-head form: as seen from below, it presents a framework of square compartments, through which the panels appear like portions of the wagon tilt. But whereas in an actual wagon head the frame supports the tilt, the case is reversed in the roof, for *the panels support the frame: i.e.* the panels are carved in rows on planks, these planks are nailed to the roof-timbers, and the visible frame is nailed to the panelled planks.

350, and their designs are all different. The bosses or rosettes are also all different, and their number is even greater than that of the panels. Besides these there are eighteen angels as "supporters" on each side, thirty-six in all, and a number of other interesting details. In fact this ceiling is by far the finest of its kind in existence. The next best that I know is that at Cullompton, Devon; but that has only 144 panels, and only eighteen different patterns of panel and rosette.

When the recent repairs to our church were in progress, the Rector mounted the scaffold with cameras, and secured no less than forty-six photographs of the ceiling, embracing every detail from end to end. From the complete series which he kindly placed at my disposal it is unhappily impossible, on grounds of expense, to reproduce more than two (Plate VII).
