BUILDING RECORDING IN 2017

SOMERSET VERNACULAR BUILDING RESEARCH GROUP

SANHS VERNACULAR BUILDING RESEARCH GROUP

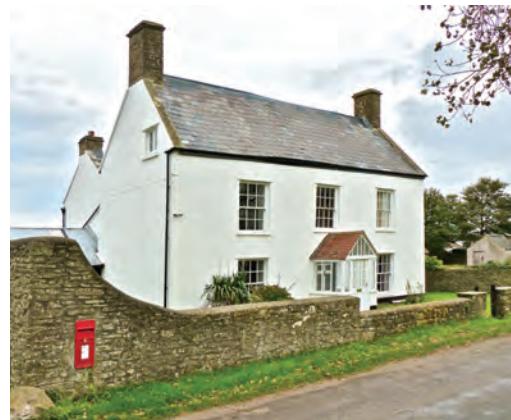
Fig. 1 Clevedon, Dowlais Farm, south frontage

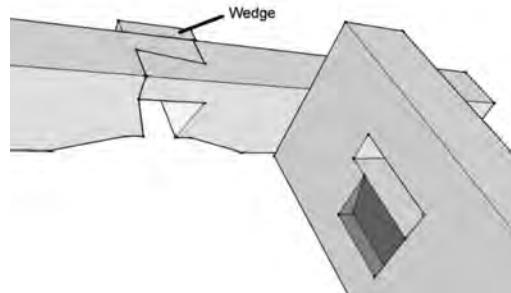
Fig. 2 Clevedon, Dowlais Farm, wedged dovetail tenon joint (drawing, Dave Taylor)

Around 1810 the property was enlarged by the addition of the front range. The slate-clad, elm roof with 46° pitch is supported on four collar trusses; the collars are half dovetailed into the principals. The purlins are joined to the trusses with rare wedged dovetail tenons. The design of the stair and door fittings (L and extended T hinges) are appropriate for this date. The first floor was heated. Doors in the rear range were replaced to upgrade it too.

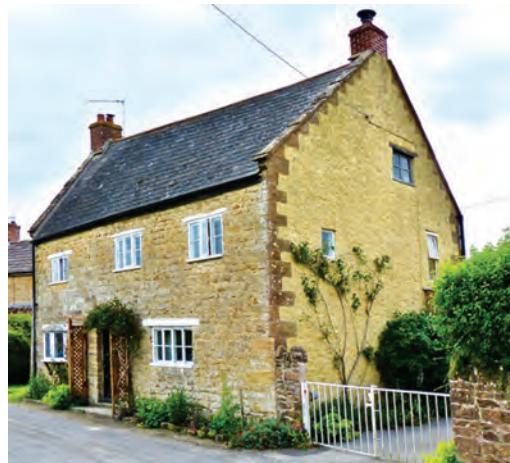
Fig. 3 Kingsbury Episcopi, East Lambrook, The Old Buffalo Inn from the north-west

The property, two-storey and attic under a pitched, slate clad roof with raised and coped gables, appears to have been cob built. The cob has largely been replaced by local rubble stone, brick

Wall thicknesses suggest that it was built in one phase; a cranked purlin was even used to accommodate a change of building width. The roof structure, collar-beam trusses and pegged through-tenons, date from the 19th century; the internal plank and batten doors and their furniture (some extended T-hinges) all point to a construction date in the early 19th century.

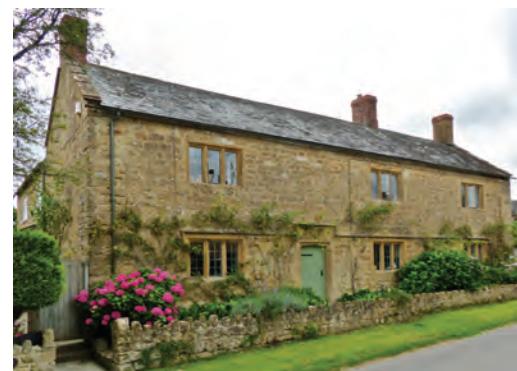
Fig. 4 Kingsbury Episcopi, West Lambrook, Mallow Cross, east elevation

A two-storey, listed building; L-shaped in plan. The front range is a classic example of a 17th-century three-room, cross-passage house, complete with three-light, hollow chamfered stone-mullioned windows all dressed in Hamstone. An entrance doorway with depressed four-centred head and moulded jambs is linked to the ground floor windows by a continuous hood mould. The coursed rubble walls are 65cm thick. The original entry doorway has hollow-step-cyma mouldings to the jambs and small incised spandrels to the door head. Internally there is nothing left of the early house.

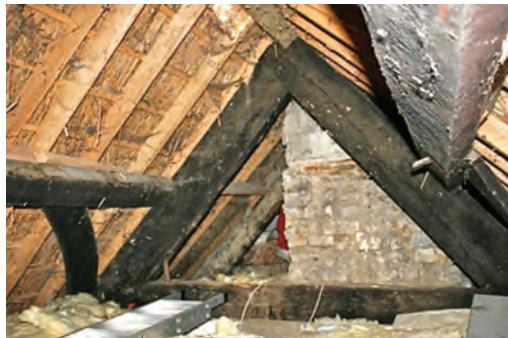
Fig. 5 Kingsbury Episcopi, West Lambrook, Tanyard House. Smoke-blackened truss, purlins and windbrace

In the late 15th century a cob built, two bay open-hall house was built for someone of yeoman status as indicated by the three tiers of purlins, wind-bracing and the arch-braced jointed cruck of the central truss. The hearth occupied a central position on the floor, the smoke rising into the roof space and blackening the roof timbers. Either side of the hall single bay rooms provided a service area for the preparation of food and an inner room, a more private space.

Mid to late 16th century a post and truss frame partition was introduced into the hall to create a cross passage and provide structure for a smoke bay or smoke hood enabling the central hearth to be located against this cross-passage wall. A peak-headed doorway remains in this partition. The hall and inner room were ceiled; the supporting beams have 13cm slightly hollow chamfers and rounded step-and-runout stops. A spiral stair was inserted giving access to first floor 'chambers'.

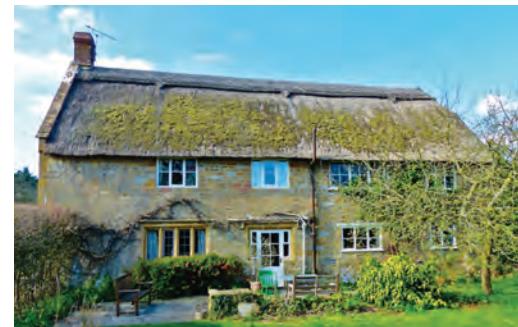
Fig. 6 Kingsbury Episcopi, Stenbridge, Whitegate House, south elevation

An original 17th century, or earlier, house of two-room plan is thought to have been the basis for the present four-room building. It is now two-storey and attic under a thatched, pitched roof. The east gable roof has a small hip and a lean-to abuts the lower part of the east wall.

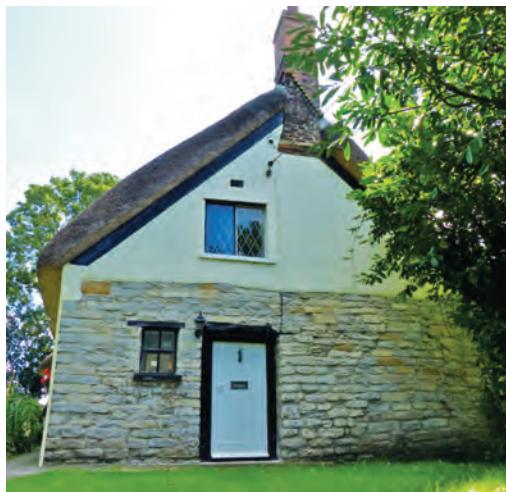
Fig. 7 Kingsbury Episcopi, Thorney, The Anchorage, west entrance into inglenook

In the early 20th century metal-framed windows replaced their wooden predecessors and the inglenook fireplace was reduced in width creating space for the insertion of a new entrance in the gable wall and a window in the room above.

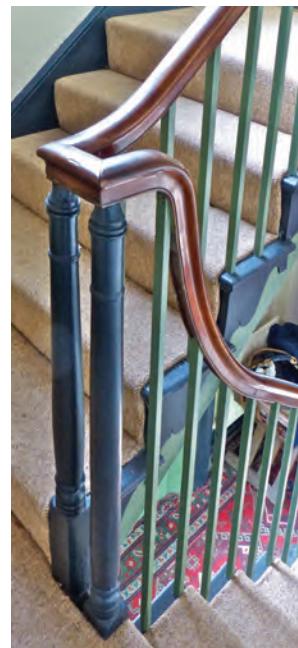
Fig. 8 Kingsbury Episcopi, Manor House. Ramped handrail and decorative brackets to treads

19th century in the elegant style of the late 18th: six-panel doors, an open-tread stair with ramped handrail and the eight over eight sash windows with slim glazing bars and unusually deep shutter boxes feature. Additionally, at least two hob grates suggest a late 18th-century date but are inset in 19th century surrounds.

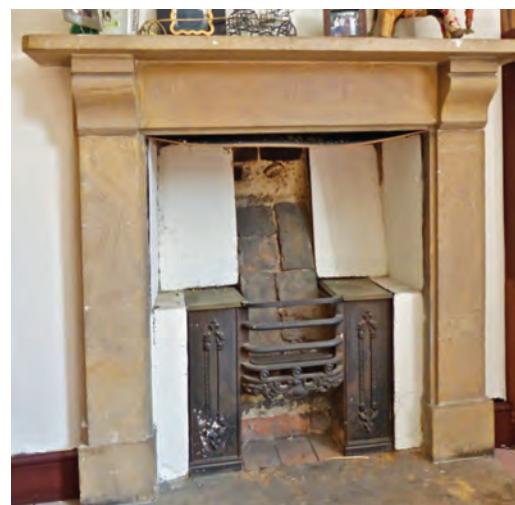
Fig. 9 Kingsbury Episcopi, Manor House, 18th-century hob grate in 19th-century surround

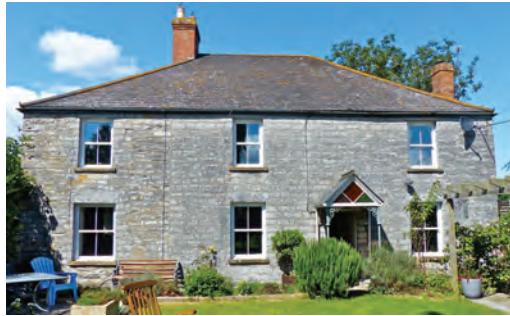
Fig. 10 Kingsbury Episcopi, *The Retreat*, front elevation

This house replaced the building shown on the Tithe map and was set further from the road. It was built of local lias stone about 1860 in a square plan with four rooms and presented a symmetrical frontage around an arch-headed front door opening into a through hall. A two-storey addition on the west

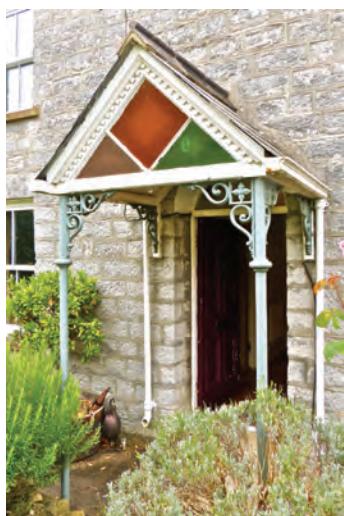
Fig. 11
Kingsbury
Episcopi,
The Retreat,
porch canopy
on cast iron
supports

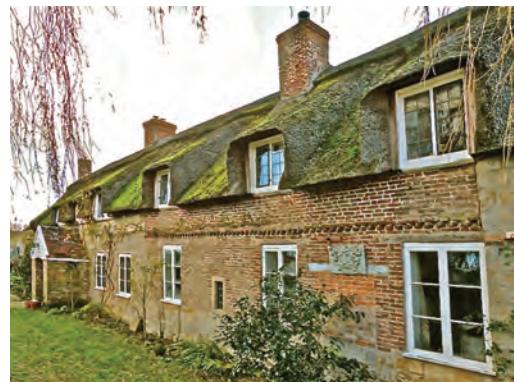
Fig. 12 Stocklinch, Ilford Bridges, front elevation displaying decorative brickwork

The house itself appears to have been extended to the west late in the 17th century and to have been re-fronted with brick, including a decorative string course, above a metre-high stone plinth, a clear display of status and wealth. Inset in the ceiling of this extension is a decoration, an elliptical foliate border containing the Speke family crest. The Speke family crest also tops a, now blocked, external doorway into this room. (Sir George Speke was granted the Hundred of Abdick and Bulstone in 1611 and documentary sources imply that the Hundred Court was held here until the second half of the 19th century.)

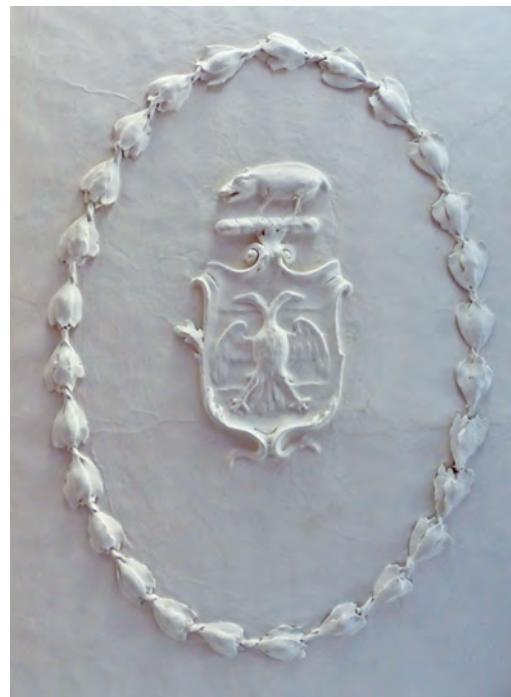
Fig. 13 Stocklinch, Ilford Bridges. The Speke crest as a ceiling decoration. The pig is shown as a porcupine in another version

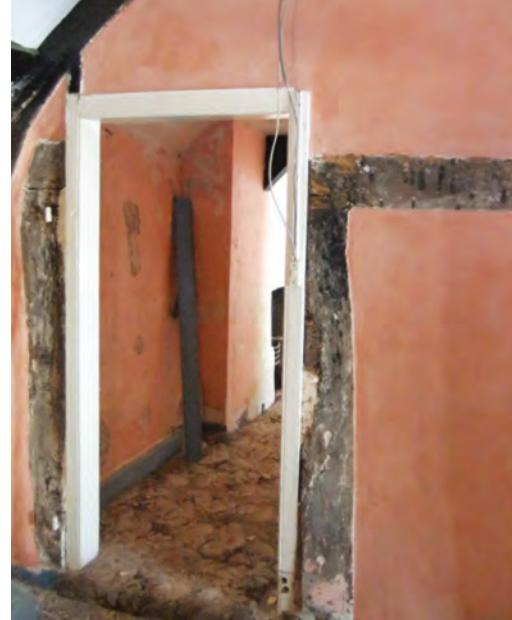
Fig. 1 11 West Street, Dunster: infill truss with evidence of earlier door to solar

A two wing house with smoke blackened jointed cruck frames and one true cruck. The house comprises four bays parallel with the road and a rear wing of two bays with two more jointed cruck frames. An infill truss indicates the end of the Hall beyond which was an inner room with solar above. At the other side of this are the remains of what appears to have been a true cruck truss, cut off at first floor level at the street elevational wall possibly when a shop front was inserted as indicated by an existing bay window. The truss infill is of wattle and daub and the wall separating the rear wing is of cob. An earlier lateral stack is indicated by herringbone fireplace backing in the street wall and slight surface irregularity externally.

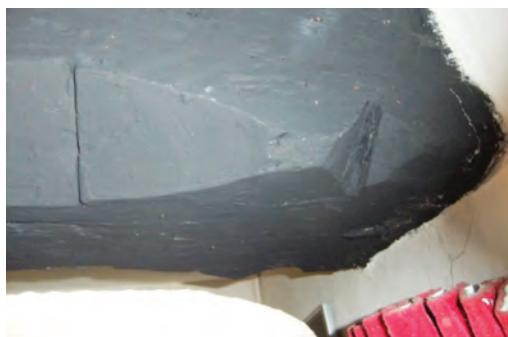
Fig.2 Stop moulding with nick at Knutsford Cottage, Milverton

A two room and cross passage house of the 17th century with workshop (now garage) beyond. Beside the large Hall fireplace the position of former staircase is indicated by a curved wall at first floor level and a blocked window. The top of the original wall before the eaves were raised is still evident in the first floor as a shelf. The bressumer at the fireplace has mortice cut outs and it has been suggested that this was for joists to support a sleeping platform, an unusual feature. The beam in what was the Hall (inserted when the first floor was added) has a chamfer with step, run out and nick stop.. This feature has been seen in a number of properties in Milverton.

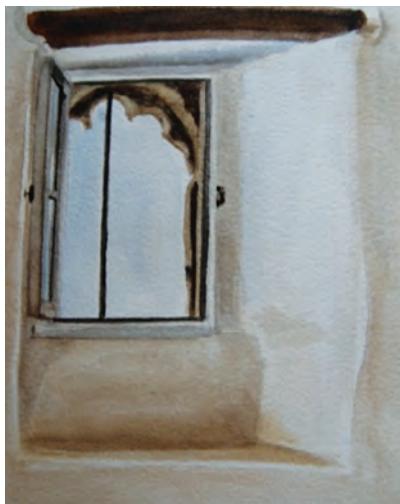
Fig. 3 Chantry Cottage, Porlock: First floor window painted by Clare Maryan-Green

An exceptionally well-preserved roof consists of 4 jointed cruck frames with cambered collars. Purlins are missing but an empty mortice indicates a bridge mortice joint where the purlin was formerly pegged. A first floor fireplace has pyramid stops and a window has remains of stone cinquefoil head. This was a 3 cell house of 2 storeys. The most visible feature is the early front door frame. A detailed chantry document transcribed by E. Chadwyck Healey, indicates that this building was "erected anew" in the lifetime of Lady Elizabeth Harrington who died in 1471.

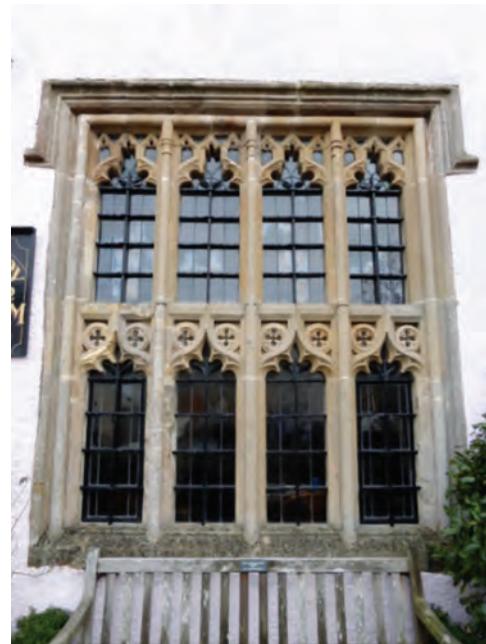
Fig.5 Dovery Manor, Porlock: Main window facing west. (photo: Catherine Dove)

The **north block** was evidently “built to impress”. By 1893, the large window facing west into Porlock, had been largely covered over, but remaining details were carefully recorded by Edmund Buckle (see “*A History of the part of West Somerset, comprising Luccombe, Selworthy, Stoke Pero, Porlock, Culbone and Oare*”; Chadwyck-Healey, 1901, pps 297-301) and the window accordingly restored. In the ground floor room is a heavily coffered ceiling (ogee and hollow moulding) and a fine fireplace of the late 15th century. The hood on the fireplace has a little damage at the centre where there may have been a crest. The circular stairs rise beside the fireplace and are coeval with it (Ref; *Archaeological Watching Brief*: Andrew Woodcock, 2007). In the first floor chamber is a later fireplace and a fine arch-braced roof springing from elaborately carved wall-plates. A garderobe is adjacent to the staircase. The arch braces are chamfered with run out stops and more original timbers than in the south block (as indicated by the jointing) can be found here.

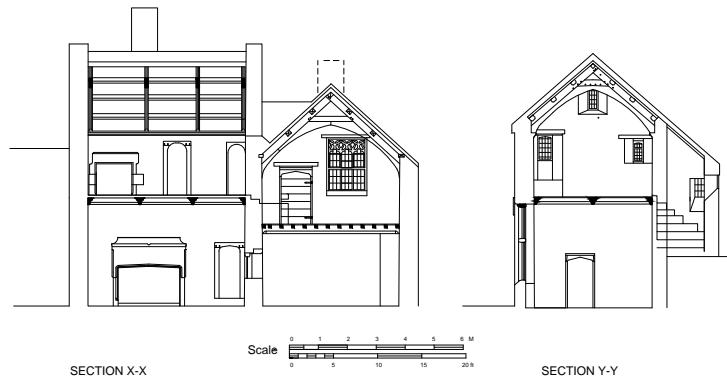
Fig. 4 Dovery Manor, Porlock: cross sections of the two main blocks

South block: The study of the building confirmed that the south block was earlier having been originally an open hall house with arch-braced cruck trusses, a principal upright of which can still be seen buried in the wall. This block including the roof structure was more heavily restored in 1893 possibly because it was in a worse state or because it was thought to be less important and later than the other block. In the recent renovation works, a link was made at first floor level with the north block in order to extend the Museum. Fireplace, beams and staircase suggest that this range was floored over in the early 17th century.

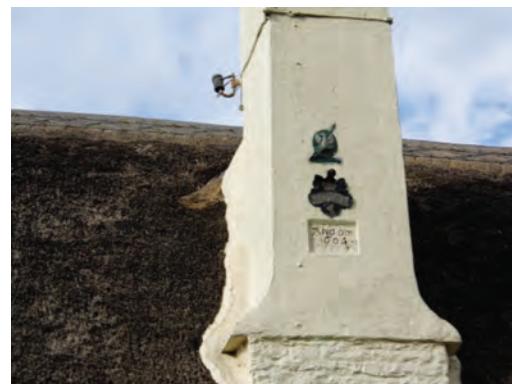
Fig. 6 Porlock, fire marks

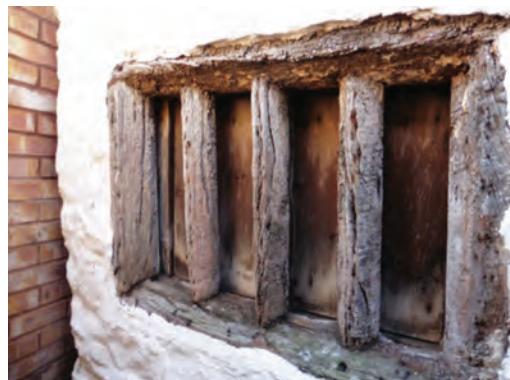
Fig. 7 Porlock, ground floor window
(photo; Catherine Dove)

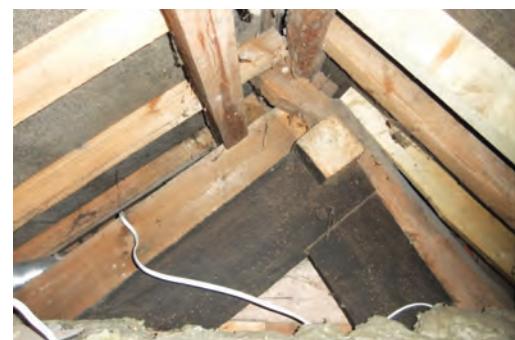
Fig. 8 Porlock, Ye Old Cottage: apex of jointed cruck frame

A small originally open hall house with two jointed cruck frames, the blade of one still in place from about 60cm above the ground floor level. Collar and purlins are missing and the ridge is diagonally set as is common in Porlock. Cob walls indicate the position of the cruck frames and there is an inserted lateral stack with modern window adjacent. The building stood on lands that supported the Harrington Chantry priests. At the time of the tithe records a tailor called Abraham Sparks lived here with his family. This name is found in Porlock's mediaeval records and the property continued in the family until the 1930s.
