BUILDING RECORDING IN 2018

SOMERSET VERNACULAR BUILDING RESEARCH GROUP

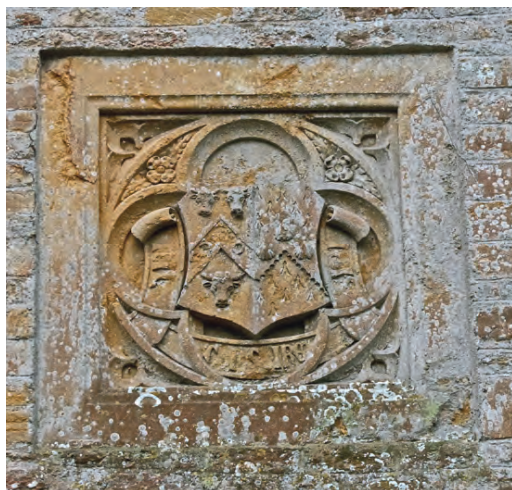
In the mid-19th century the lean-to was added, and a Troyte-Bullock coat of arms added to the west gable (Fig. 1), possibly reflecting the building of North Coker House and the acquisition of this property by the same family.

*Fig. 1 East Coker, North Coker, Chantry House,
Troyte-Bullock coat of arms on west gable*

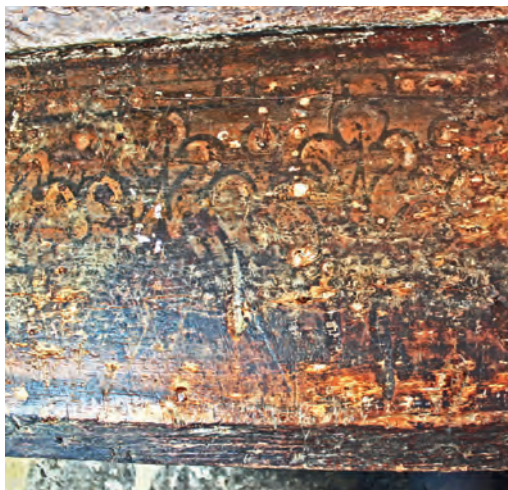
*Fig. 2 Isle Abbots, Pitts Cottage,
Painted decoration on fireplace lintel*

A second phase is likely to accord with the date stone of 1583, the year when a John Pitt was born; it was possibly an investment by his father to mark this occasion. The property was upgraded; the central and a west gable fireplace were inserted as were the framed ceilings, one over the open hall. The central fireplace, backing on to the cross passage, is notable for its original floral painted decoration below a brick-like banded motif (Fig. 2). The painting itself has apotropaic marks scratched into it – the Marian mark ‘VV’ (virgo virginum) and a hexafoil (daisywheel).

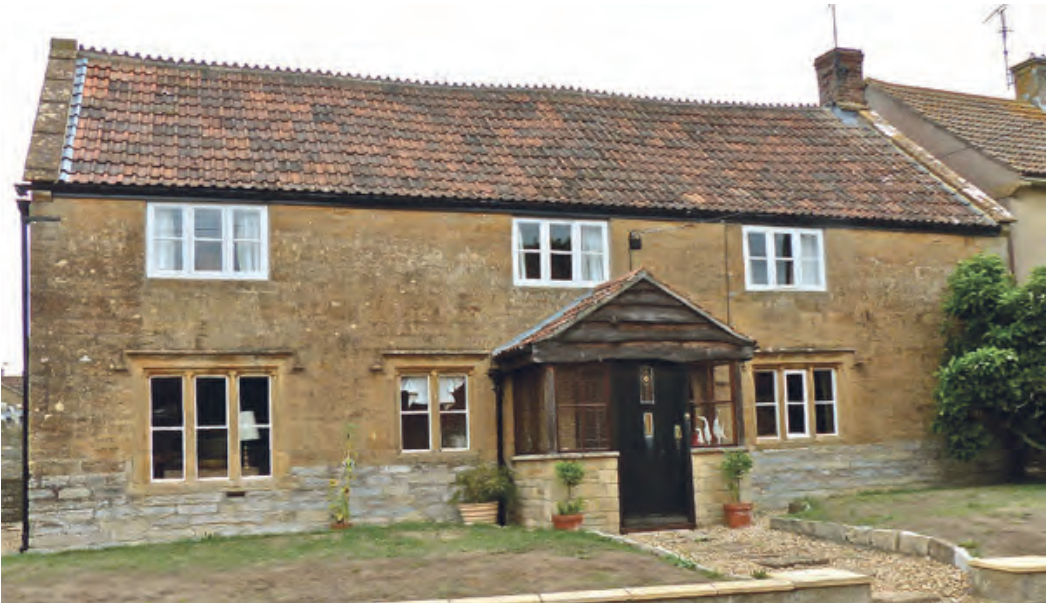
Once built of roughly coursed local lias stone, walls 0.6m thick, the front elevation is now Hamstone ashlar on a metre high lias plinth whilst the west gable is entirely of brick (Fig. 3). The roof is of double Roman clay tiles with cockscomb ridge tiles laid between raised and coped gables, indicating former thatch. It is now supported on three reworked elm trusses, two of which were formerly the upper elements of jointed crucks. One is smoke blackened suggesting an original smoke bay at the eastern gable. Jointed crucks and trencled purlins indicate an original mid-16th-century build.

Fig. 3 Kingsbury Episcopi, Kingsbury, Doke House, Front elevation with Hamstone walling on lias plinth

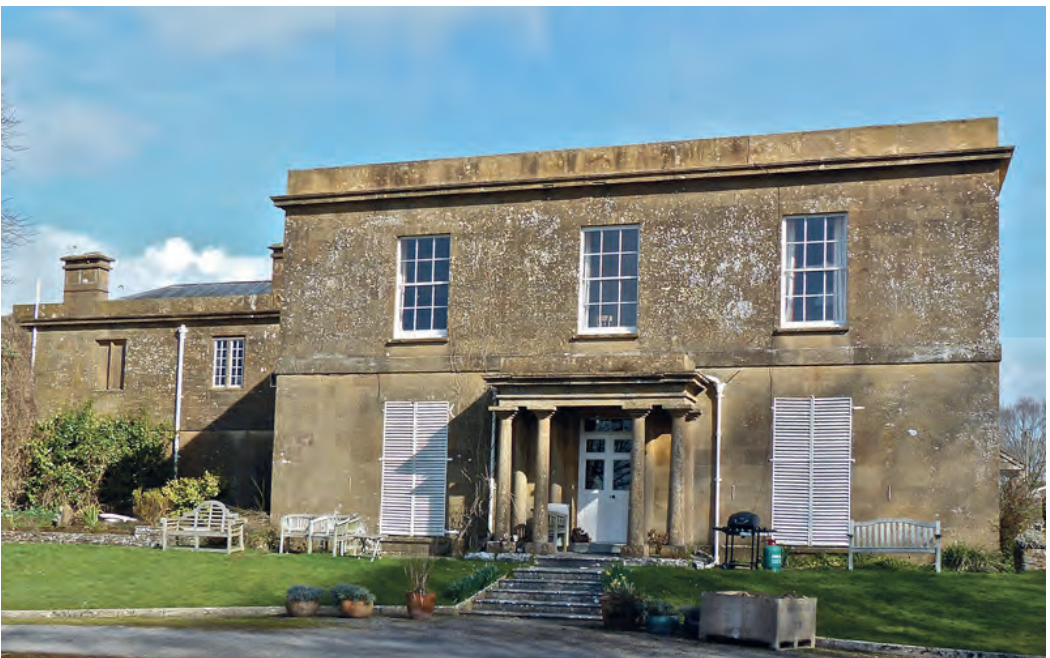
Fig. 4 Kingsbury Episcopi, New Cross, New Cross Farm, Classical front elevation and additional wing on west side

To the west and aligned with the rear of the main building is a narrower, lower two-storey wing added in the mid-19th century. The use of two fine, but unmatched, 17th-century fireplaces and similarly dated two-light stone mullioned windows point to reuse from another building. To the rear a wider ground-floor window has been converted to a double-width door with steps down to the yard level. It is believed that the ground floor in this wing was not for domestic use but rather for farm processing.

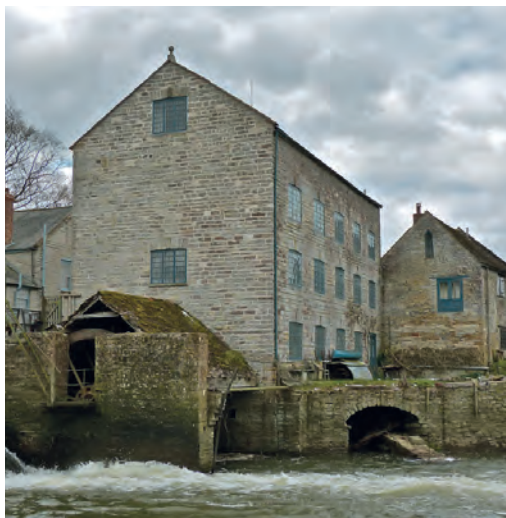
The mill, a rectangular industrial building constructed in coursed lias stone is three-storeys high with an attic floor (Fig. 5). The 34° pitched roof is supported on four tie-beam trusses positioned in line with the main floor beams. The floors were all 'open' and connected by enclosed straight flights of stairs situated against the west gable wall. Details of the mill machinery, provided by Martin Watts, are included in the survey report. In 1875 the mill was described as 'working four stones'. In 1964 the upper floors of the mill were altered for domestic occupation which included the installation of a water turbine, now removed, to generate electricity.

Fig. 5 Kingsbury Episcopi, Thorney, Thorney Mill, View across the R. Parrett showing external wheelhouse

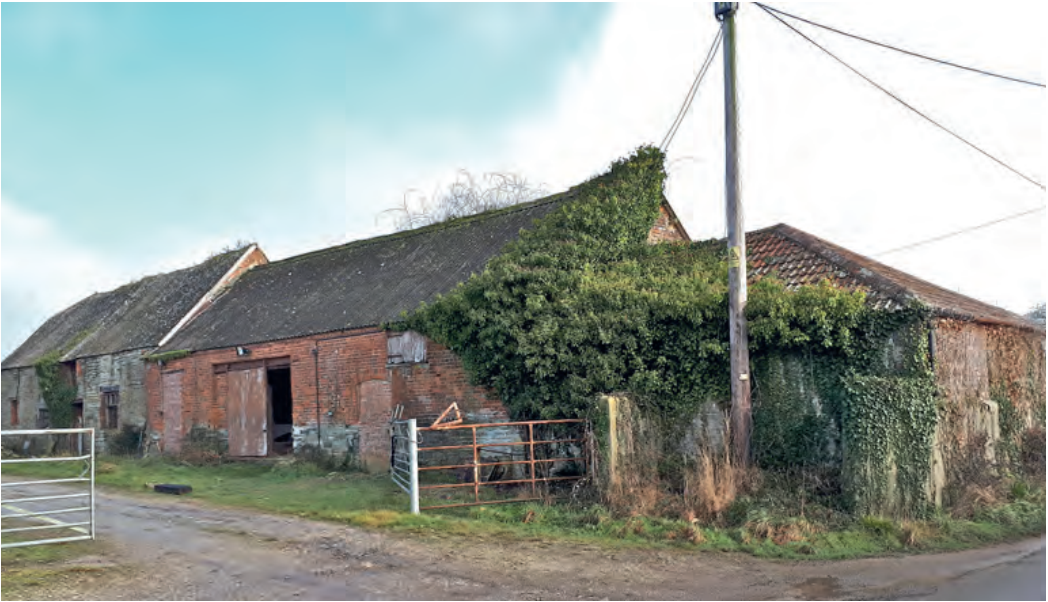
A single-storey range of farm buildings with five phases of build dating from the Agricultural Revolution, c. 1800 (Fig. 6). The two-storey principal barn, in the centre of the range, was built of coursed and squared local lias stone. Tie-beam and collar trusses support the probably half-hipped roof. It would have been variously used for

Fig. 6 Limington, Draycott Farm Barns, Stone and brick barns viewed from the south west

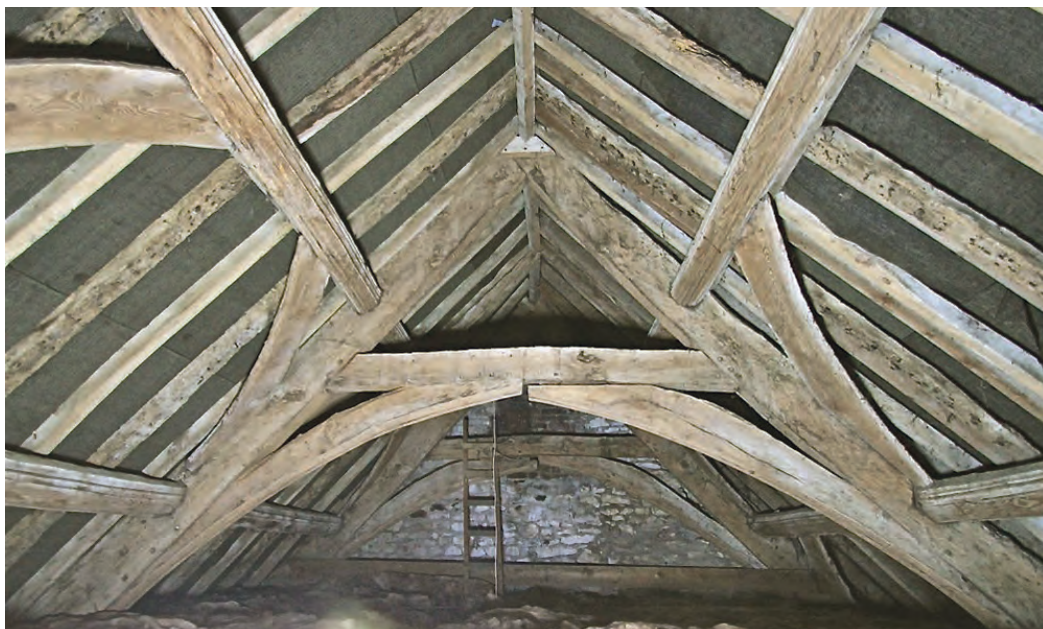
The roof, now showing multiple stages of repairs, is constructed of oak arch-braced collar trusses with a pitch of 50° (Fig. 7a). The principals meet with a plain tenon joint at the pierced apex. The trestle-sawn collars are slightly cambered and supported by moulded, open arch braces meeting at the centre of the span. The two tiers of moulded purlins house wind-bracing (Fig. 7b). This is clearly a roof structure that was meant to be seen

Fig. 7a Milborne Port, 14-17 High Street, The west end of the high quality arch- and wind-braced roof

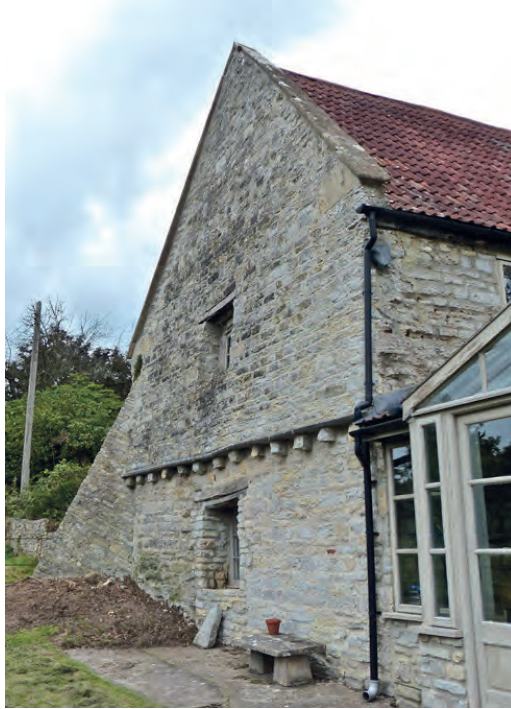
Roman clay tiles (Fig. 8a). Wall thicknesses are about 0.75m, but are 0.8m at the west end where the upper floor and gable are jettied out on stone corbels. All one construction, it is possible that this building was a 'longhouse', a two-unit dwelling (hall and unheated inner room) separated by the passageway from cattle/storage at the unheated end where some windows were unglazed. The lack of an obvious food preparation area suggests a detached kitchen.

Fig. 8a Pilton, Upper Westholme Farm, Stone-jettied west gable

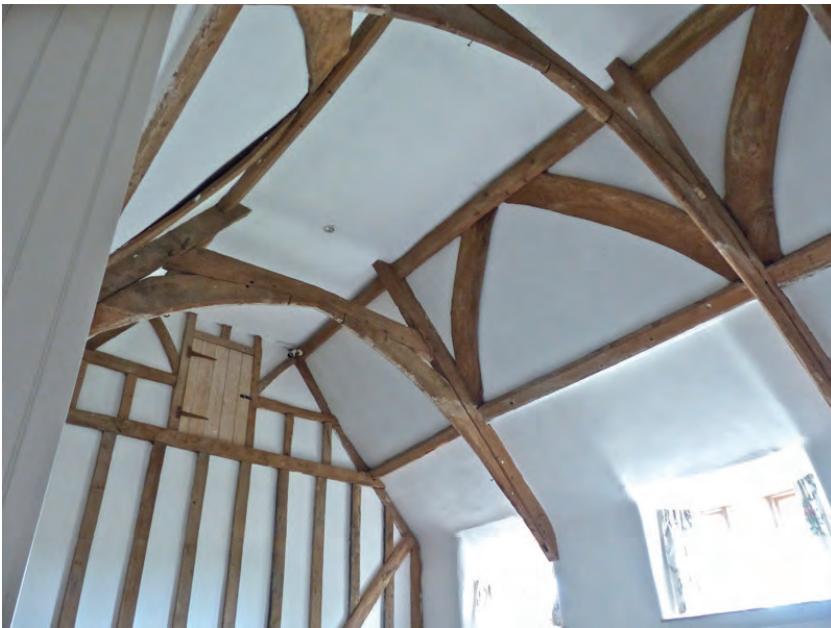
Once part of the Glastonbury Abbey estate, the main features of the house, particularly the arch-braced roof and the framed ceilings (Fig. 8b), point to a construction in the second half of the 15th century. The absence of smoke blackening of the roof confirms that it was built with a hall fireplace and chimney. The floor above the hall has a fireplace opening into this chimney and is probably original, heating a room that was open to the roof exposing the arch-braced collar trusses, deep cambered collars and wind braces. Extant detail in the property suggests high status: two framed ceilings, one of nine and the other of twelve panels, both beautifully, but differently, moulded. Doulling stone and Hamstone four-centre headed doorways with security bar slots in the jambs gave entry to the passage and dwelling and the winder stair in the turret was accessed from the hall via a four-centred arch wooden doorway.

Fig. 8b Pilton, Upper Westholme Farm, Roof in the domestic end of the house

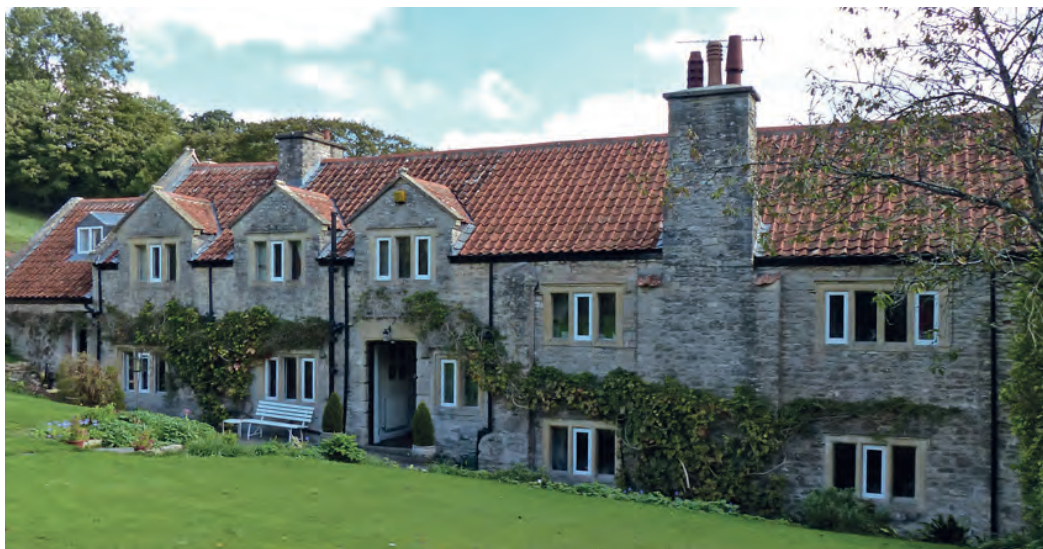
Fig. 9 Shepton Mallet, Ham, Cleavers, Old and new mullioned windows on west elevation

The farm was sold in the 1920s and planning permission for conversion to a dwelling was obtained in 1937. Use of 17th-century style mullioned windows, some original to the period, gives the house its 'old' appearance (Fig. 9).

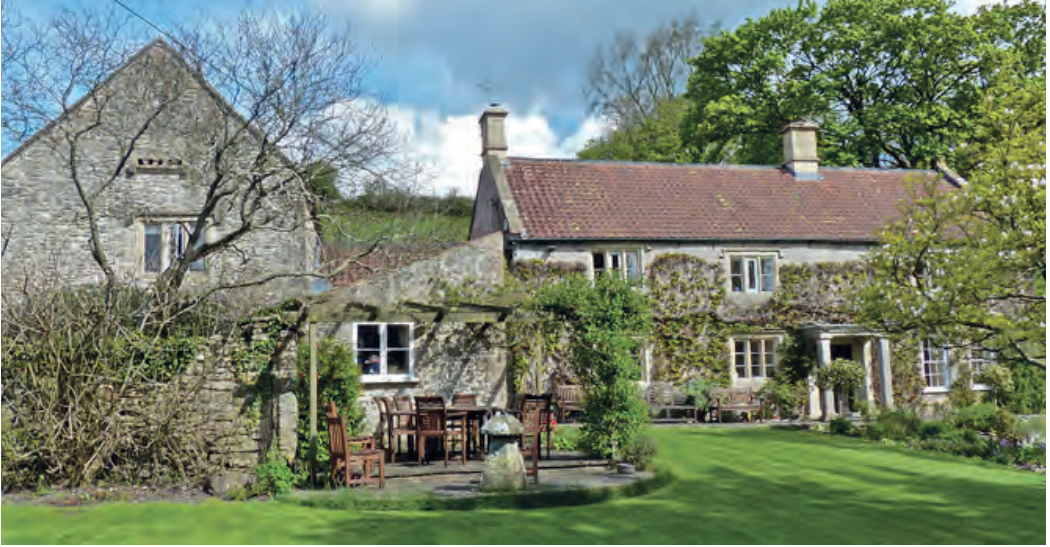
Fig. 10 Shepton Mallet, Ham, Ham Manor, South elevation showing the three elements of the house

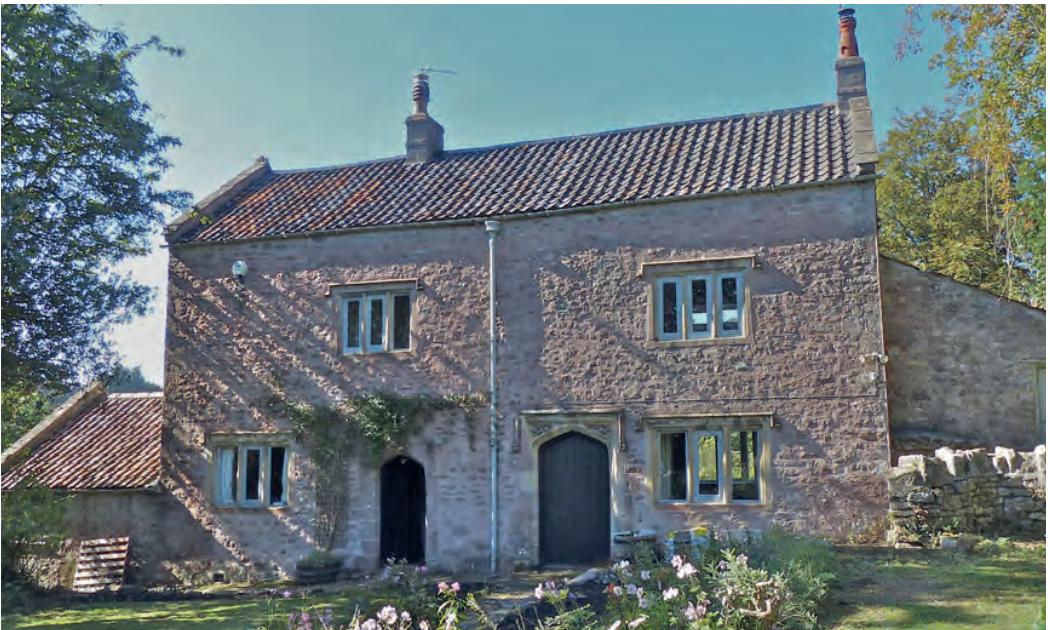
Fig. 11 Shepton Mallet, Ham, Old Manor, left-hand door is 16th century, right-hand door is 19th century. Mullioned windows inserted

The house is a listed two-storey property with attics built of local limestone rubble with squared quoins (Fig. 11). It was formerly an unheated non-residential building - a barn. The main part was probably built in the mid-17th century as a barn/storehouse. The four-centred entry doorway may date from the late 16th century. An in-line, adjoining but originally unconnected, building was erected in the late 18th century, and in the mid-19th century there was another addition on the west side. Evidence for late 19th-century conversion to a dwelling can be seen in the stair window, the brick chimney stacks and the roof all creating a dwelling that gave the appearance of an old house with ovolo moulded mullioned windows.

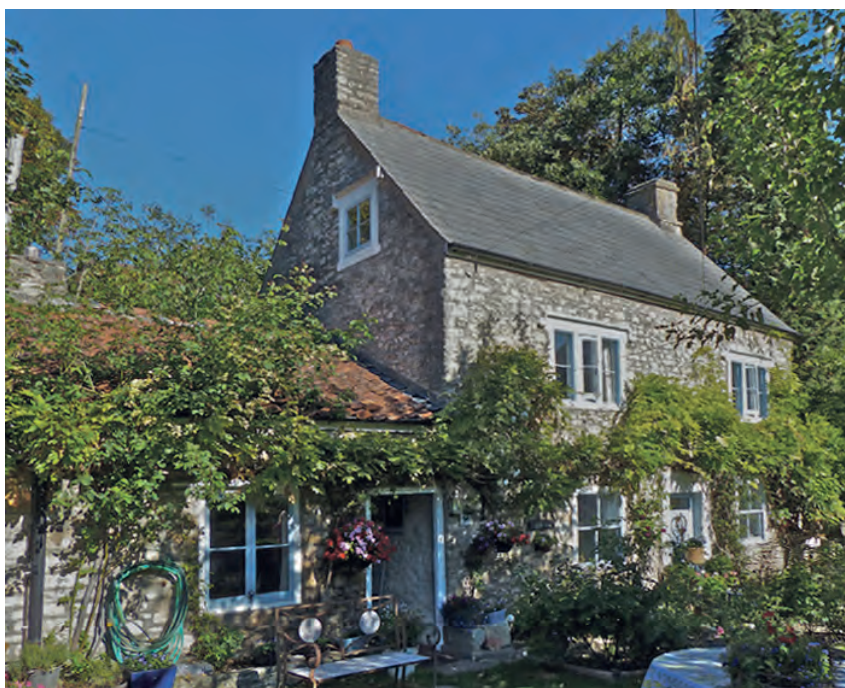
This small, listed house backing onto the mill leat comprises a two-room main house (kitchen/living room and an unheated parlour) of two storeys and attic in height (Fig. 12). It is built from local rubble stone with squared quoins, and has two single-storey in-line extensions. Extremely steep newel stairs rise through to the attic.

The front elevation has windows symmetrically arranged and a central entrance door. The upper windows, front and gable, have hood moulds above stone bead-edged surrounds (Fig. 12); the ground floor has sash windows beneath timber lintels. The front door also has a stone bead-edged surround.

Fig. 12 Shepton Mallet, Bowlish, Wells Road, Weirside, Hood moulds over 18th-century first-floor windows

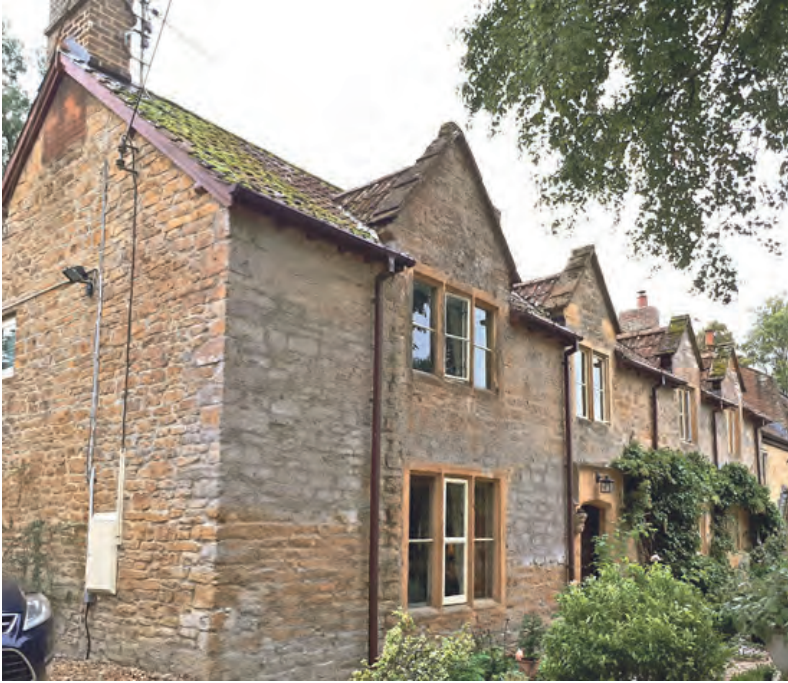
Fig. 13 South Petherton, 24 Silver Street, Kings Pleasure, House viewed from north east

Formerly known as 24 Jugglers Hill, this is a listed building of two storeys constructed from coursed, well-cut and faced Hamstone and some local marl stone (Fig. 13). The plan is rectangular and suggests a three-unit cross passage build, perhaps of c. 1600, with later rear extensions. However, the walls to the east of the cross passage are thinner, at 0.5m, suggesting a rebuild in c. 1800. An almost completely concealed post by the entry door may be the base of a cruck truss, a surviving remnant of a single-storey medieval open hall house constructed from cob.

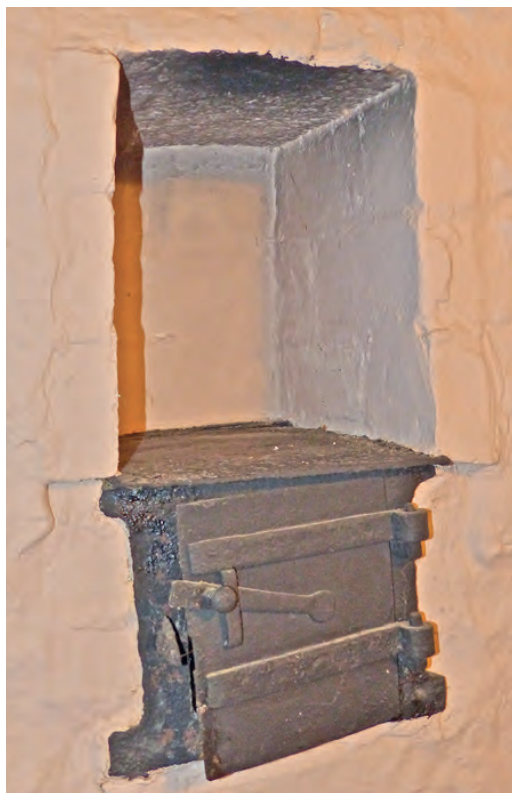
Early in the 18th century a single-storey extension was added on the south gable. This became the kitchen with a large fireplace incorporating an oven and a summer oven (Fig. 14); new doorways created a cross way against the original gable wall. A second floor was constructed above this in the late 18th century, part of the

Fig. 14 Sparkford, Little Weston, The Dairy House, Summer oven within the large inglenook

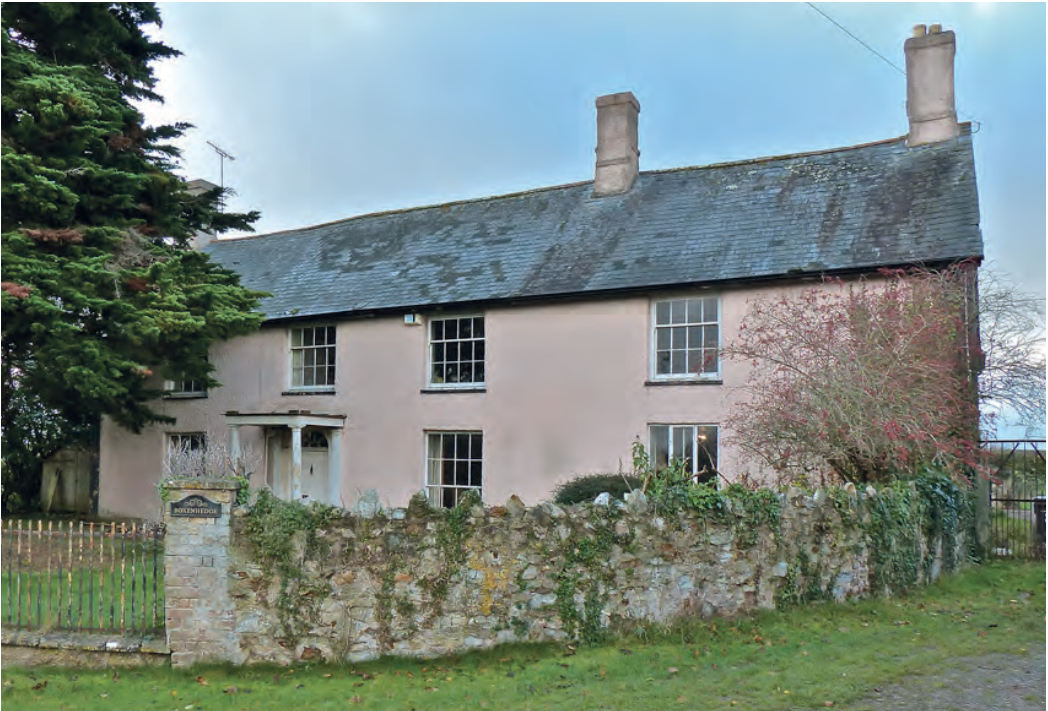
This listed property has a plan of two rooms either side of an entrance hallway, a further in-line room to the west, two rear wings and a stair turret (Fig. 15). Wall thicknesses vary; some walls are of cob indicating a possible earlier building on site. Walls are rendered and colour-washed beneath a roof of asbestos slates, possibly previously thatched.

Fig. 15 Trull, Dipford, Boxen Hedge, Regency styling to the front elevation

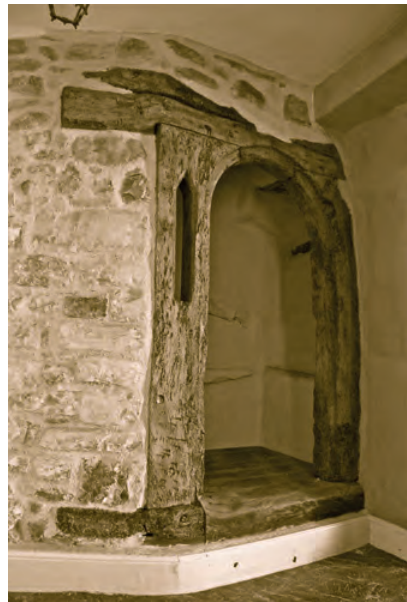
Fig. 16 Williton, Doniford, Doniford House, Door frame with pierced window at foot of solar stair turret

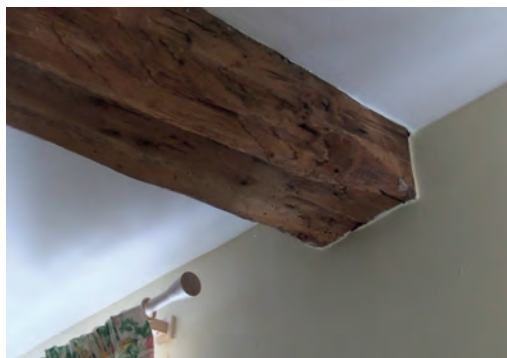
Fig. 1 Milverton, Irongates, First-floor beams

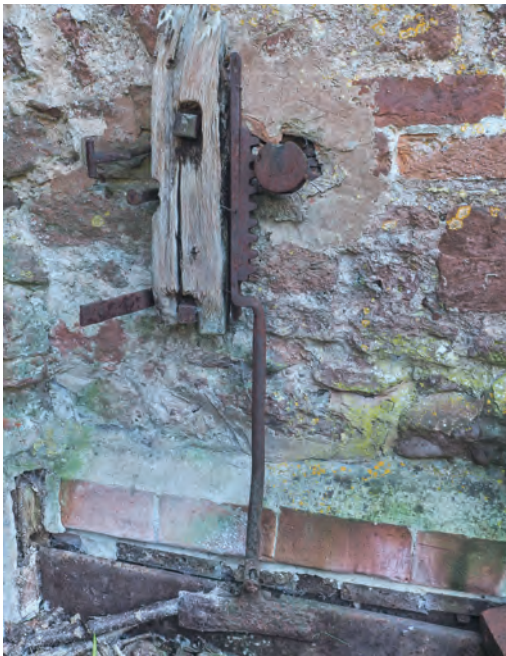
Fig. 3 Milverton Mill, sluice control

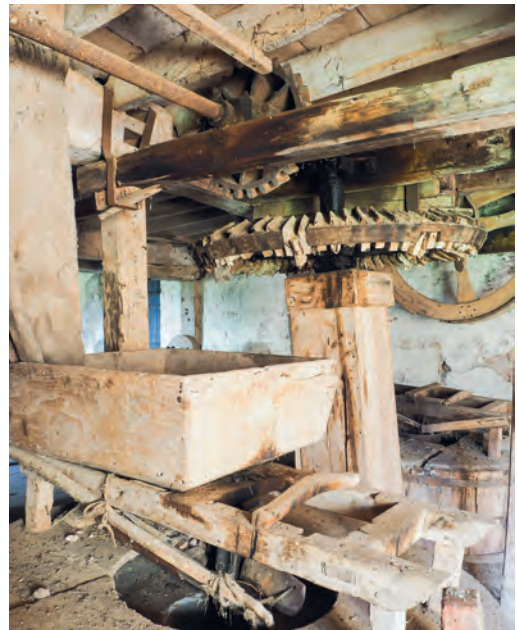
Fig. 4 Milverton Mill, Crown wheel with drive to two pairs of grinding stones and threshing wheel

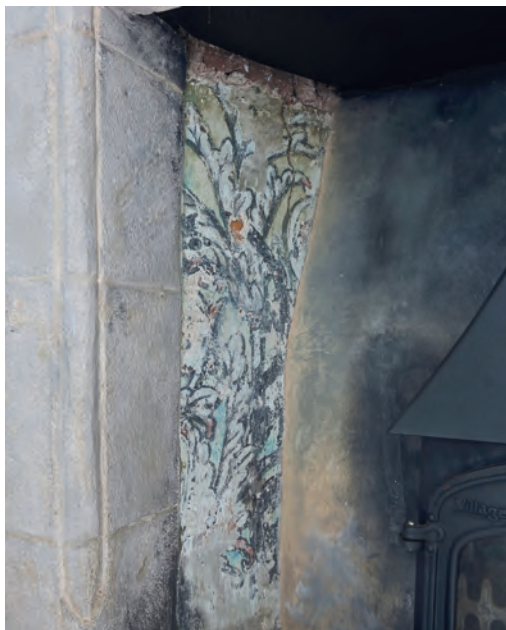
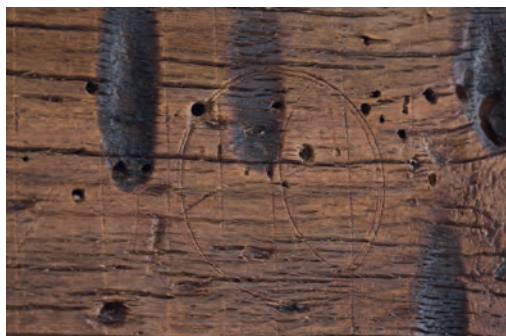
The detailing includes rustic plasterwork possibly incorporating human figures and a number of moulded door frames. One particularly interesting feature is a painted fireplace (Figs 5 and 6) similar to those described in the book *West Country Households 1500 – 1700* (Allan, Alcock and Dawson (eds) 2015). The examples in the chapter ‘Sgraffito-Decorated and Painted Plaster on Devon Fireplaces’ by Ann Adams are mainly in Devon although one has been seen in Chard as well as in Milverton.

*Fig. 5 Milverton, Rocklyn,
Painted work to fireplace reveal*

*Fig. 6 Milverton, Rocklyn, apotropaic
marks to fireplace bressumer*

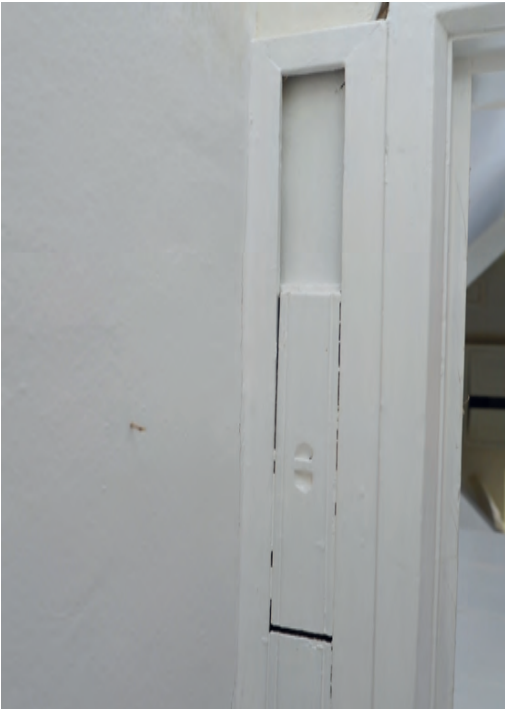
A symmetrical 18th-century frontage with rear extension following an earlier alignment. The house has been heavily altered with a large (41 x 21cm) wall-plate carrying the rear slope having been cut through with its end now supported on a cast iron column in order to allow space for a staircase to the attic. The attic rooms, no doubt used for servant accommodation, have early ventilation arrangements with cast iron grating at the outside wall face and a timber hinged door internally (Fig. 7). At the internal wall to the stairwell is a sliding

Fig. 7 Milverton, St. Mildred's, sliding ventilating door

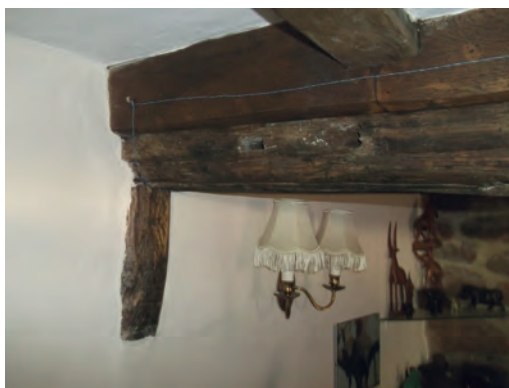
Fig. 9 Minehead, 11 Church Street, beam with roll moulding in former Hall

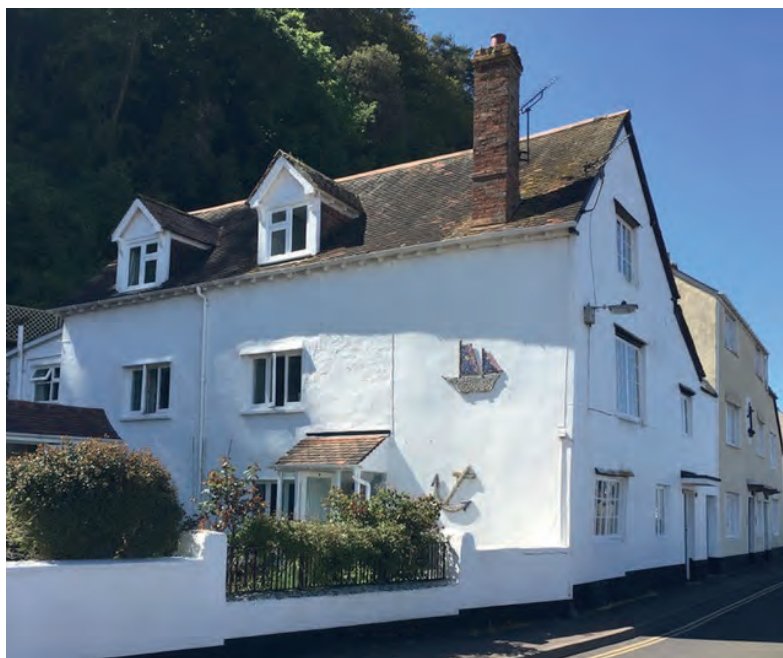
Fig. 10 Minehead, 45 and 47 Quay Street

In its original form it would have been a good quality merchant's house of three storeys with gable towards the sea (Fig. 10). Remains of a half-beam, heavily repaired, indicate an early partition in the ground floor separating a small room adjacent to the road, possibly a former workshop. The original circular staircase winds around a fireplace and another straight staircase was inserted when the property was made into two cottages as evidenced in the tithe record.

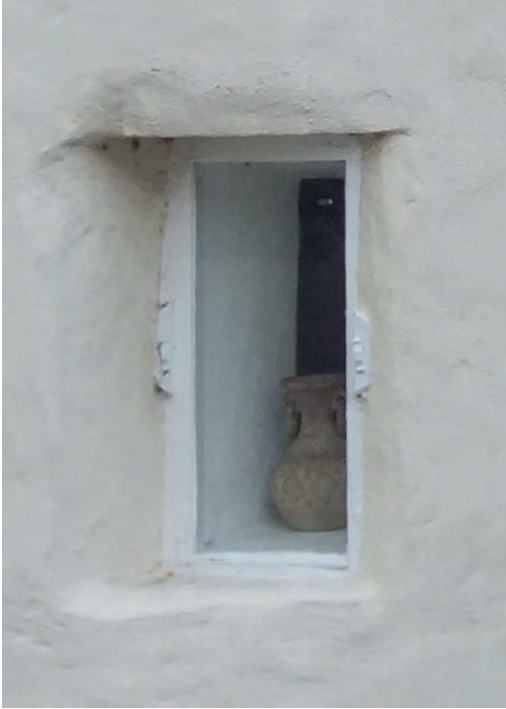
Fig. 11 Porlock, The Cottage, slit window with turnbuckles for missing shutter

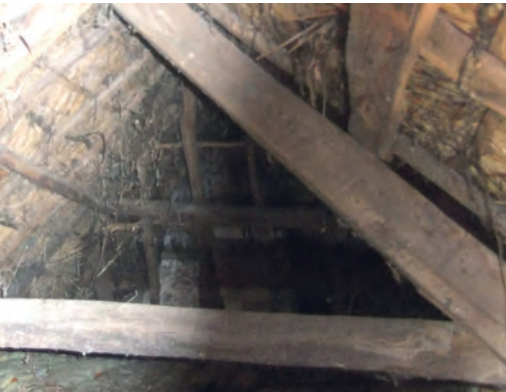
Fig. 12 Porlock, Locks Cottage, construction of earlier hipped roof still visible
