ROOD STAIRS OF THE DIOCESE OF BATH AND WELLS

JOSHUA SCHWIESO

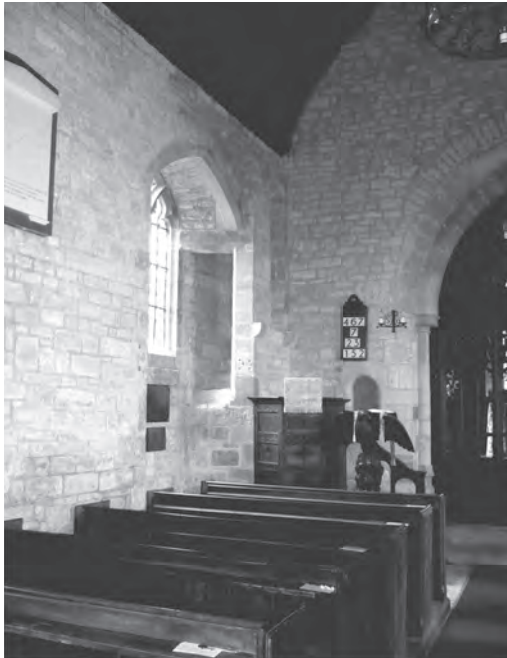
Fig. 1 Weston Bampfylde

Simple stairs could be fitted within the thickness of the church wall. They almost inevitably rise as a straight run, though in small buildings they may curve, not having to rise very far. Occasionally, as at Weston Bampfylde (Fig.1), these stairs start from a window bay. This awkward arrangement would

At Laverton the stair rises from a three light window within the buttress. As at Weston Bampfylde, this stair would be supplemented by a wooden stair or ladder when in use.

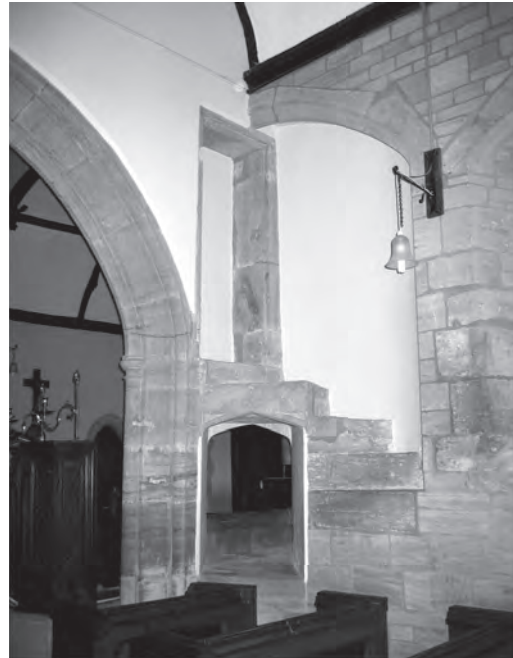
Fig. 2 Broadway

have required a wooden stair or ladder across the lower part of the window bay, but the window would have provided light to both screen and loft. A few stairs rise in an open recess (e.g. Broadway Fig. 2).

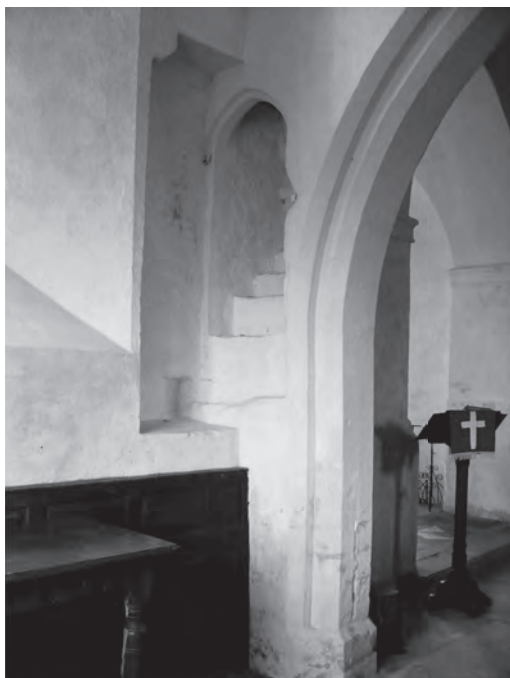
Fig. 3 Emborough

The stair may only have one or two steps, passing through a spandrel of the nave arcade from aisle to nave proper (e.g. Emborough Fig. 3). Clearly a ladder or stair has been lost in such cases since the “lower” doorway is, on average, 6 feet (182.88 cms) from the floor. The churchwarden’s accounts for Somerton refer to the removal of the rood stair c. 1581 and the insertion of a new window (Dunning 1974, 150), though the spandrel passage survives. Twelve spandrel stairs remain in the diocese.

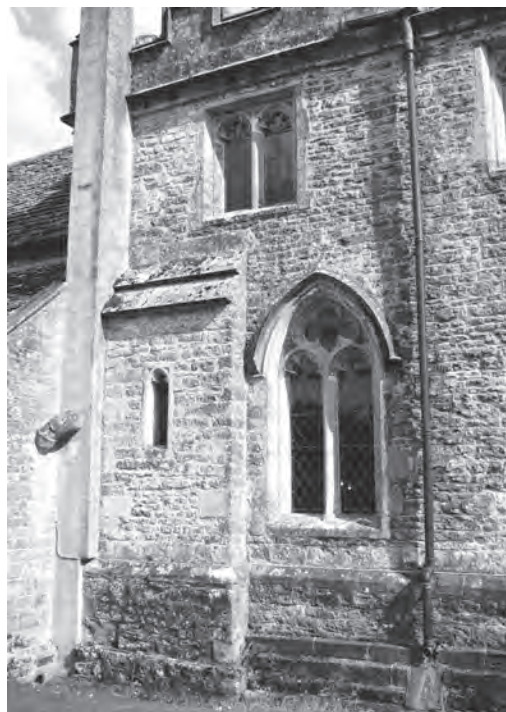
Fig. 4 Hemington

step in as they rise, rood buttresses are normally of the same depth most of the way up and are wider than they are deep. Most have sloping roofs of stone slabs (e.g. Hemington Fig.4), though some are now slated, e.g. Selworthy. Could such churches originally have been thatched? In two cases the buttress is gabled.

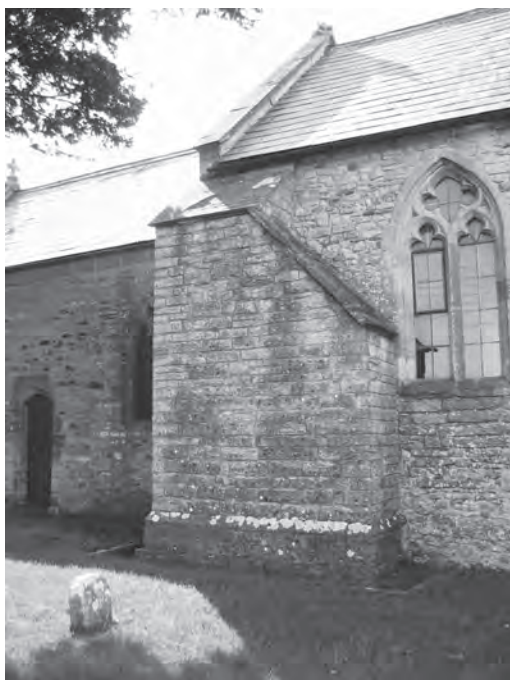
Fig. 5 Lyng

In some cases, perhaps to economise on material, the buttress steps up or slopes from west to east following the rising stairs, being higher at the upper doorway end than the lower (e.g. Lyng Fig 5).

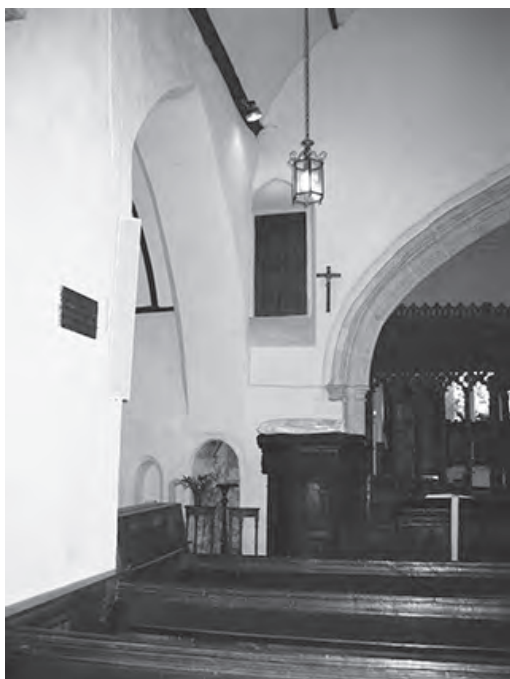
Fig. 6 Pawlett

Room for a spiral or a newel stair could be found where the chancel arch meets the nave arcade and, or, arch into a chancel chapel (e.g. Pawlett Fig. 6). Sometimes the walls are slightly thickened to accommodate it as at Tickenham.

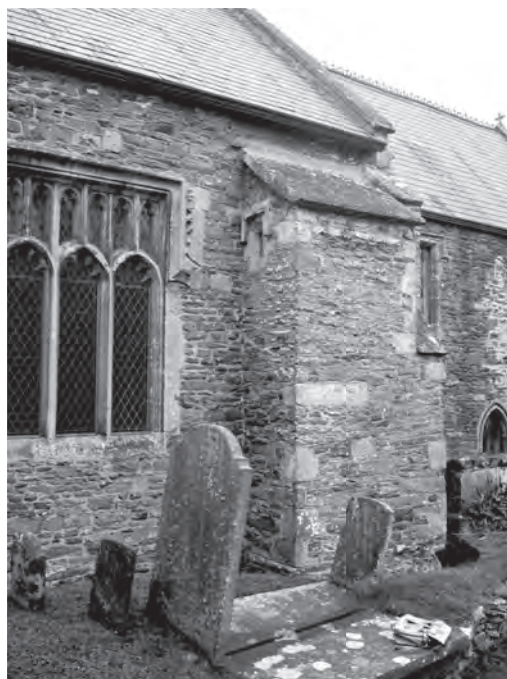
Fig. 7 Clapton in Gordano

The majority of rectangular turrets have sloping roofs (e.g. Clapton in Gordano Fig. 7) and only serve the rood loft. At Chilthorne Domer a rectangular turret continued upwards to the roof, narrowing above the level of the door onto the rood loft, suggesting that the main use of the stair was to reach the loft, roof access being secondary.

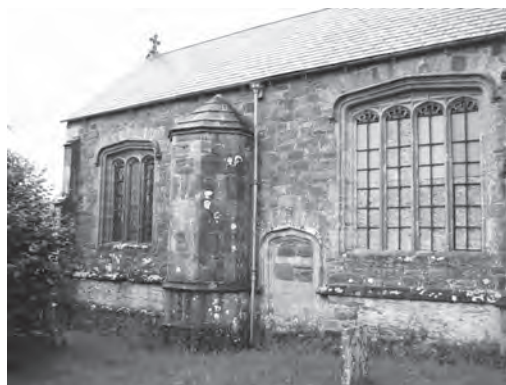
Fig. 9 Huish Champflower

The most architecturally appealing stairs have multiangular turrets. These may have ashlar quoins (e.g. Cheddar), or be wholly of ashlar (e.g. Stogumber Fig. 8). They normally also access aisle or nave roofs, though a few terminate below roof level (e.g. Huish Champflower Fig. 9). They are normally 5 sided, becoming irregularly heptagonal or octagonal above roof level.

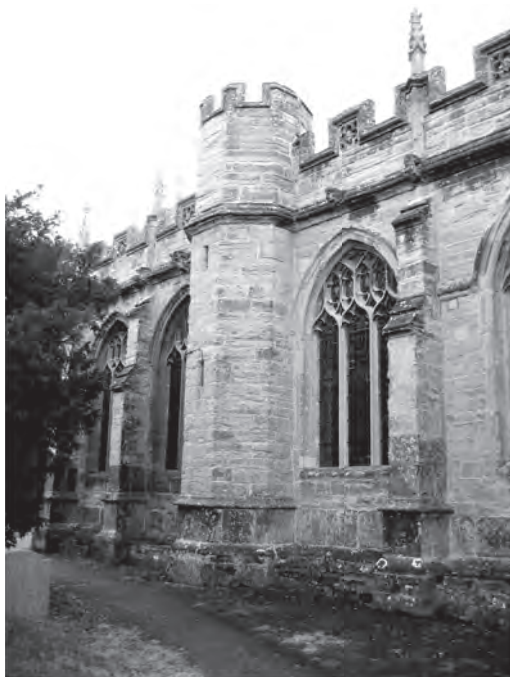
Fig. 8 Stogumber

Turret tops may be incorporated into aisle or nave parapets or given independent parapets. These may be panelled (e.g. Cheddar) or crenellated as at Stogumber. These are architectural features in

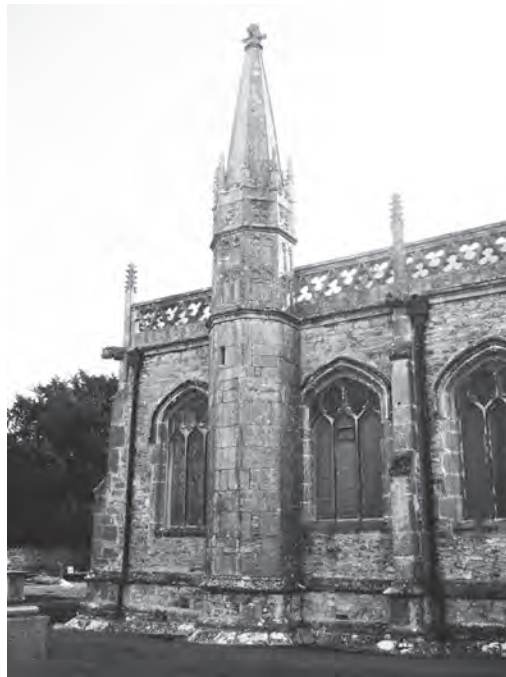
Fig. 10 Burrington

their own right. At Burrington (Fig. 10) the ashlar octagonal turret is crowned with a small stone spire, with pinnacles on the corners, above a row of quatrefoils, followed by a double tier of cusped blank tracery. Minehead has one of the finest rood turrets in Britain. Though technically multiangular, this huge turret is almost rectangular and contains a magnificent stair lit by 6 windows of varying size

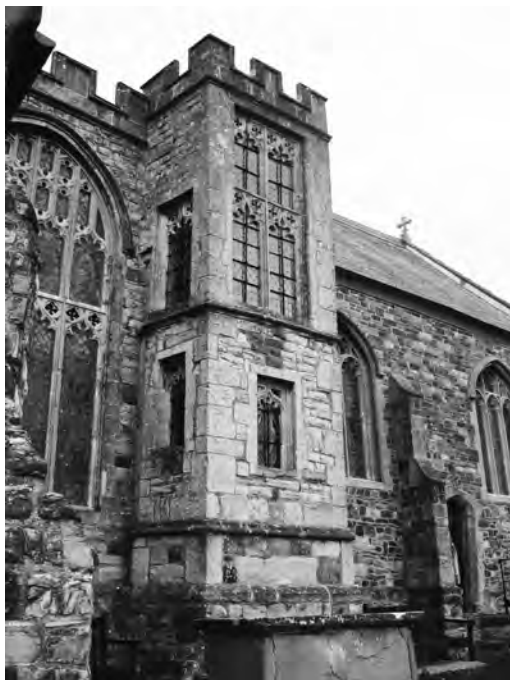
Fig. 11 Minehead

(Fig. 11). There are 37 multiangular turrets in the diocese.

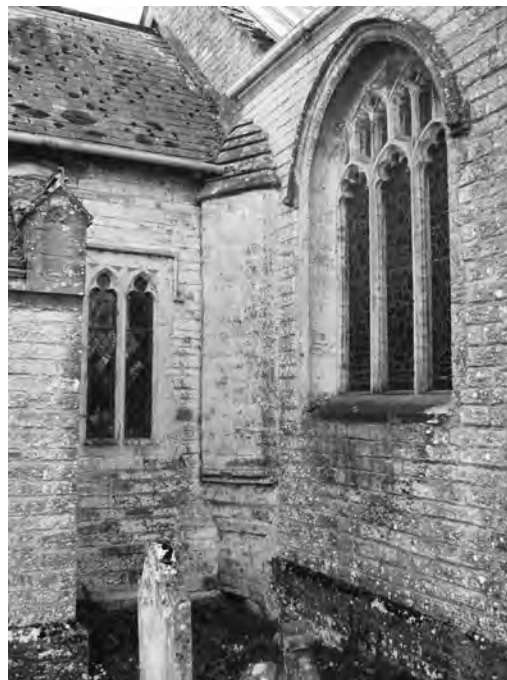
Fig. 13 Huish Episcopi

Where the rood stair stands at the junction of nave aisle and chancel (e.g. Curry Rivel), or nave and transept (e.g. Chard Fig. 12) the multiangular turret may only have 3 sides, at ground level. In a few cases such turrets are corbelled out above ground level (e.g. Huish Episcopi Fig. 13),

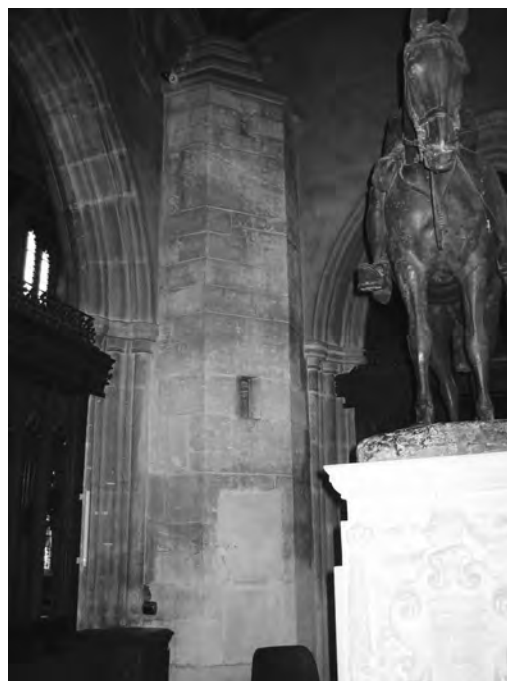
Fig. 14 Mells

At Mells (Fig. 14) a neat quarter turret with sloping stone roof stands at the junction of chancel and nave aisle *within* the north chapel. Foyle & Pevsner (2011, 555) regard this north chapel as an addition whilst English Heritage implies that all the arcades are of similar date (NHLE, Mells). It is therefore unclear as to whether the turret was originally outside or not.

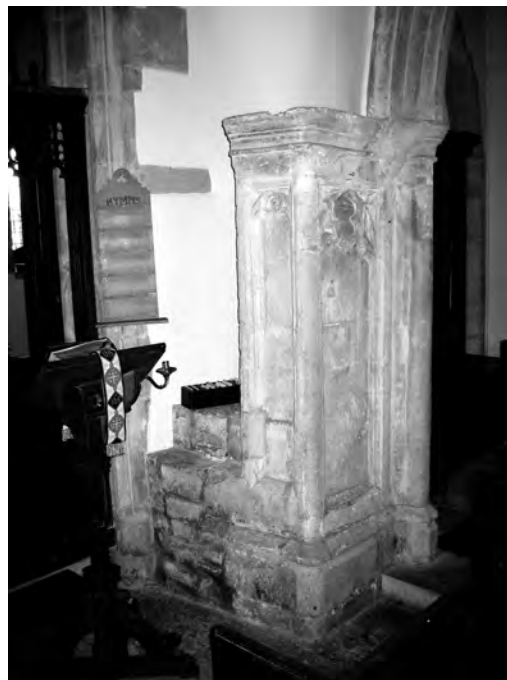
Fig. 15 Priddy

Two stairs do not fit the above categories. At Priddy there are the remains of a small panelled internal turret, now used as the pulpit (Fig. 15). Similar, though grander, structures survive at Totnes in Devon and Buckminster in Leicestershire. At Batheaston the rebuilt south aisle wall preserves the form of a substantial stair which started in a window bay before becoming a corbelled out quarter turret. Unfortunately the internal arrangements of this unique structure were lost during the mid-19th century rebuilding.

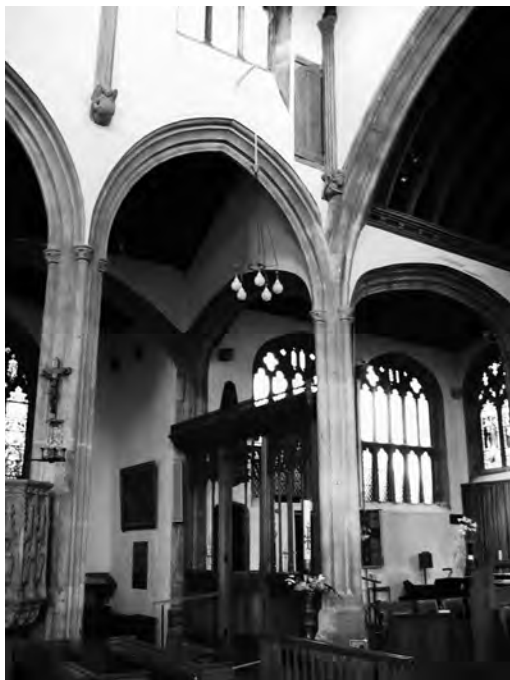
Fig. 16 Glastonbury

At Glastonbury St John two quarter turrets, one where the north aisle meets the north transept, the other where the same transept meets the north chancel chapel, provide clear evidence of a change over time. The aisle stair leads up to a doorway opening near the top of the aisle wall, which is now blocked by one of the supporting shafts and brackets of the north aisle roof. This seems to have served a loft that ran across the west side of a central tower taken down around 1465 (Dunning 2006, p.38). The chapel stair, accessed from the north chancel chapel, leads to a passage that passes horizontally above the (thickened) arch from the north aisle into the chapel, reaching a doorway high above the east

respond of the north nave arcade (Fig 16). It is likely that this replaces the aisle stair
