A CRUCK-ROOFED BUILDING
IN NORTH CADBURY.

A PRELIMINARY CATALOGUE OF CRUCK-ROOFED BUILDINGS IN SOMERSET

BY SIR ROBERT DE Z. HALL, K.C.M.G., F.S.A.

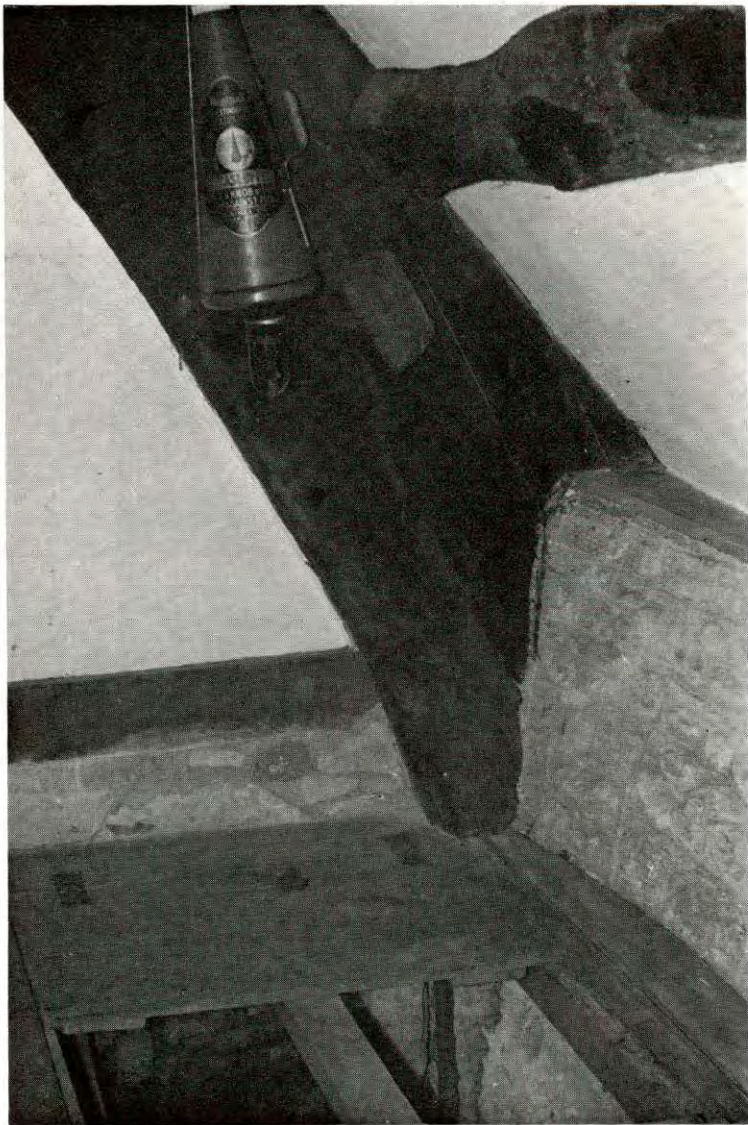
PL. XI Cruck blade, showing positioning of purlins and relation to later stairway.

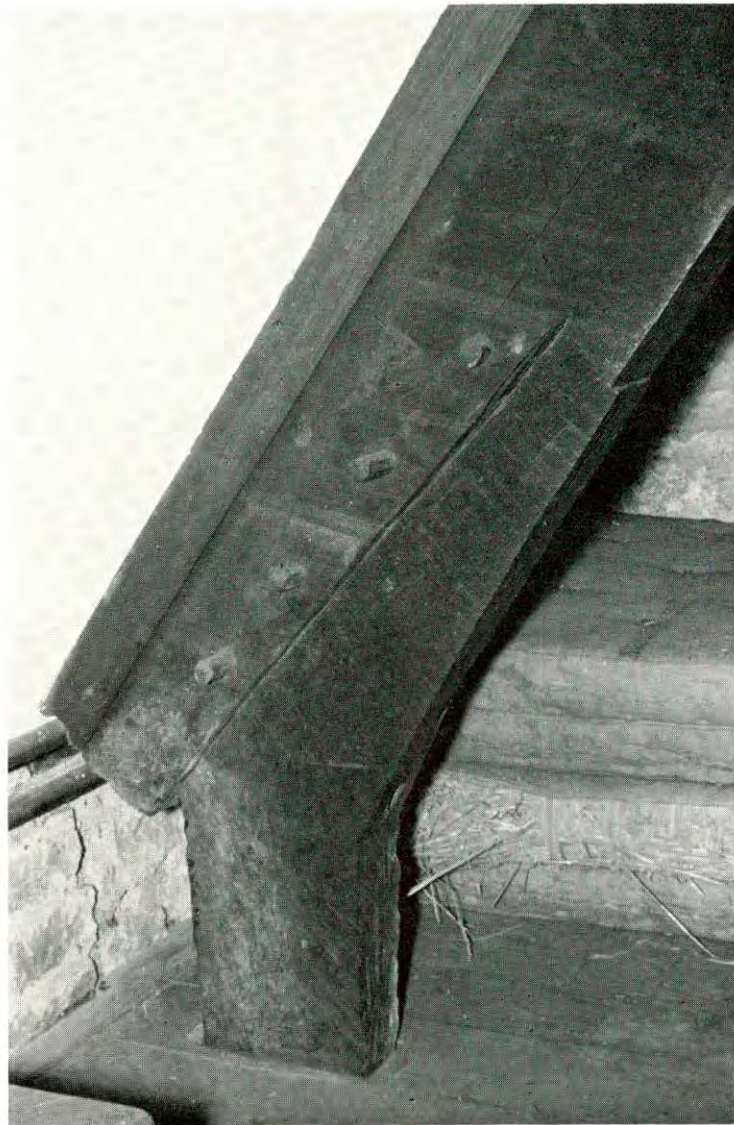
PL. XII Eastern jointed cruck blade, detail.
