A PROBABLE LATE-MEDIEVAL LANTERN CROSS HEAD FROM STAPLETON, MARTOCK, SOUTH SOMERSET

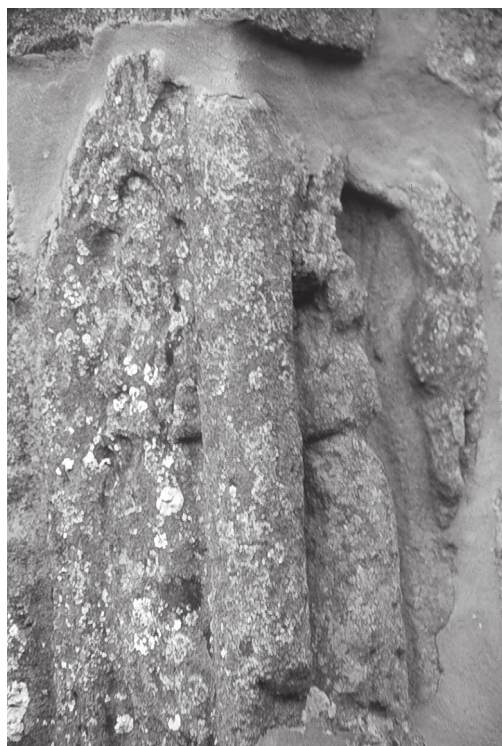
Fig. 1 A probable medieval lantern cross head at Stapleton, Martock; south and east faces

In November 2009 attention was drawn to a carved stone built into the south-east corner of a barn on the west side of the road in the hamlet of Stapleton in Martock parish (NGR *c.* ST 46252085 – house called ‘Eweleaze’). In photographs, the stone appeared to have a niche under an ogee arch inhabited by a female figure in a long dress. Examination in the field however showed that the photo was only one side view of a two-sided stone built into the corner of the building, with one face to the south and one to the east (Fig. 1). The second face also has a female figure under a niche. Close examination suggests that these visible faces form two sides (of four) of a square block of stone which looks like the head of a lantern cross. The stone therefore probably has two other decorated panels, facing inwards into the wall. If these faces have figures on them, they are likely to be less weathered and better preserved than the two faces currently exposed to the weather.

The stone is made of Jurassic limestone, and the south face is 490mm tall and 190mm across, the east face 420mm by 260mm. At each of the visible corners is a column-like pillar, the best-preserved of which is 460mm high and around 60mm in diameter. The two niches are occupied by female figures which are quite eroded so that the details of the carving are not clear. The figure on the south face may be holding a lily (the Annunciation?) or a sceptre in her right hand. The figure on the east face may be holding a baby in her folded arms. The iconography of the scenes on the stone remains unclear. It would be useful to see the other two sides of the stone (if they are still intact) and perhaps then some attempt could be made to explain the carvings.

This stone looks like the head of a late medieval lantern cross, but if so what is its context? Nearby is Stapleton Cross, the junction of the road running north from Martock to Long Load, and the road from Ash to Coat – other hamlets of Martock. This stone
