FAIRFIELD HOUSE, STOGURSEY: EXCAVATIONS, 2009

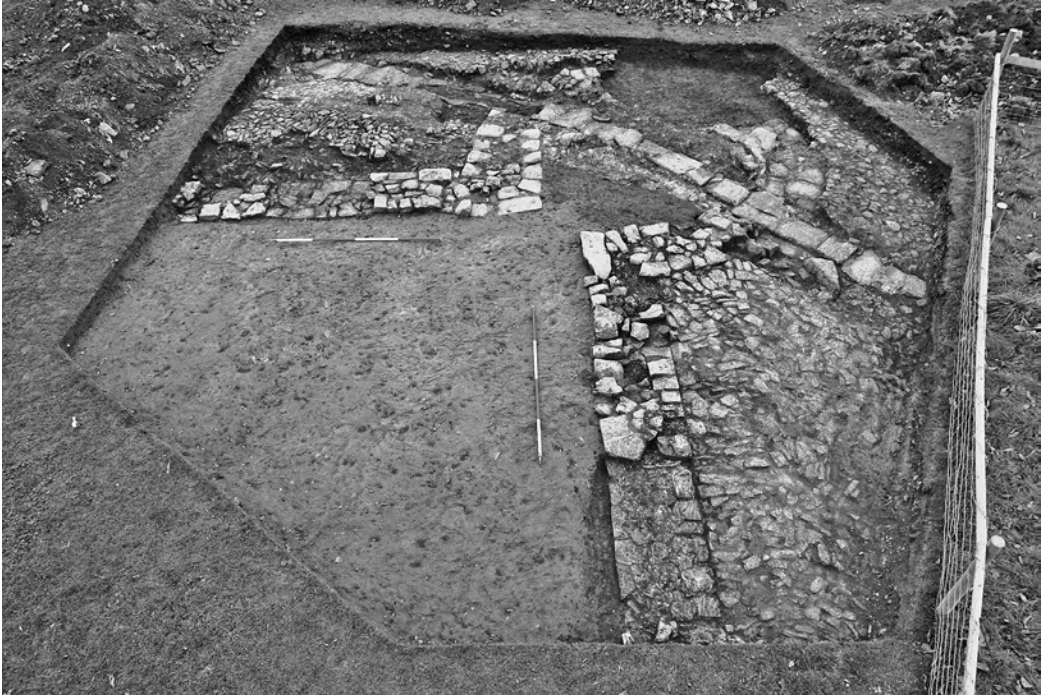
Fig. 2 Fairfield House: north-east corner of fortifications and circular tower; view east

landscaping of the grounds of Fairfield House that created the open, flat parkland of today. To the north-east, however, demolition of the late medieval structure had been less thorough, and in a trench excavated in the last week of the project, the foundations of the north-east corner of the fortification were revealed, complete with circular tower (Fig. 2). The excavations also revealed parts of the external cobbling and sunken roadway that skirted the enclosed area.
