A MEDIEVAL PACKHORSE BRIDGE AT DOWLISH WAKE, NEAR ILMINSTER

ALAN GRAHAM

SUMMARY

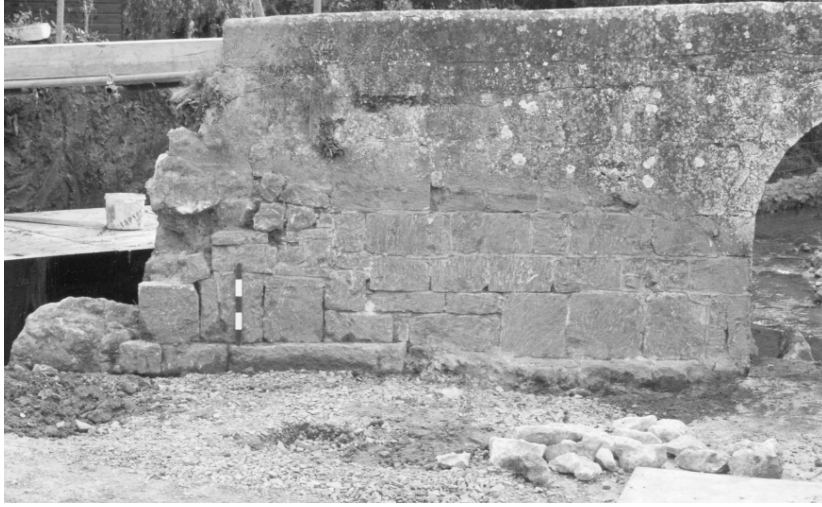
Fig. 4 South end of bridge, 0.5m scale stands on base course of Period 1 bridge; view west

An earlier period of construction was identified beneath both ends of the existing bridge during the recording of the elevations (Figs 2 and 3). This comprised masonry of ashlar blocks, stepped out slightly from the line of the existing bridge and set on a wider base course of ashlar slabs (Figs 4 and 5). During the insertion of the new arches, the east-west faces of this

masonry were exposed, the lowest two courses surviving to the north with elements of three courses on the south. In addition, a foundation of unshaped blocks was exposed beneath the southern abutment. Within the masonry forming the three faces of the abutments, there was an infill of mortar, loam and rubble. The southern abutment seemed clearly to have been built against the face of a vertical cut through earlier stream bed gravels (Figs 4 and 5).

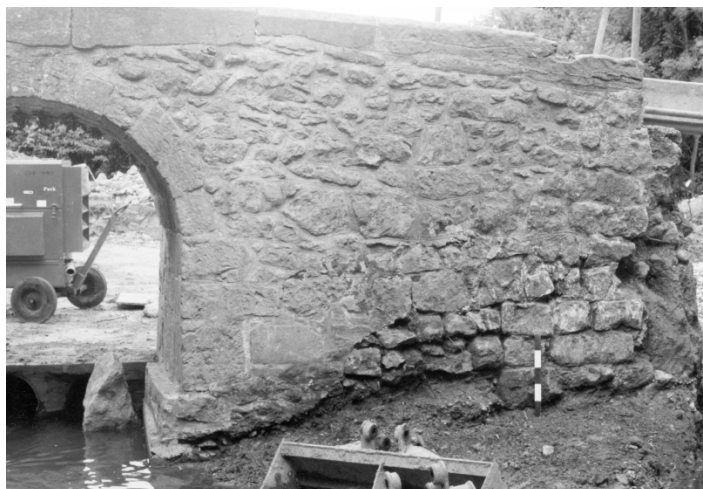
Fig. 5 South end of bridge, 0.5m scale stands in front of Period 1 abutment; view east
