FAIRFIELD HOUSE, STOGURSEY, SOMERSET: AN ARCHAEOLOGICAL STUDY OF THE GROUNDS AND THE HISTORIC FABRIC OF THE HOUSE

ALAN GRAHAM AND RACHEL SHAW

THE BUILDING SURVEY 1991-2001

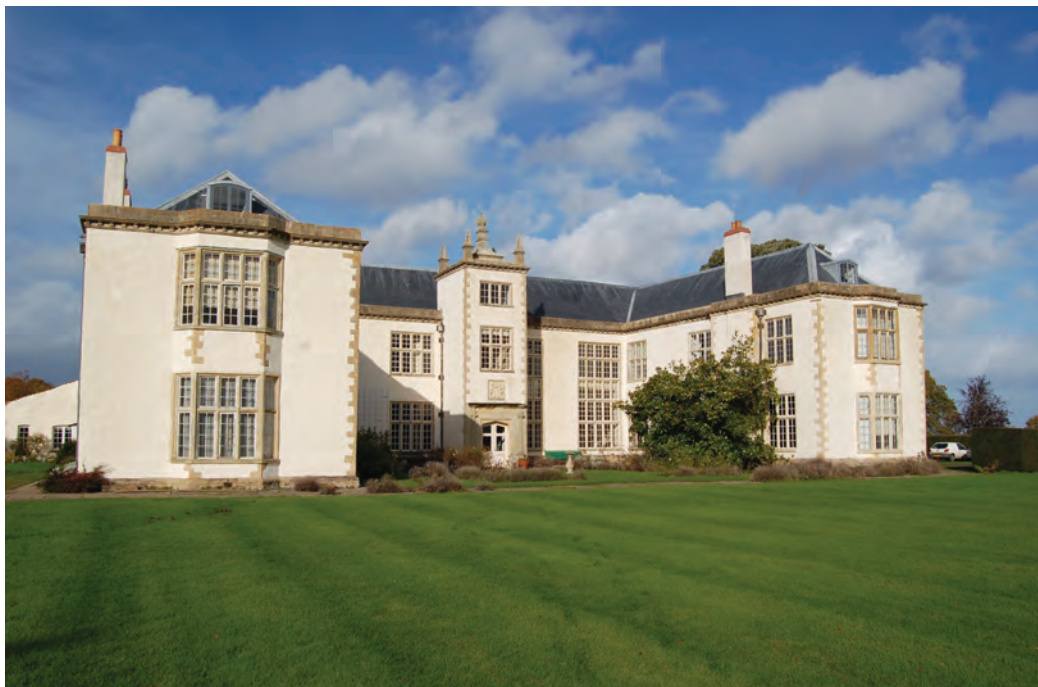
Fig. 2 The south elevation of Fairfield House (photo by Bob Croft)

In the south elevation of the north wing with its central porch (Figs 2 and 4), the wall is built of *lias* rubble with limestone dressings, set in lime mortar with a coarse aggregate, and is essentially a single build, butted against the west wing. Like the west wing it has a plinth course, but set at a slightly higher level and with an ogee moulding which is continuous around the porch. West of the porch there are four eight-light windows; those

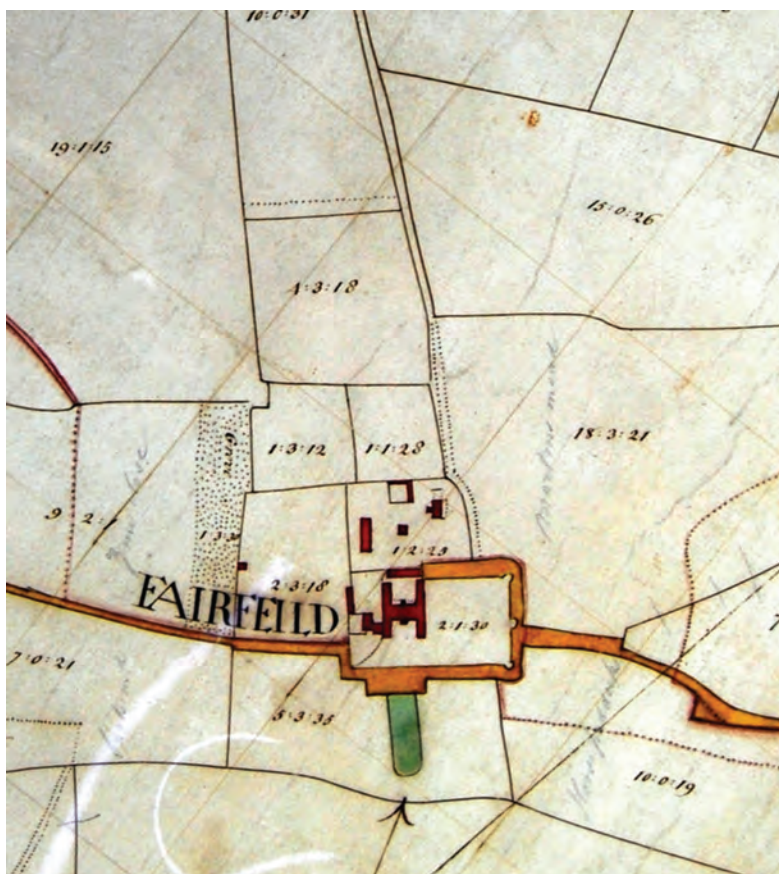
Fig. 3 Fairfield house and grounds as shown on the mid 18th-century map of Stogursey parish (D/P/stogs 23)

From the middle of the 18th century a number of detailed maps survive which show the development of both house and grounds. Two maps are of particular importance; one is a map of the parish of Stogursey (D/P/stogs 23/4) dated to the mid 18th century and showing the house and grounds at that time, much as they would have been known to Thomas Palmer writing his history of the estate in 1733 (Fig. 3). The other is the Chilcote survey of the estate in 1795 (DD/AH 65/12), which was

The earlier of the two maps (Fig. 3) is important in that it shows the manor house and its gardens as created by the successive periods of building documented above (and described in Phases 1-3 of the Building Survey below), including features which were swept away by the extensive changes of the later part of the 18th century. The house is shown occupying the north-western part of a rectangular walled enclosure, characterized by

three round towers along its eastern side. These are the three towers 'yet remaining' of Palmer's account of 1733 (above) and the enclosure is probably that for which a license was granted in 1473. To the east, the road from Stogursey comes to just south of the middle of the enclosure's eastern side, turning sharply south to follow the outside of the wall until just south of the middle of the west side, whence it continues west to Stringston. A road is also shown going around the enclosure's north-east corner, giving access to buildings and yards to the north of the house and the farm buildings beyond. The map shows no detail of the interior of the rectangular

enclosure, only the outline of the buildings in its north-west quarter. The house itself appears much as today; with the three wings and central porch facing south and attached service wings to the north (see also Fig. 7). It also shows, however, an attached building to the west (referred to below as the West Annexe) which is no longer extant and which at this time formed the southern side of a yard to the north-west of the house. The map shows the road skirting the walled gardens around the house, with a wider area to the south, possibly indicating a gateway, and a long pond or pool south of the road. Though the map does not show any detail of the gardens within the enclosing wall, oil paintings of the early 18th-century hanging in Fairfield do show this detail, though in a rather stylized way. All show the symmetry of the southerly aspect of the house with formal gardens to the south of it crossed by a path

The earliest plan of the house, dated to the middle of the 18th century, shows these buildings as the mirror image of the main house (Fig. 3). It is possible that elements of the western range are medieval, being attached to the identified medieval structure of the west wing of the main house, but the fabric is simply not accessible for survey. Visual

The cobbled surfaces immediately adjacent to the walls of the enclosure in Trench 12 have been described above. Trenches 6 and 11 (Fig. 14), to the east and north-east revealed the surfaces of a metalled road, and demonstrated what precisely the lines on the Stogursey parish map (Fig. 3) represented. Trenches 5 and 7, lying further east and north revealed no archaeological features.

In 2005 the trench was set out as a 3 metre square located using the mid 18th-century map (Fig. 3) to cross the line of the south wall of the annexe (Fig. 14). Only the eastern half was excavated further than the removal of the topsoil, and of this only the southern half was taken to a remotely

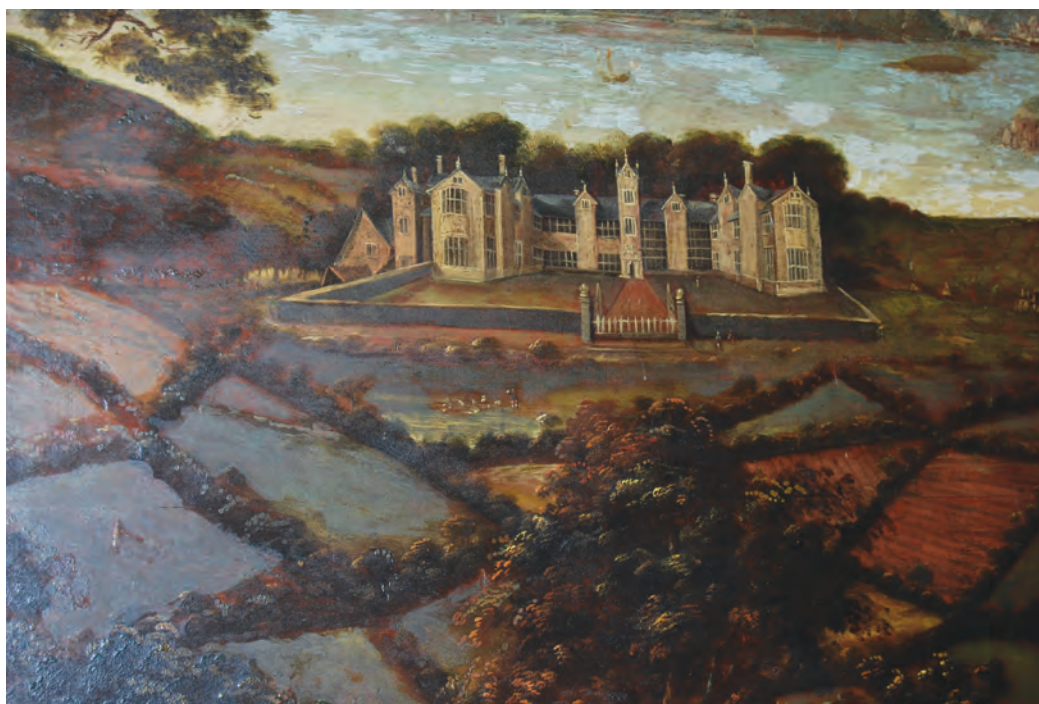
Fig. 4 Detail from an 18th-century painting of Fairfield showing the Elizabethan house built by the Palmers

to the main door. One shows the long pool shown on the map, but this is absent on what is probably the latest painting (Fig. 4) which shows a walled garden specifically south of the house much smaller than the area of the map.

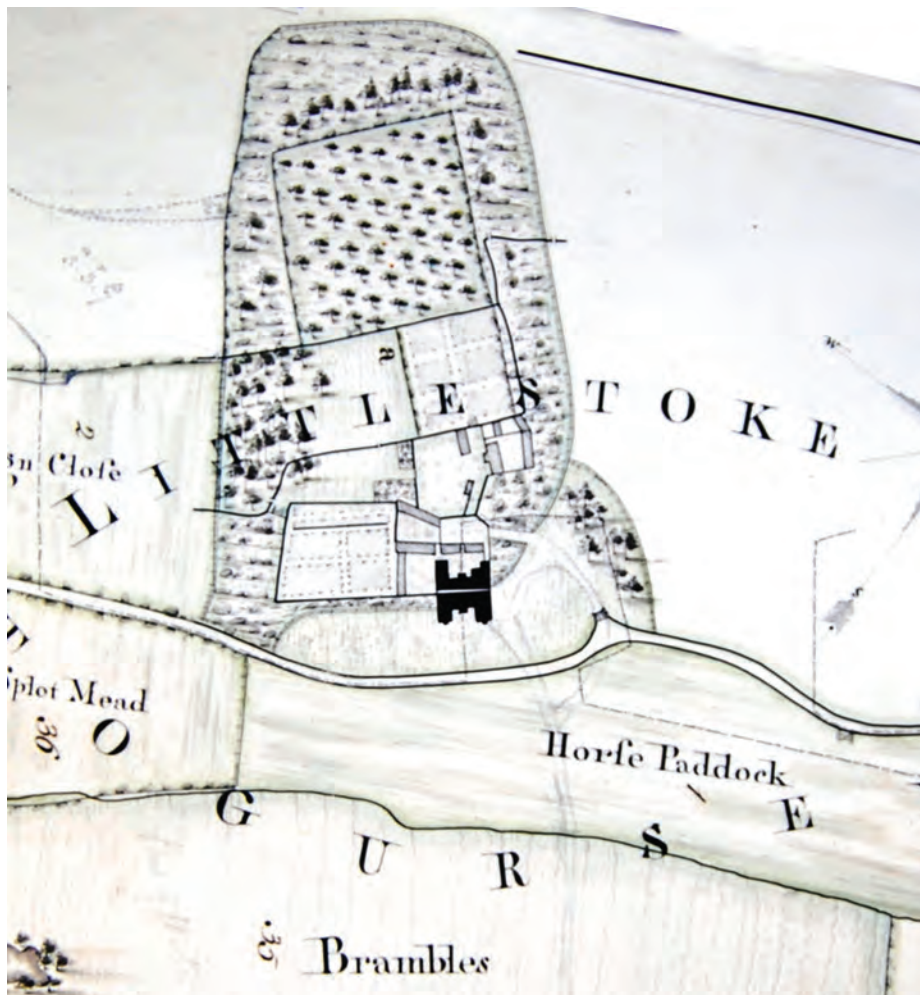
Fig. 5 Part of a map of Fairfield in 1795, from Chilcott's surveys of the manors of Fairfield and Durbarrow (DD/AH 65/12)

commissioned by John Palmer-Acland who had inherited the estate in 1771. This map (Fig. 5) shows the changes to both house and grounds made under the new owners in the later 18th century.

The survey of 1795 shows a landscape much changed (Fig. 5). The old, walled enclosure has gone and the public road follows a smoother course to the south of the house. A new entranceway from the road lies to the south-east of the house from which curving drives lead to its east side and to the stables and yards to the north. The buildings of the west annexe have also gone. It can also be seen that the formalization of the estate grounds had begun in earnest. Though the boundaries of the small fields that lay to the north and east of the house in the mid 18th century (Fig. 3) can still be seen on the map of 1795, they are now shown laid

out as gardens and orchards. A large, walled garden now lies west of the house, perhaps an intentional replacement of the walled garden that previously lay east of the house, and the grove that lay west of this in 1750 has now been expanded to form an encircling girdle around the whole of the house grounds, with only the southern aspect left open. The maps themselves give the broad period when these changes took place, but a more precise date is suggested by the account book of Richard Taylor for the period 1st April 1779 to 30th March 1782 (DD/AH 40/4.2). He was in charge of extensive building works at this time and the book lists all his expenses and payments to labourers, contractors and suppliers and his remuneration by the Palmer-Aclands. Though much of the work carried out was probably on the re-ordering and renovation of the Elizabethan house, in 1782 he was paid for the demolition of the 'old kitchen' and a dairy, both of which may have been parts of the west annexe. There are also references to work on the 'garden wall', but it is not clear whether this was demolition or construction.

Pencilled onto the map of 1795 (Fig. 5) are the lines of a proposed longer drive going off to the south beyond the public highway. This drive was not constructed until the public road was moved to its present position probably in the early part of the 19th century. Letters from Peregrine Palmer-Acland in London to Mr. Watts, the estate manager, suggest that he was a driving force behind many of these later changes, even before he inherited the estate in 1831. A letter dated February 18th 1822 states '*I would have the hedges in the new road made clean from weeds also this spring*' (DD/AH 63/1/1.10). If this refers to the new Stringston-Stogursey road, it indicates its construction before 1822. The earliest map to show the new road and longer drive, however, is the tithe map of 1841 (Fig. 6) which shows the new road, drive and lodge at the crossroads. The old road from the east has been relegated to acting as a second drive to Fairfield House, while to the west it has gone, its course marked only by field boundaries.

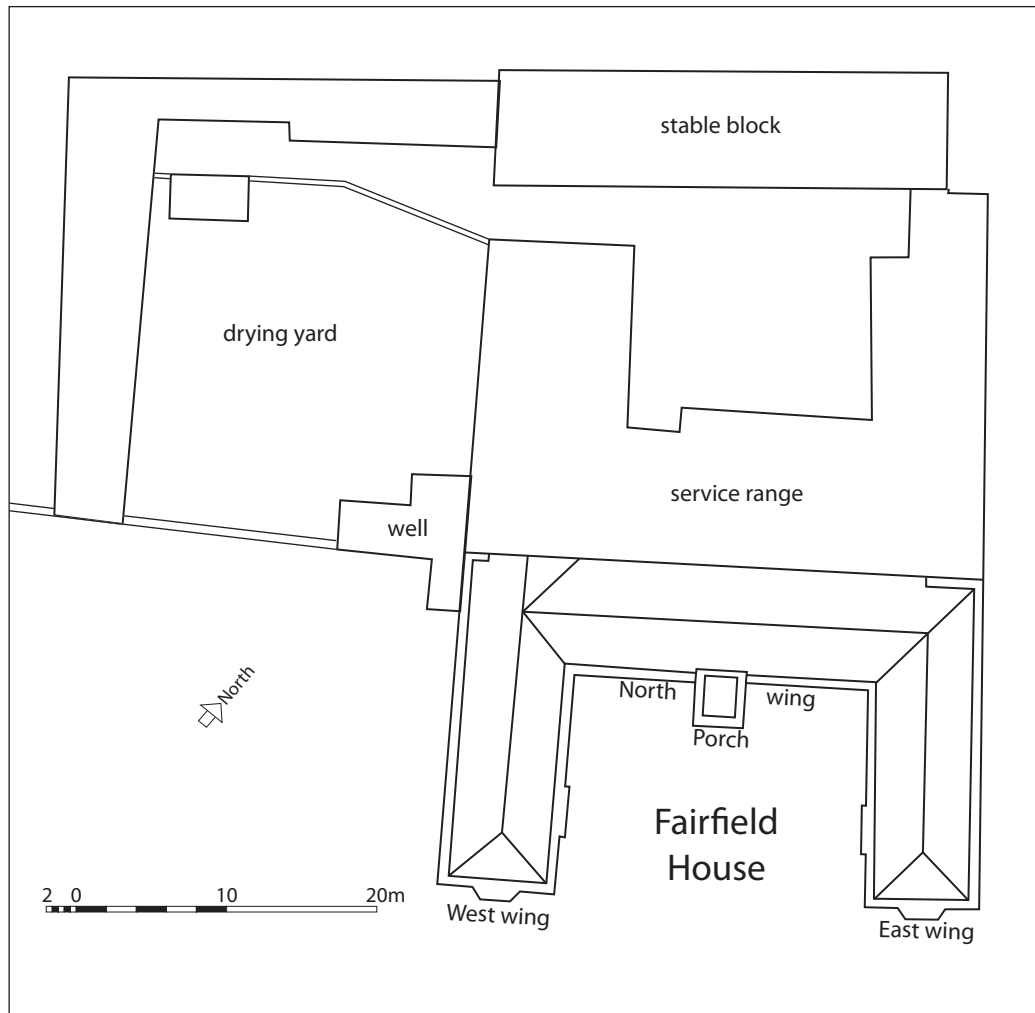
Fig. 7 Plan of Fairfield House with, in outline, the service ranges to the north.

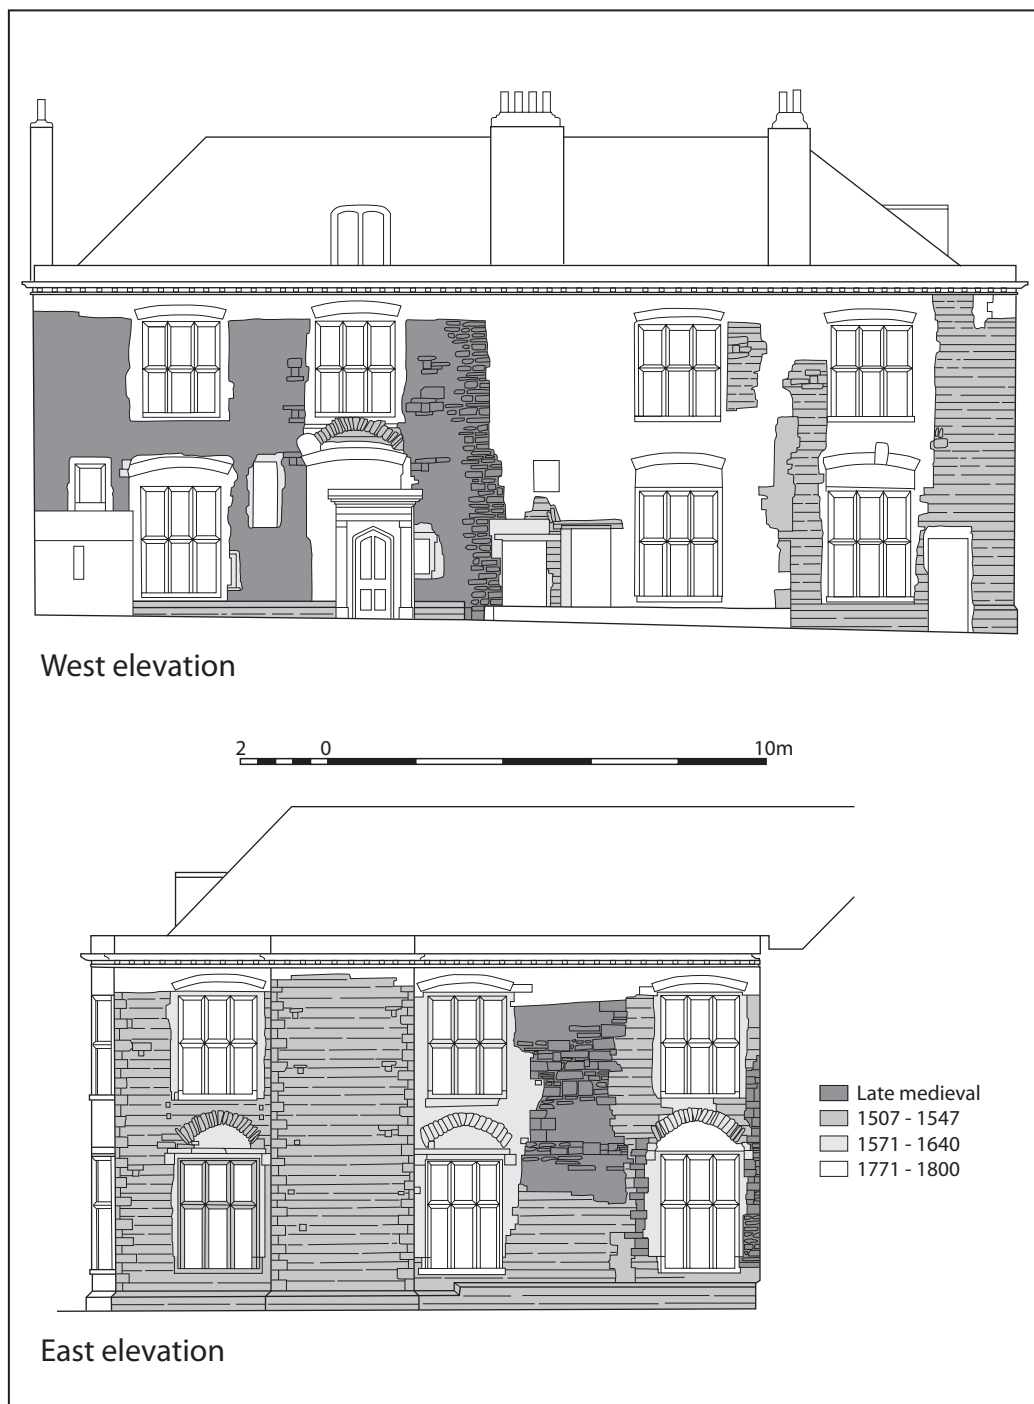
Fig. 8 Elevations of the west wing (from a drawing by Kirsty Rodwell 1993)

The northern half of the west elevation of the west wing (Fig. 8) was constructed of lias rubble of variable size set in lime mortar; it was truncated to the south by phase 4 rebuilding and the uneven NW corner, without proper quoins, suggests that the original range has been shortened. There are no surviving original openings. The only contemporary features are two sets of three large putlog holes. A smaller area of similar walling survives between the windows of the east elevation (Fig. 8); a higher proportion of large blocks makes the junction with work of the next phase clear. There is part of an original window, its jamb (2m high) and sill formed of lias blocks; the head is missing. The opening (visible to 0.20m) is splayed and retains limewashed plaster. Beneath the sill is a band of eroded stonework which suggests the possibility of a former lean-to roof line. The strip of wall at the north end of the elevation may also belong to this phase and may include another opening.

Late 18th-century alterations made extensive use of brick, as well as reused stone. In the west wing (Figs 8 and 9), a new cornice and parapet were added; windows on the east and south elevations were modified by removing the hoods and lowering the sills and provision was made for eight new windows (one subsequently replaced by a door) of the same pattern in the west wall, by creating openings with brick relieving arches. The West Annexe was demolished and the former internal wall largely rebuilt to incorporate six new flues to two new chimney stacks.

To the south, there are two bays eight foot wide, but that the roof continued as a third bay to the south of Truss 1 is clear. The two upper purlins on the east slope and the three upper purlins on the west slope of the roof match the purlins of the rest of the roof. The top two on each side have been cut off to form a hip (see below), but the third purlin on the west is complete and shows the carpentry joint to slot into a truss eight foot south of Truss 1 (the other purlins of the bay are recent replacement timbers). The position of this truss, however, does not match the position of the present gable end, suggesting a later extension of the wing by up to 2 feet (0.70m), though the survey of the building's walls showed no evidence of this (Fig. 8).

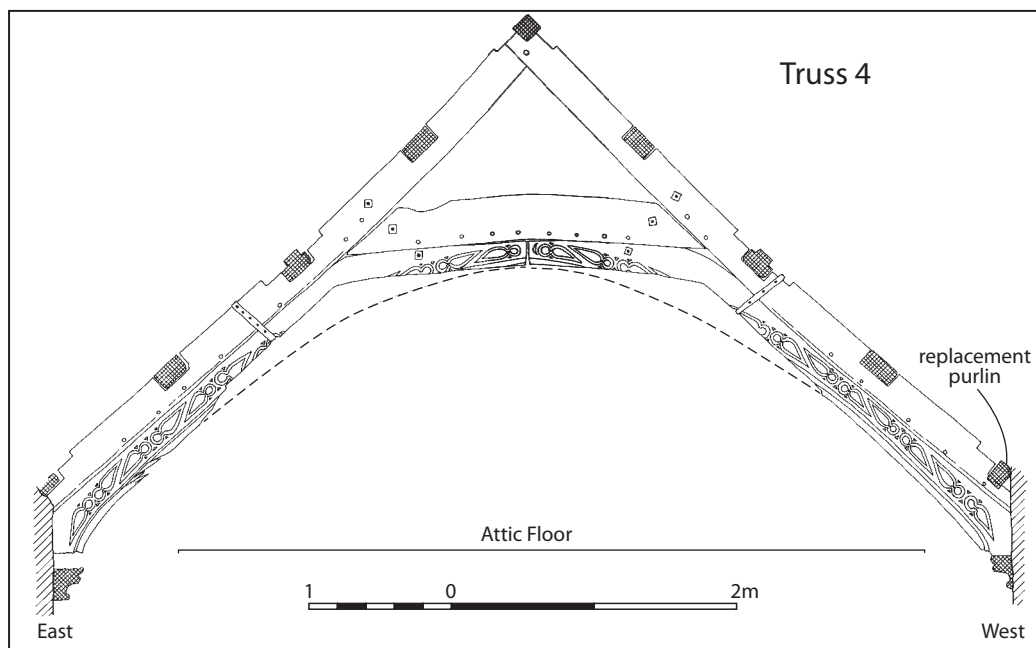
Fig. 11 The early 16th-century roof of the west wing; elevation of Truss 4

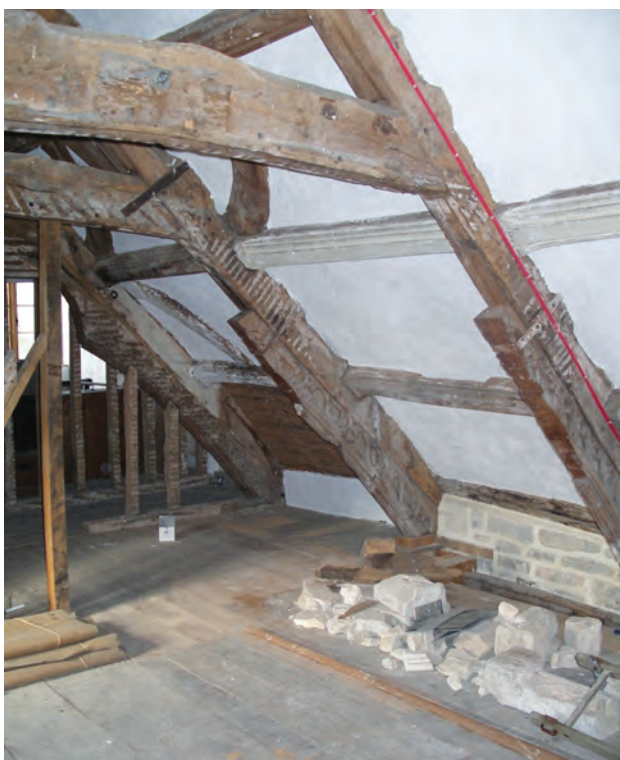
Fig. 12 The decorated beams of the early 16th-century roof, showing Trusses 7, 6 and 5, looking from the south-west (photo by Bob Croft)

all have elaborately carved braces, whereas Truss 3, between the two sections of roof, is plain except for a moulding on its northern edge only (on Trusses 4-7, the moulding is symmetrical on both edges). It is probable, therefore, that this truss lay against an internal gable, dividing the space beneath the roof into two chambers. A dendrochronological date was obtained from elements of Trusses 1-4, all having a felling date of 1508-1528. This suggests a single period of construction, above a first floor hall of two chambers.

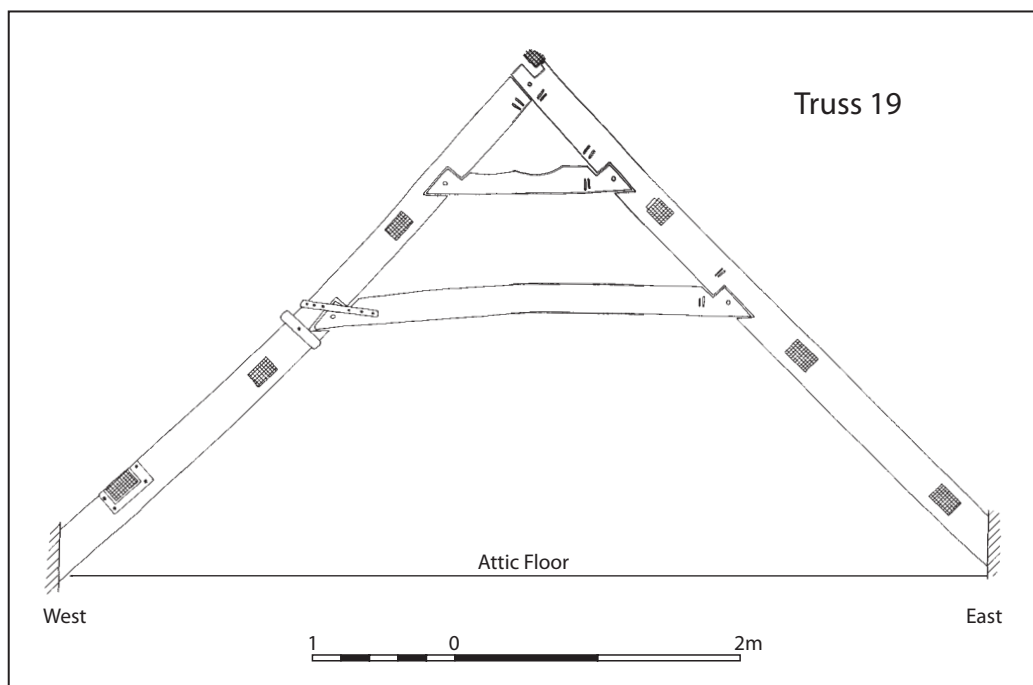
Fig. 13 The early 17th-century roof of the east wing; elevation of Truss 19

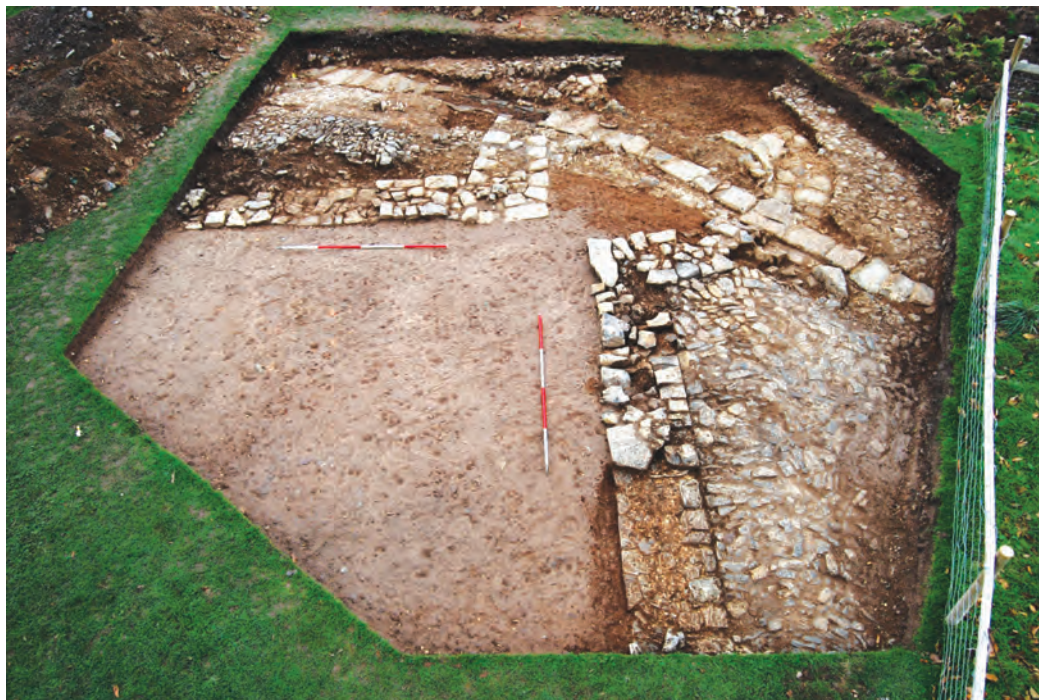
Fig. 15 The north-east corner of the enclosure of 1473, as revealed in Trench 12. Internally the clean surface of the geology; externally the cobbled surfaces. Culvert 4 cuts across the tower from top left to right. Scales 2 metres

The nature of this was best shown in Trench 12, which exposed the remains of the wall and tower of the enclosure's north-east corner (Figs 15 and 16). A single course of both the northern and eastern arms of the boundary wall was exposed at a depth of c.0.20m. Both were approximately 0.80m wide

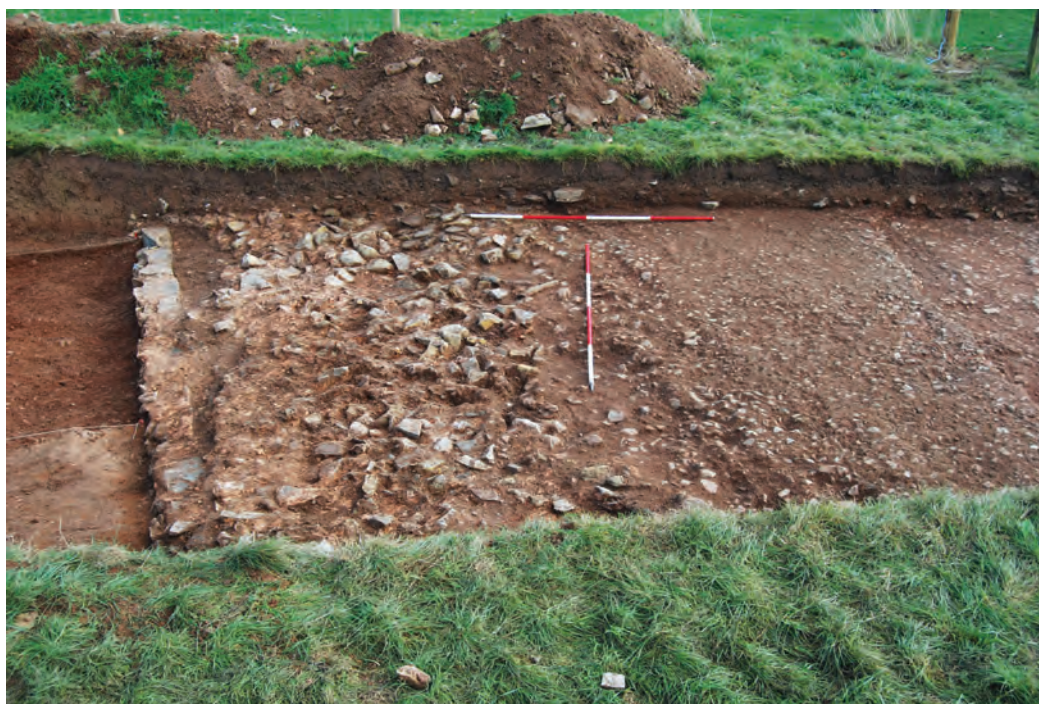
Fig. 19 Trench 6, the retaining wall 606 which defined the eastern side of the hollow around the enclosure with the metalling of the road. Left of the scales is the rubble from the collapsed/demolished wall. Scales 2 metres, looking south

In Trench 6, a sequence of layers of gravel metalling was excavated (Figs 19 and 20). Immediately inside the enclosure wall in Trench 12, the surface of the geological sequence was found below the topsoil at a height of 38.55m OD.

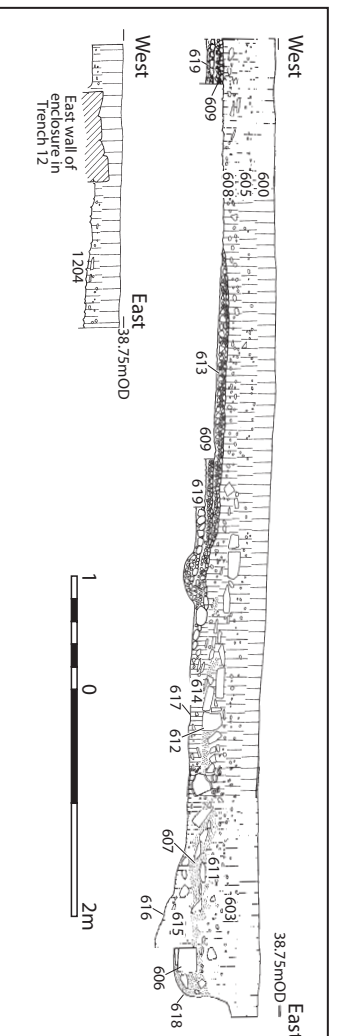
Fig. 20 Long section of Trench 6 and short section of Trench 12, across the top of the demolished enclosure wall

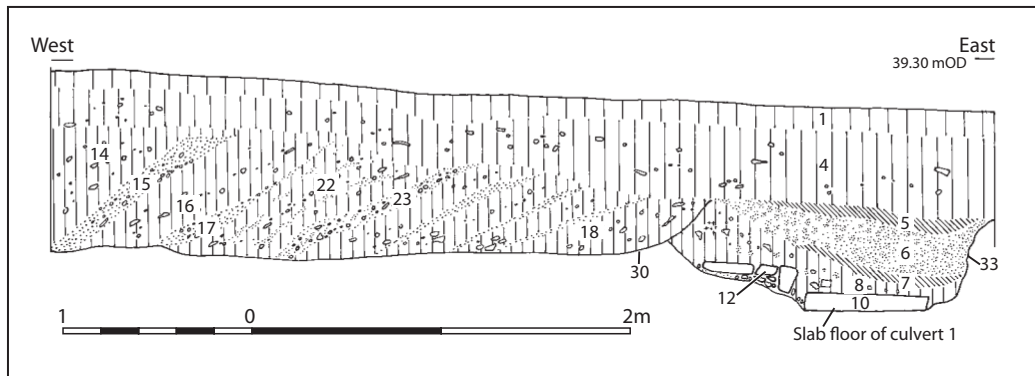
Fig. 22 North section of Trench 2 showing the demolition debris tipped into Culvert 1 and the tipped layers in Pit 30

This ran along the eastern side of the trench and had been constructed within an uneven trench 33, some 0.60m deep below the surface of the natural gravels (Figs 21 and 22). Its line appeared to curve, running initially parallel with the west wall of Fairfield House and then curving towards the south east. The trench was about 1.40m wide and within the area of the excavation only elements of the culvert's

Overlying the fills of Pit 30 was a homogenous, dark, gritty loam (layers 3 and 4) up to 0.40m deep (Fig. 22). This contained pottery that could be split into an early 18th-century group and a mid 19th-century group. This layer may represent dumping

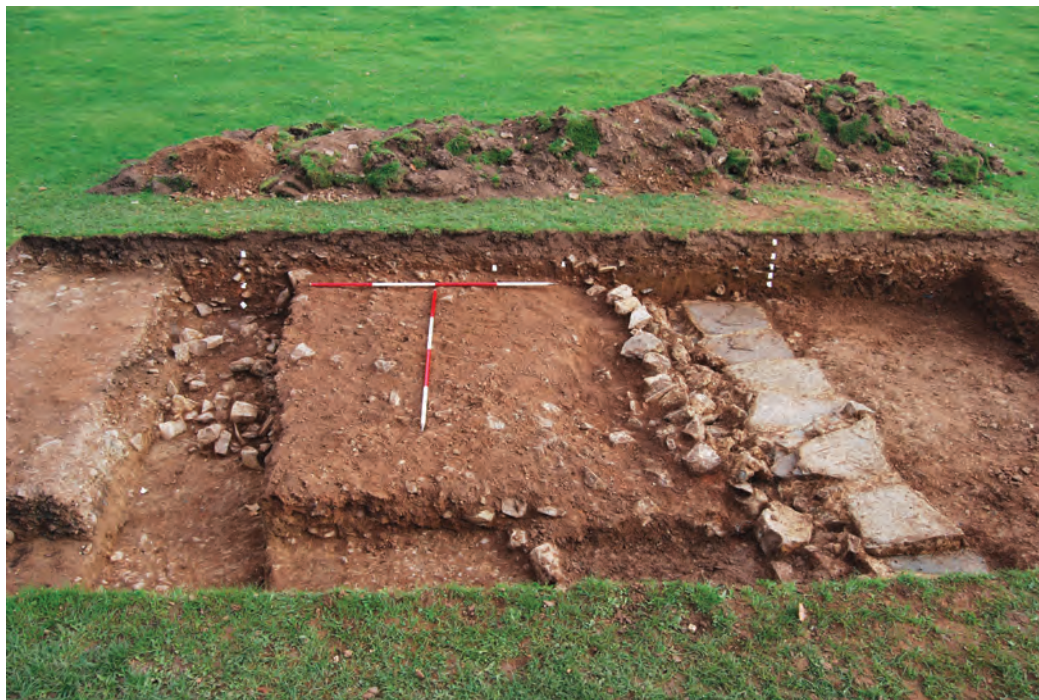
Fig. 25 Trench 1 showing, to the left, limestone rubble in Trench 68, being the line of the southern wall of the enclosure of 1473. On the right the large capstones of the later culvert, cut into the metalled surfaces of the now disused public road. Scales 2 metres, looking east

The eventual disuse of the road was indicated in Trench 1 by the construction of a large, stone built culvert cut into its northern side, and the spreading of a dump of clay spoil over the latest metalled surface (Figs 14 and 18, Culvert 3 and layer 81). Culvert 3 was built into a wide trench cutting the

northern side of the layers of road metalling and had a floor of limestone slabs, substantial mortared walls and heavy capping stones over the channel, which was 0.45m wide (Fig. 25). Blue Lias clay had been used as a packing in at least one side of the construction trench, which was otherwise filled with rubbly loam and mortar, layer 84, which contained small sherds of pottery dated to the 17th and 18th century. Above this was a layer of clean clayey loam 83 (probably redeposited from digging elsewhere) which spread southwards over the road metalling, with a thin spread of mortar fragments above it, 82. This was covered by a sequence of layers of gravelly loam filling in the remaining hollow above the line of the road and generally making up the ground level over the whole of the trench to c.38.55m OD (layers 76, 54, 53, 52 and 51), the same height as the levelling in Trench 12 to the north. These layers contained a mixture of small pottery sherds of the 18th century as well as sherds dated to the early 19th century. These comprised a fine pearlware rim of c.1810 and a creamware sherd with part of an inscription to

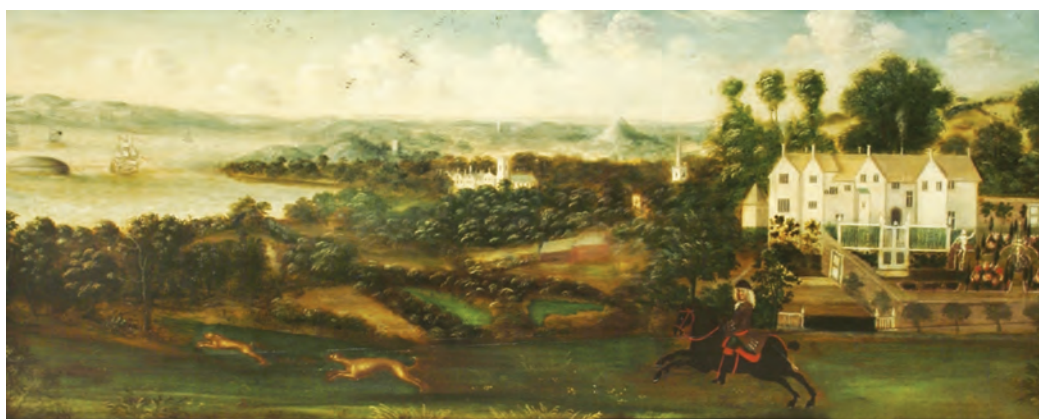
Fig. 27 18th-century oil painting of Fairfield House and gardens, from the Palmers ancestral home, Parham in Sussex. Now at the Somerset Heritage Centre

A recently recognized painting of Fairfield from Parham House (now at Somerset County Council Heritage Centre) shows the house in the north-west corner of a walled garden, with doorways in the wall and a large gateway south of the main door of the house (Fig. 27). The walled garden has all the expected elements of the pleasure garden of the earlier 18th century though it may have its roots in the Elizabethan and Tudor garden, with geometrical paths and beds, statuary and trained trees. Though the layout of both house and garden may have been treated by the painter with the same artistic licence as the wider Somerset landscape of the background, it nevertheless captures the essence of Fairfield prior to the major changes of the later 18th century.
