# KEYNSHAM ABBEY EXCAVATIONS

## 1961–1991 FINAL REPORT

### PART II: SUMMARY AND REVIEW

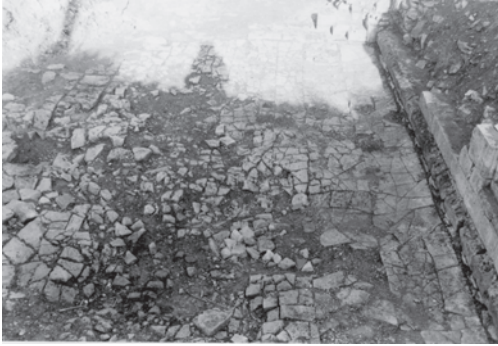
Fig. 2 Floor of east cloister alley, north end; view north

The appearance of the cloister alley after clearance was described in 1987 (Lowe *et al.* 1987, 92). The broken floor of the east alley is illustrated (Fig. 2). The north side of the aumbry, interpreted as a book cupboard as at Tintern, can be seen on the right of the photo. Only the stone framing on its lower and north sides survived robbing (Fig. 3). Later, following subsidence of the floor, an area measuring 2.8m by 1.5m was excavated and two burials were found. The first lay in a coffin cut from a single block of Bath stone (Fig. 4). To its north the second skeleton lay on a layer of crushed Bath stone in a grave marked to the south by the stone coffin and to

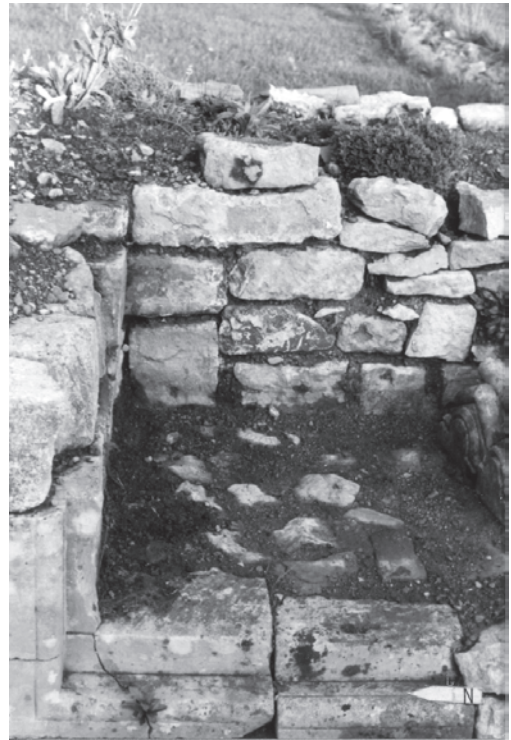
Fig. 3 Aumbry; view east

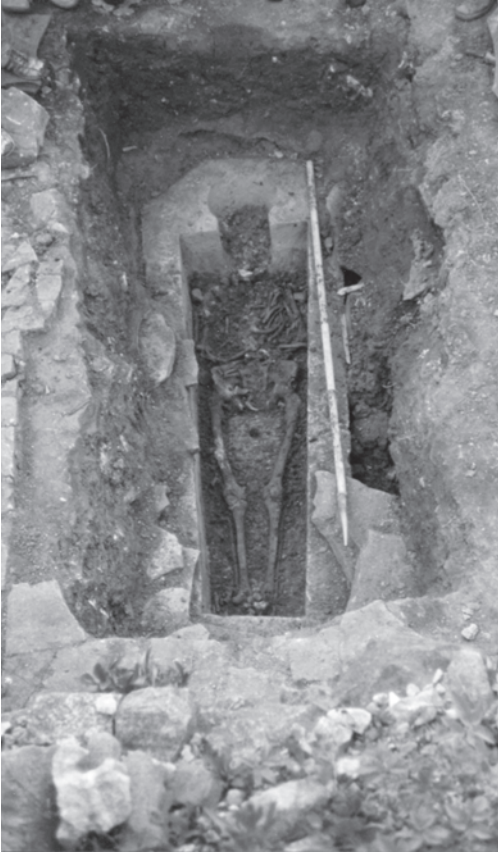
Fig. 4 Bath stone tomb in east cloister alley; view west

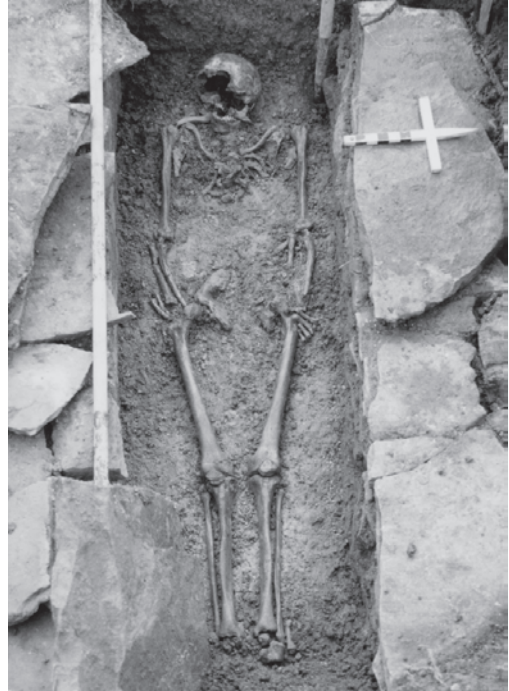
Fig. 5 Slab-sided burial in east cloister alley

the north by a wall of pennant stone (Fig. 5). Both tombs were covered by thick pennant stone slabs which had broken and fallen onto the burials below with infilling layers of sand, sandy mortar, and clayey soil above. The coffin and pennant stone-sided grave lay directly beneath a red clay bedding layer for the alley floor of Bath stone slabs. Both skeletons were incomplete and both had apparently been limed.

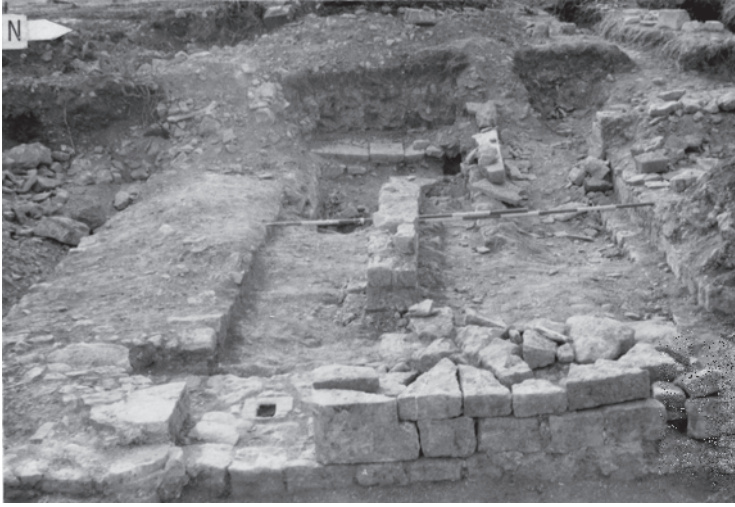
*Fig. 6 North cloister building; view west*

On the south side of the nave was a building range leading westward from a vestibule connecting transept and cloister to the east (Figs 6–8). Because the entrance from the transept into the vestibule had no provision for a door, the vestibule was argued to be original 12th-century work (Harrison and Lowe 2004, 63). Although there may have been later changes to the range to the west this too must have

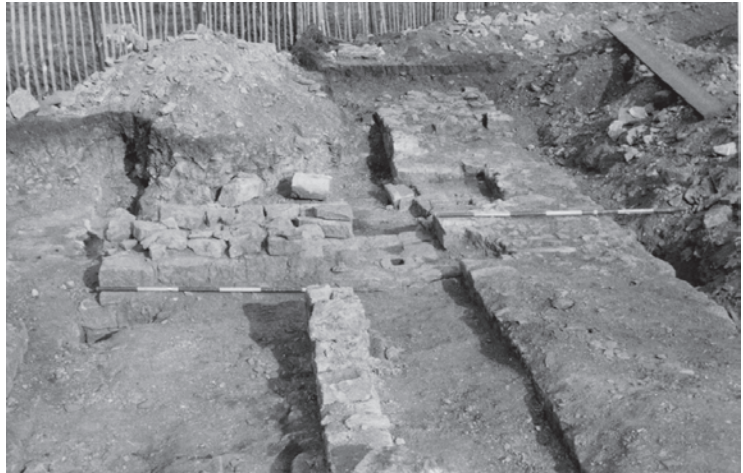
*Fig. 7 North cloister building; view east*

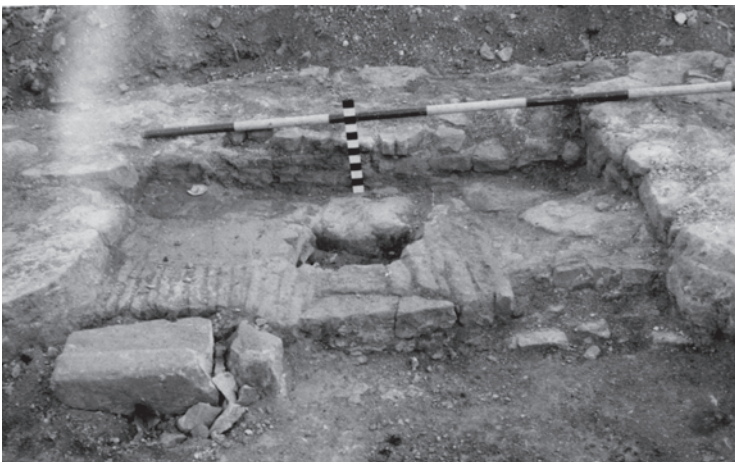
*Fig. 8 North cloister building, recess in south wall; view south*

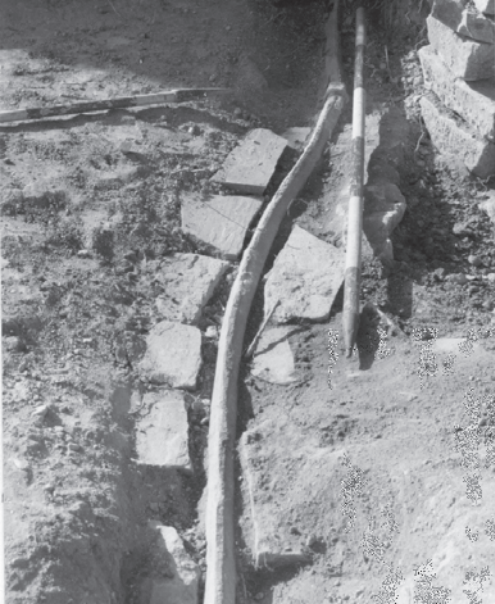
Fig. 9 Vestibule: lead piping under floor; view north

Lead pipework was found running from the nave to the cloister garth which would have carried off water used in ceremonial functions in the nave (Fig. 9; Lowe *et al.* 1987, 92, fig. 4; Harrison and Lowe 2004, 63). The pipe ran in a stone-sided culvert from a pillar drain just north of the west doorway into the vestibule (Figs 10 and 11). This lay on the line of the nave wall and suggests the possibility that there was a doorway here from the vestibule through into the nave.

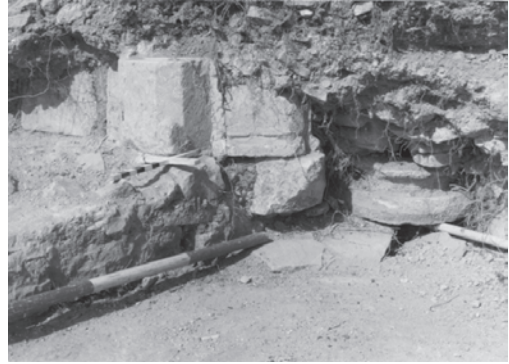
Fig. 10 In situ pillar at possible entrance from vestibule to nave; view north-west

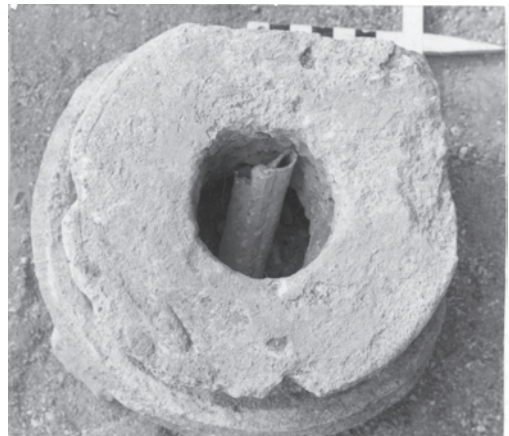
Fig. 11 Lead pipe in pillar

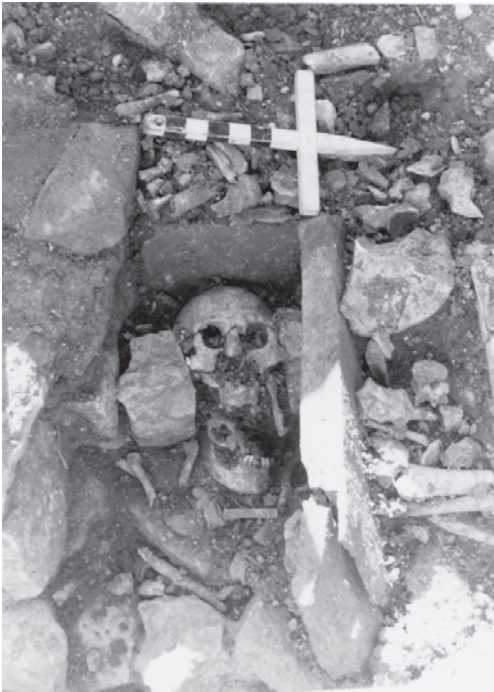
Fig. 12 Cist burial beneath chapter-house; view west

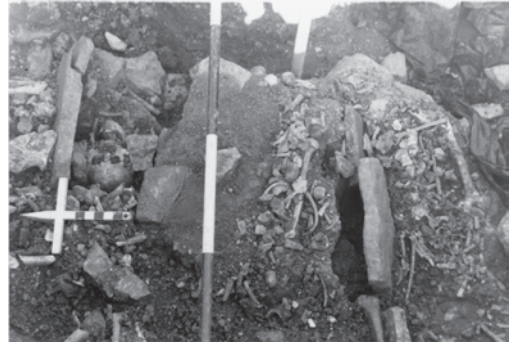
Fig. 13 Disarticulated bone and top of slab grave, cist burial to left; view east

not carried down below a deposit of numerous broken and disarticulated human bones including a pelvis, long bones, ribs, and vertebrae. These lay either side of the line of stones while a group of noticeably small bones overlay the rough walling on the south side of the cist grave to the north. The bones lay on a loose sandy clay with occasional lumps of red sandstone in a soil matrix of brown clayey earth.

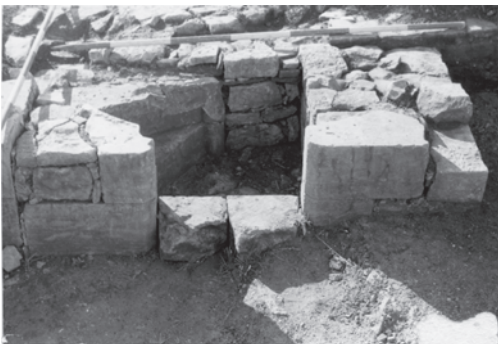
Fig. 14 External stairs in the slype leading to the dormitory; view south

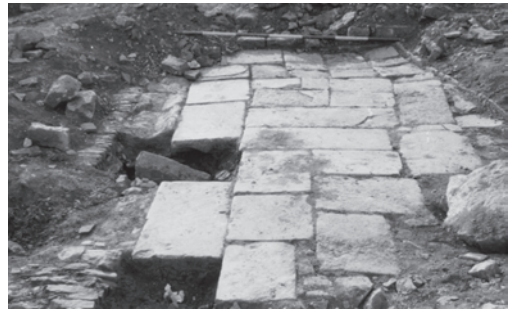
Fig. 15 Paved floor in possible reredorter; view west

Sections of walling suggest the presence of a range running at right angles to the south of the dormitory (Fig. 1). To its south an area of substantial stone slab floor was cleared suggesting the position of the reredorter (Fig. 15). Of interest is the curving stonework to the west suggesting a drain, its position suggests it may have been incorporated into the structure from an earlier phase.

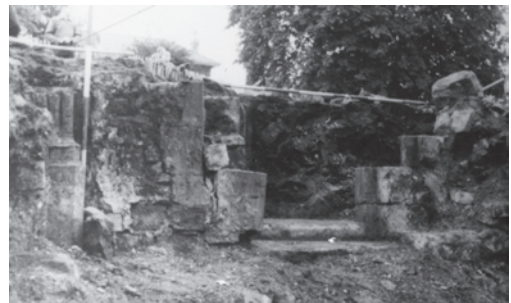
Fig. 17 Doorway to possible infirmary; view south

Rapid recording during the road construction revealed an east-west running wall and stone doorway some 22m to the south of the refectory (Fig. 17). The wall was the north wall of a building and *c.* 1m wide. The doorway was *c.* 1.5m wide with a shallow step up to the interior and marked by chamfered stone sides. To the east was a decorated pilaster. This ornate entrance must mark a building of significance, perhaps the infirmary. Walls were recorded to the south, on the interior of the building, as well as a drain 9m from the wall (Lowe *et al.* 1987, fig. 2).
