MORE DOVECOTES IN HISTORICAL SOMERSET, WITH OTHER EVIDENCE OF EARLY PIGEON-KEEPING

JOHN AND PAMELA MCCANN

INTRODUCTION

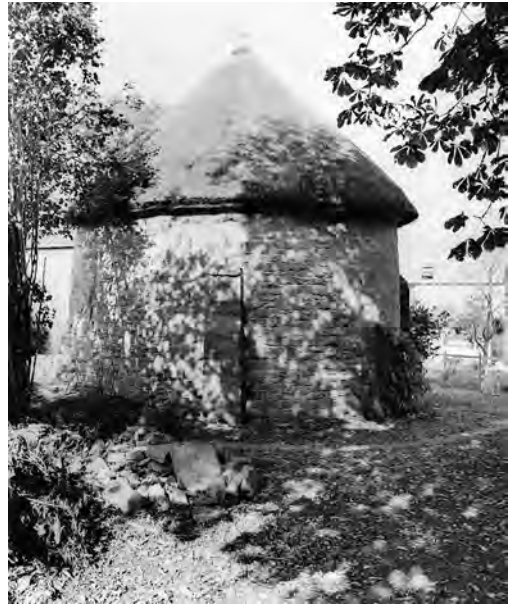
Fig. 1 The dovecote of The Grange, Woolavington, from the south (photo John McCann)

This building was examined in October 2005 by courtesy of Stephen Wheeler. In 1965 it was wrongly listed as a cockpit. In a report of August 1983 the late Desmond Williams repeated this interpretation.² It is a round stone building 25m south-west of The Grange, 14ft in internal diameter and 14ft high to the eaves, with four stepped buttresses irregularly disposed and a thatched conical roof (Fig. 1). Together with The Grange it is listed as on the south side of Lower Road, but division of the property has left it isolated on a small plot now approached from Puriton Lane.

The wall thickness of 3ft 2in, the four buttresses, and the association with a manor house which has

an early 16th-century core all suggest that it was built as a dovecote. A partial collapse has confirmed this by revealing original nest-holes (Fig. 2).

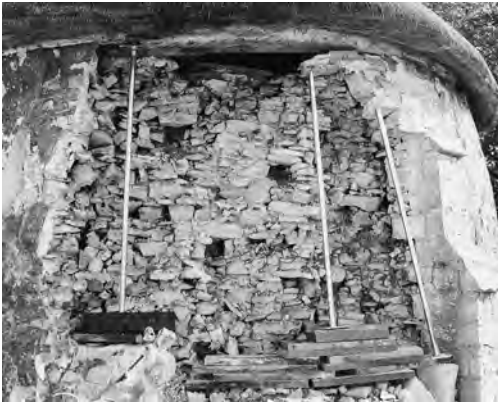
Fig. 2 The dovecote of The Grange, Woolavington. The collapsed west section in October 2005 (photo John McCann)

A partial collapse of the outer masonry on the west side has exposed nest-holes in chequer pattern, some still containing nesting material. They are bridged by large slabs of lias. The only nest-hole which could be examined is 6in high and 7¾in wide, and has been blocked with lias rubble on the inside. As that part of the building was in a dangerously unstable condition no other nest-holes were measured.

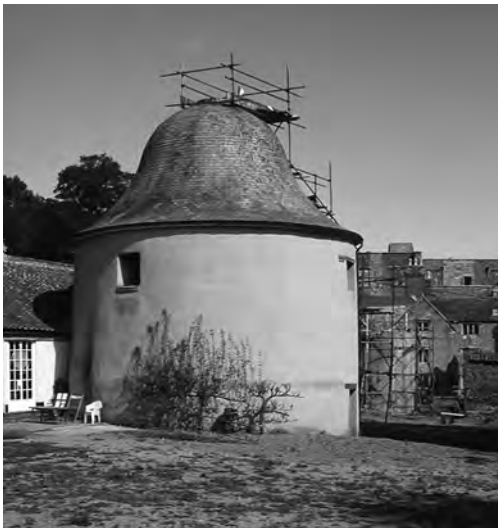
Fig. 3 The dovecote of Halswell House, Goathurst, from the south-east (photo John McCann)

The dovecote is 23ft in internal diameter, and 22ft high to the eaves. The wall batters slightly, and is 3½ft thick at the doorway. Originally it was built of stone rubble but at various times there have been major structural failures which have been repaired with cob and brickwork. A plinth 4ft high and the eastern part, including the doorway, survive from the original construction in stone. Sections to the south and west, amounting to one-third of the whole have been rebuilt above the plinth with brickwork.

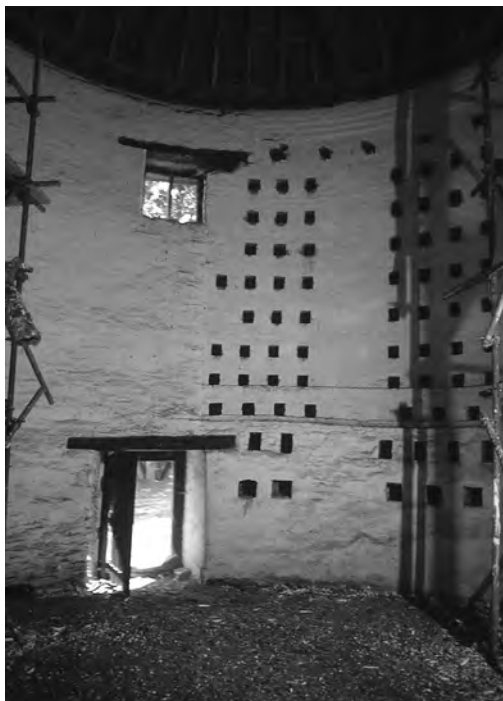
The whole interior is newly lime-washed. There are two tiers of nest-holes in the stone plinth and nine tiers above arranged in grid pattern (Fig. 5). They are simple rectangular recesses 19–20in deep from

Fig. 5 Halswell House, Goathurst. The interior, facing east. The plinth and doorway are original. The east window has a charred frame and lintel (photo John McCann)

front to back; those formed in stone rubble and cob are 8in square, those in brickwork are 6in square. A total of 320 nest-holes are present and in good order. About three times that number have been blocked and concealed by plaster and lime-wash. There are no alighting ledges.

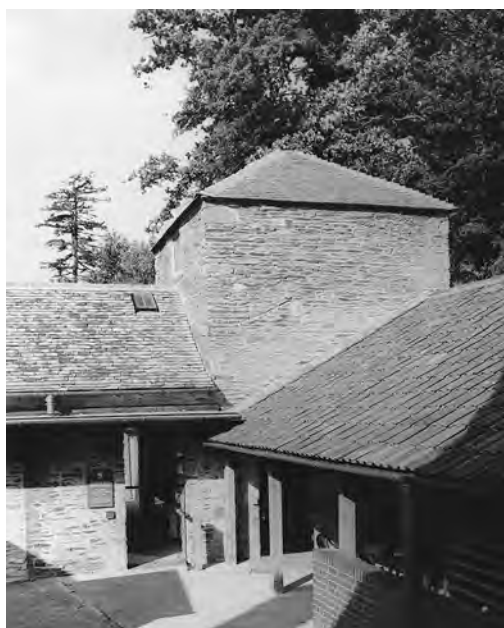
Fig. 6 The dovecote in Hestercombe Gardens, Cheddon Fitzpaine, from the south-south-west (photo John McCann)

Externally the dovecote is 15½ft square; from present ground level at the north doorway it is 13½ft high to the eaves. The outside is of coursed stone

rubble with lime mortar, but the inside is of hand-made bricks of fine quality 9 x 4¼ x 2¾in.

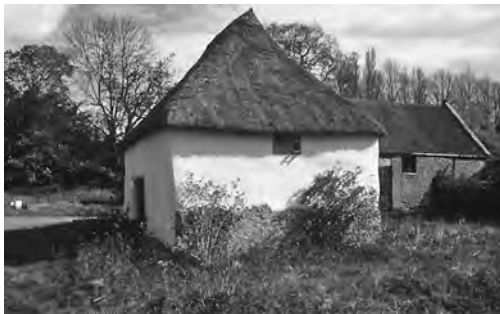
Fig. 7 The dovecote of Church Farm, Trent, from the south-west (photo John McCann)

The original entrance was evidently in the middle of the long side facing west, but it has been enlarged with brickwork to form an aperture 6ft high by 5½ft wide, and is fitted with two re-used iron-studded oak doors. At the doorway the wall is 3ft 3in thick.

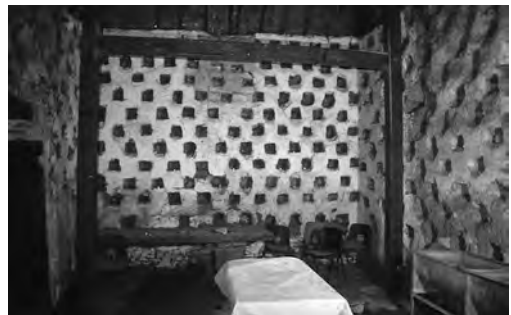
Nest-holes in chequer pattern occupy all four walls from 2ft 3in above the stone-flagged floor to the eaves (Fig. 8). They are formed in the solid cob, 7in square and 15in deep from front to back, widening slightly at the inner ends. There are eleven tiers, with 14 nest-holes in each tier in the long rear wall and eleven in each end wall. Above the altered doorway five complete tiers survive. Originally there would have been about 550 nest-holes less those omitted for a small doorway. The alterations to the long front wall have left only four nest-holes in each tier to each side of the doorway. Some nest-holes beside and below the window aperture have been damaged, leaving 520 nest-holes in good order. Most of the interior has been whitewashed.

Fig. 8 Inside the dovecote of Church Farm, Trent, from the south (photo John McCann)

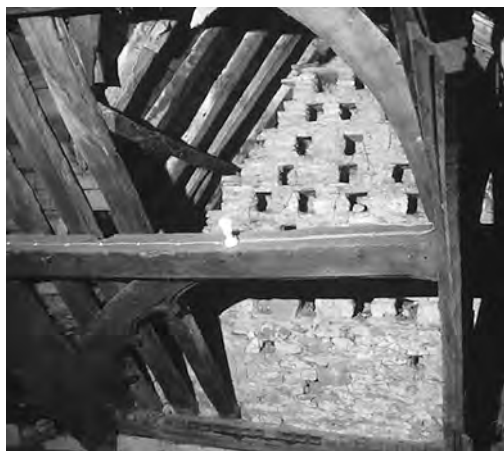
This building was examined in July 2005 by courtesy of Peter Sapsed. The relevant part of this complex house is a hall aligned north–south, probably built in the 14th century. A highly decorated cross-wing has been built against the south end, dated c. 1441 by dendrochronology.¹⁷ A short pitched roof bridges the space between the two roofs, with a diagonally-mounted ridge-piece and one purlin in each pitch, boarded under stone tiles. Above the moulded and brattished north wall-plate of the cross-wing the south gable enclosed by this short roof is 10ft 8in high by 13ft 4in wide. High in it is a triangular group of nest-holes arranged in nine tiers, with eight in the lowest tier, and diminishing tiers rising to the apex, making a total of 31 (Fig. 9). They are formed in the original stone rubble, irregular in size and shape, but most of the entrances are 6–6½in high by 5–7½in wide. In depth from front to back they vary from 12½ to 14in. They have been out of use since the bridging roof was built.

Fig. 9 Nest-holes in the south gable of the medieval hall, Birdcombe Court, Wraxall (photo John McCann)

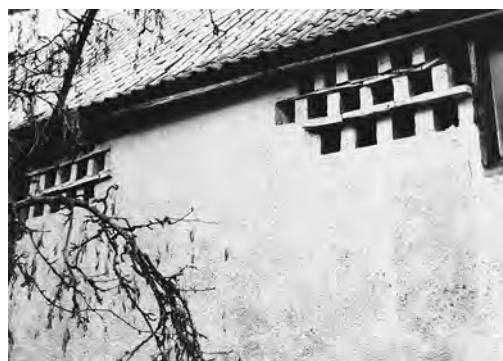
Fig. 10 Nest-holes in the south elevation of the medieval range of Steyning Manor, Stogursey (photo John McCann)

The entrance of each nest-hole is 7in high by 6in wide. The depths front to back vary around 16in. Each side of each nest-hole is formed by a thin piece of slate cut to size. The nest-holes widen out slightly at the inner ends to form reversed-wedge shapes in plan, and the inner ends are closed with thin vertical slates which sound hollow when tapped. The wall is 18in thick, composed of stone rubble. The nest-holes do not appear inside the house.

At Steyning Manor we believe the nest-holes were originally formed as irregular bulb-shaped cavities in the stone rubble, as was common in the medieval period, but that in the 18th century thin pieces of slate were inserted at the sides and back to make them easier to clean. A new emphasis on the desirability of regular cleaning of dovecotes and nest-holes first emerges in 18th-century farming literature. Earlier it had been normal practice to clean out dovecotes only once a year, always in winter to avoid disturbing breeding birds. In 1577 Thomas Tusser, in a calendar of the monthly tasks of the farmer, described this as a job for January:

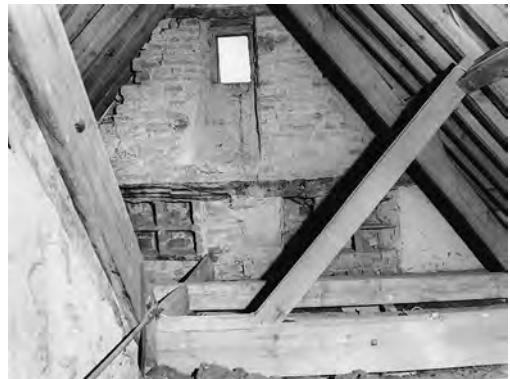
In the gable a few feet above the first-floor window a drip-mould indicates that a second-floor window has been blocked with stone. It is slightly narrower than the six-light window below, so it was of five lights. Inside the resulting recess nest-boxes for pigeons have been constructed.²⁰ The original whitewashed splays are visible to each side, and

a whitewashed surface extends behind the nest-boxes (Fig. 11). Twelve nest-boxes in two tiers were formed with hand-made bricks $9\frac{1}{4} \times 4 \times 2\frac{1}{2}$ in laid on edge. They are simple rectangular recesses 9in high x 11in wide x 13in from front to back, arranged in two groups of six with a stone pier between. The two floors are of hardwood $1\frac{1}{2}$ in thick; the lower one is the original window-sill. The gable is 9ft high by 18ft wide. High in it is an original window 19in high by 13in wide with a deep splay below extending 2ft 4in down the wall, by which the pigeons must have entered. Nine feet to the north there are remnants of a wattle-and-daub partition which evidently formed the opposite wall of the pigeon loft. The east and west walls would have been attached to the purlins, but the roof has been rebuilt so no evidence of them remains. Human access to the pigeon loft would have been by a trap-door above a first-floor room.

Fig. 11 The Manor House, Marston Magna. The nest-boxes formed in a blocked window on the second floor of the rear range (photo John McCann)

It is likely that the second-floor window was blocked for economy when the window tax was introduced in 1695, or when it was increased. The whitewash behind the nest-boxes shows that they were not constructed until some time after the window was blocked. When in use for pigeons the window high in the gable would have been protected with inclined slats six inches apart to prevent the larger birds of prey from entering, while allowing pigeons to pass through. Other nest-boxes made of wood, wattle-and-daub or lath-and-plaster would have been provided against the east, north and west walls of the loft, but no evidence of them survives.

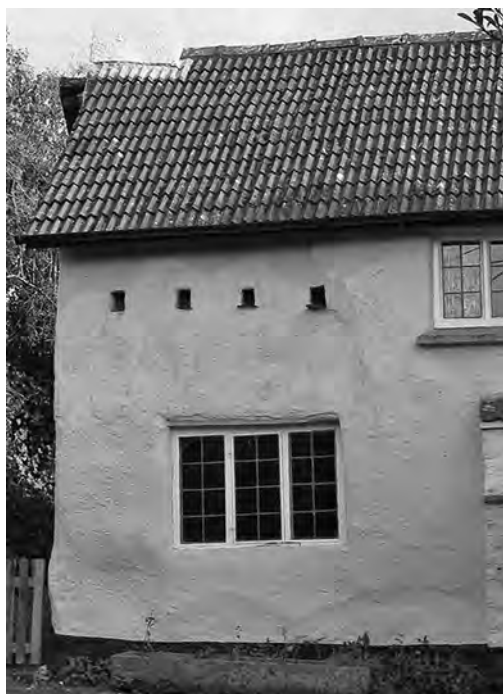
J.C. Bond reports four nest-holes high in the north wall of an ancillary building, now converted to a dwelling (Fig. 12). Each has a small perching step. They were accessed by ladder.

Fig. 12 Nest-holes in an ancillary building of Troyte's Farm, Tivington in Selworthy (photo J.C. Bond)

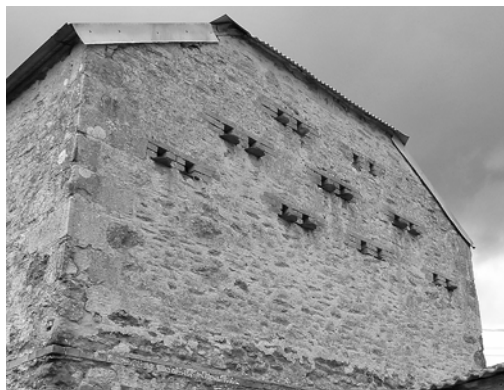
In the east gable of an early 19th-century stone barn there are nine pairs of nest-holes formed in brick (Fig. 13). Each has (or had) a stone perching step. They were accessed by ladder.

Fig. 13 Pairs of brick nest-holes in the gable end of a stone barn at Tirelands Farm, Enmore (photo Somerset Vernacular Building Research Group)

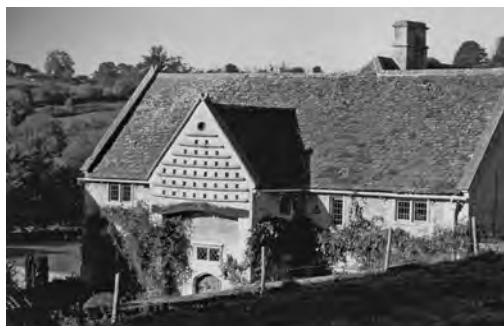
(Fig. 14). At the base are three tiers of eight nest-holes, above that single tiers of six, four and two, making 36 nest-holes in all, and above that is an oval oculus. Below each tier of nest-holes and below the oculus are perching ledges which extend across the full width of the gable. The nest-holes are square, too inaccessible to measure. The whole assembly is constructed of limestone ashlar on a cranked tie-beam supported on the side walls of the wagon porch.²¹ The original building is of Doulling limestone rubble with ashlar quoins.

Near the north-east boundary of the county is a former barn which was converted to a house *c.* 1920, which displays a conspicuous assembly of nest-holes and perching ledges in a gable over what was formerly the central wagon entrance

Fig. 14 Nest-holes at Rowley Grange, Norton St Philip (photo by permission of the NMR, © English Heritage)

Dovecotes and Pigeon Lofts of Wiltshire,²² but they are rare in Somerset. Rowley Grange is within three miles of Wiltshire, and in this respect has adopted a style which is more typical of Wiltshire. Display and social assertiveness are the most obvious explanations of them, because traditionally pigeon-keeping was associated with high social status.²³ No explanation of the difference between their distribution in Wiltshire and Somerset is apparent.
