BASE CRUCKS IN SOMERSET

I: GLASTONBURY ABBEY FARM AND THE PRIORY OF ST. JOHN, WELLS

BY CDR. E. H. D. WILLIAMS and R. G. GILSON

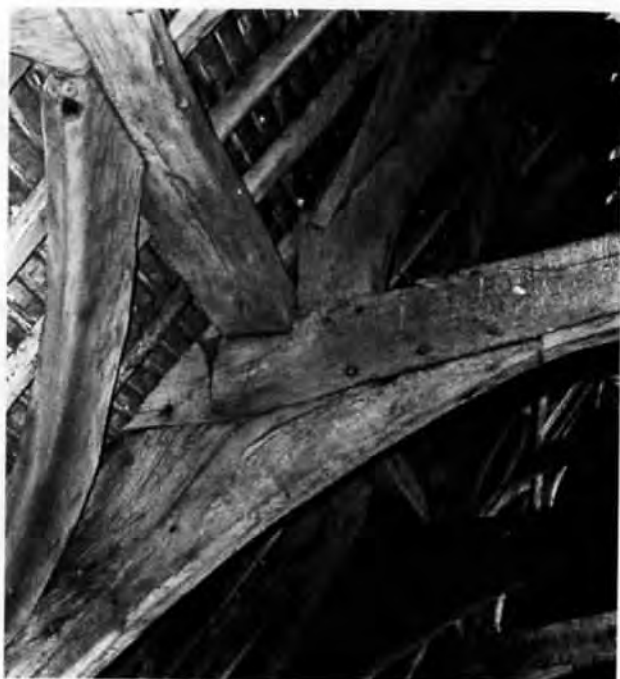
Glastonbury Abbey Barn
Junction of base cruck, tie beam and roof plate

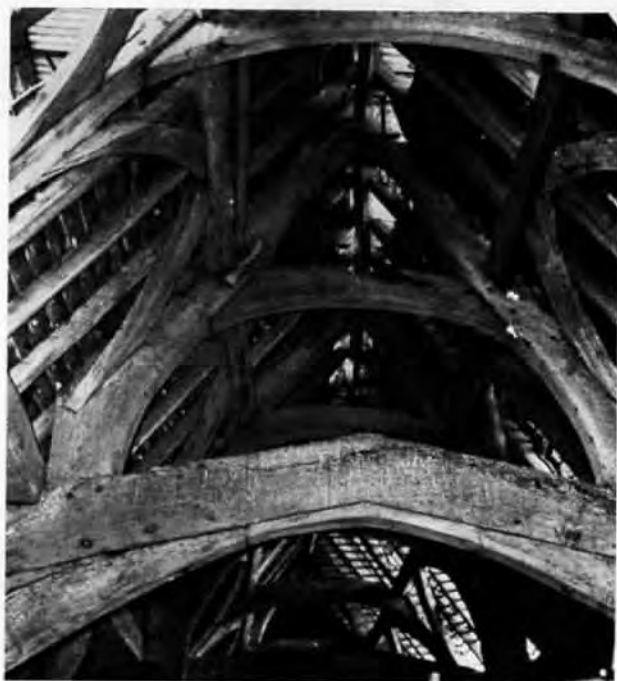
Glastonbury Abbey Barn
Upper cruck standing on the tie beam
