## Two Early English Responds

RECENTLY DISCOVERED AT SHEPTON MALLET CHURCH.

## A Piscina and part of a Reredos at Downside Farm, Shepton Mallet.

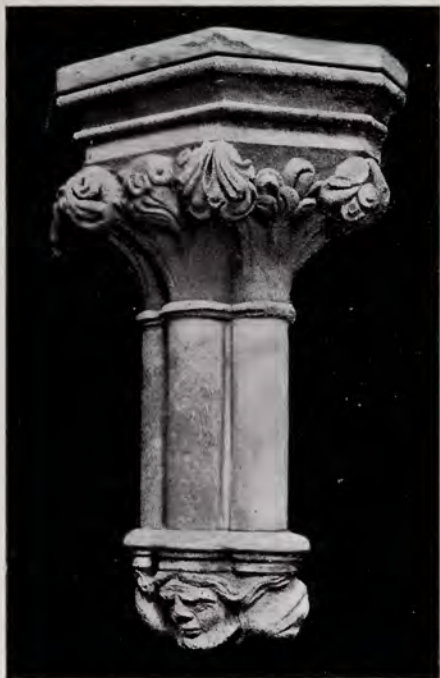
Fig. 1. Recently discovered Respond.

These responds are very like those of the existing chancel

arch. One of each pair is illustrated on Plate VIII: the second of each pair is similar but not identical. All four are so like those supporting the vaulting at the east end of Wells Cathedral nave, that there can be no doubt they were all executed by the same masons and at the same time, namely about A.D. 1190—1200. On comparing the responds of the chancel arch with those recently discovered it may be seen that the former are a little taller and narrower. The acanthus corbels of the chancel arch appear to be later than the rest of the work, and may have been added as repairs in the late 15th century, when the Rood-loft was removed from beneath the chancel arch, and a new loft constructed above it.<sup>1</sup>

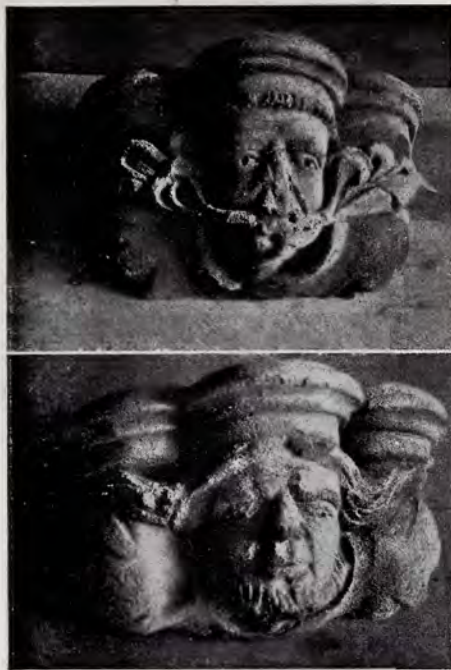
Fig. 2. Corbels of recently discovered Responds.

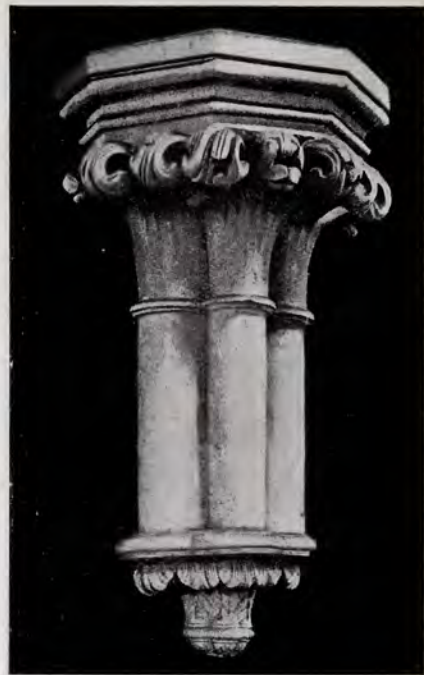
Fig. 3. Respond of Chancel Arch.

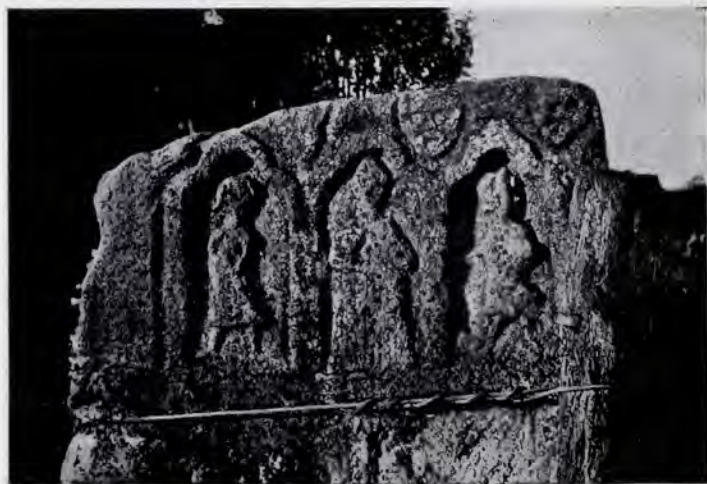
Fig. 2. Part of Reredos at Downside Farm,  
Shepton Mallet.

The Reredos (Plate IX, fig. 2) is now placed as a coping stone at the end of a wall by the entrance to the farm-yard. The stone is of irregular shape, seeming to have had parts broken away ; and what remains of it is (like the piscina) extremely weathered. Its dimensions are, width 26 inches, height 14 inches, thickness 13 inches. On it are carved three trefoiled canopies containing figures. The details are indistinct, but the central figure is evidently a mitred bishop with the hands in the attitude of prayer : the figure on his left holds a sword erect in the right hand ; and the other figure

appears to be drawing a sword from its sheath. Three of the spandrils contain rude masks ; the fourth spandril is broken.

The form of the arches suggests the 13th century. Even allowing for the effect of extreme weathering, it seems as if the work must have been very crude ; and in this respect it resembles the piscina. Both carvings seem to have been the work of a tiro, perhaps an amateur.
