LESSER KNOWN CRUCK JOINTS IN SOMERSET

John Rickard

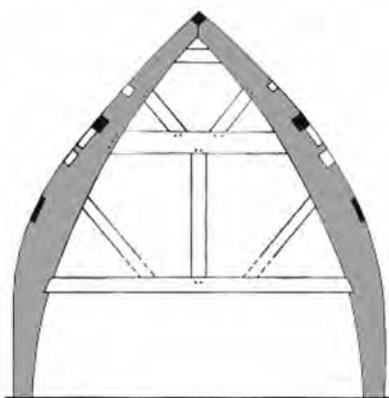
Fig. 1 A true cruck of full height with paired blades, after Moran [2]

Cruck constructions have been recorded in Somerset during more than half a century of studies of vernacular building. The extensive work by Alcock and others, published by the Council for British Archaeology in 1981 [1] identified more than 3000 true crucks (Fig. 1) in England and Wales.

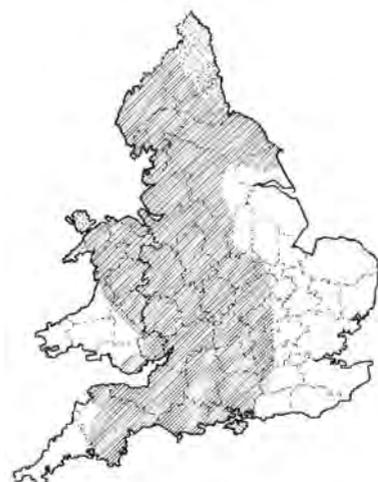
Fig. 2 Distribution of true crucks, after Brunskill [3]

Examples of the use of true crucks as an element of construction is widespread in most of the western regions and well into the north as illustrated in Fig. 2.

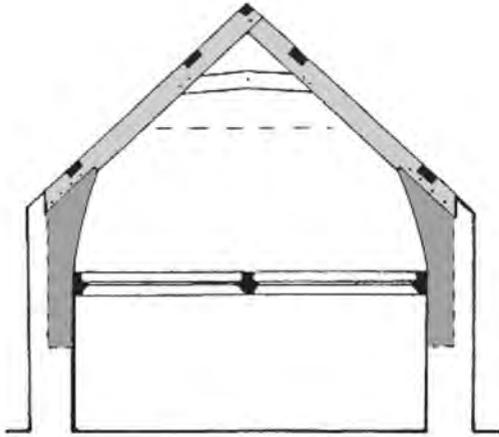
Fig. 4 A jointed cruck with the cruck posts set above floor level, after Penoyre [5]

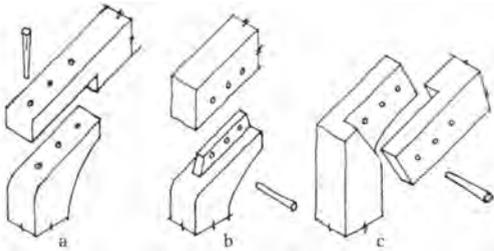
Fig. 5 Cruck Joints, after Brunskill [3]

The illustration in Fig. 5 shows the joints (b and c) referred to directly by Alcock, and another (a) possibly noted by Williams. Type (b) is the widely found long tenon, though usually the principal is scarfed as shown in (a). Examples of 5(c) do not appear to have been recorded in Somerset. Type 5(a) is usually pegged from the underside.

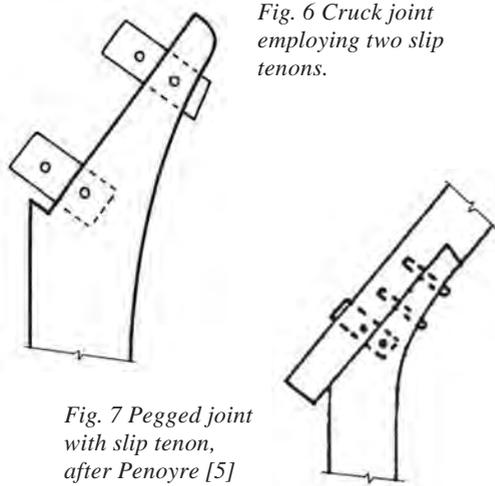
Fig. 6 Cruck joint employing two slip tenons.

The joint in question is shown in Fig. 6 and is a variant on Fig.5b in which the integral long tenon is replaced with two slip tenons. The structural advantage of this variant is that the tenon is loaded along the grain and is thus less likely to split. It is also more efficient in that less of the cruck post is sacrificed in making the joint. However only four previous examples of this form have been noted.

The Wheathill joint, (Fig. 6) survives from a partially complete truss made entirely of elm. Because it was no longer *in situ* it offered the possibility of straightforward sampling and subsequent radiocarbon analysis to establish a

date range for this type of joint. The upper end of a principal rafter retained an area of the natural tree surface. A slice cut from this location was prepared and a sample of sound wood, 50–53 growth rings below the surface, was sent for analysis. The sample gave a date range (68.2% prob) of 1406–1437 calAD. Adding the 50–53 years of growth gave a felling date of about 1470 ± 20.

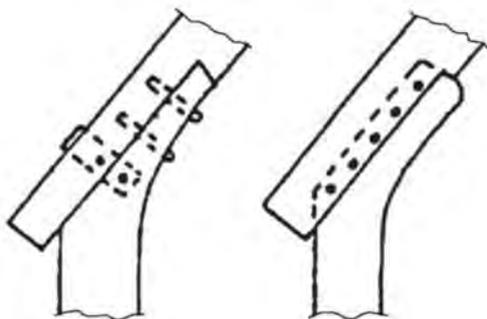
Fig. 9 Cruck joints, after Penoyre [5]

This terminology has continued to be used in describing jointed crucks in the County, and was further consolidated in the caption that accompanied the original of the illustration shown in Fig. 9 in which the left-hand joint is described as ‘face pegged with slip tenon’ that on the right, being ‘side pegged with long tenon’.

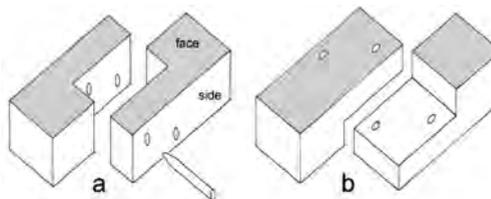
Fig. 10 Scarf Joints, after Alcock *et al.* [6]

The joint 10(a) is defined [6] as a face-scarf with square abutments; 10(b) is a side-scarf with square abutments. The timber is of rectangular section and the illustration shows the *face* as being uppermost; Alcock adds that 10(a) is *side* pegged. Alcock points out that trusses are marked out whilst lying on the ground and hence the ‘face’ is uppermost.

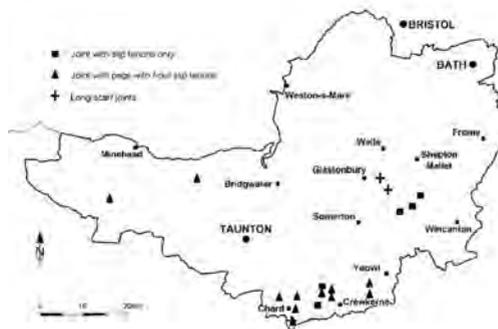
Fig. 11 Distribution of lesser known jointed crucks

The dispersion of these joints is illustrated in Fig. 11 which shows a group of Fig. 6 type joints lying just to the east of the A37 road between Shepton Mallet and Yeovil plus another two in the Chard-Crewkerne area. The joints that use a combination of slip tenons and soffit pegs (Fig. 7) occur most frequently in the area between Yeovil and Chard although there are two 'strays' in the west. Two of the long scarf joints are in buildings that were associated with Glastonbury abbey. The third is at Tatworth in a building that has a complex roof history.
