# SHORTER PAPERS

10 LOAD LANE, WESTONZOYLAND  
NGR ST 34870 34665 HER NO. 13885

CHERYL GREEN

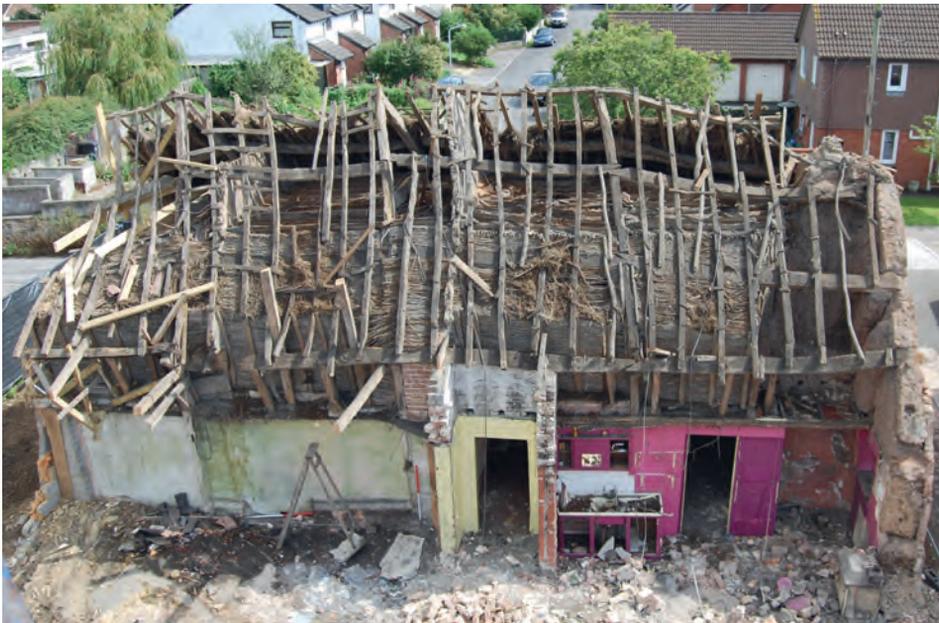
Fig. 1 Rear elevation showing original frame and cob gable (2 x 1m scales; looking SE)

Context One Heritage and Archaeology carried out a programme of historic building recording prior to and during demolition of a Grade II Listed farmhouse (Historic England Listed Building reference 1060100). The controlled dismantling provided the opportunity to record extensive details of the historic fabric that had previously been concealed within an early 19th-century shell. The recording confirmed that the 'earlier core' described in the listed building entry was early post medieval, enabling key questions to be addressed relating to form, construction and joinery techniques (Fig. 1)

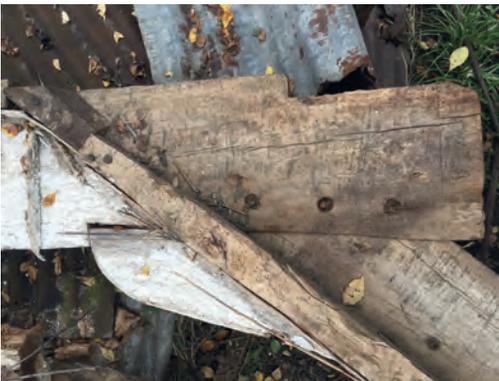
*Fig. 3 Side-pegged long-tenon joint of Truss 2 following removal*

The farmhouse frame was a jointed cruck of three trusses, the end of the purlins embedded in the cob of the gable ends (Fig. 2). Side-pegged long-tenons (Fig. 3) joined the collared principal rafters and main post, the tenoned apex with ridge-piece held in a V-notch

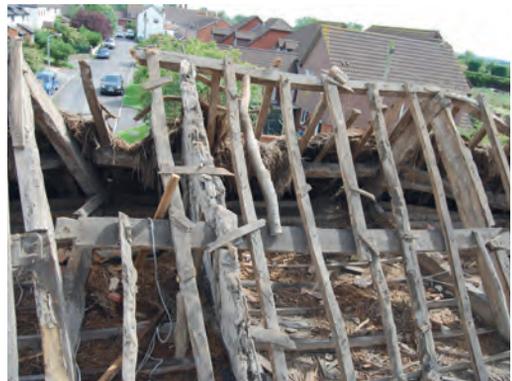
*Fig. 4 Truss 1 and 2 with collars, and purlin with splayed scarf joint and dovetail joint (looking SE)*

(Fig. 4). According to roof apex-type classification, this equates to type E (Alcock 1981; McDermott 2005, 95), the most common apex type for jointed crucks, and also recorded for the Sedgemoor Inn (Vernacular Architecture Group (VAG) Report, February 1973). The thatched roof (which was partially *in situ* beneath the modern roof) was supported on three rows of trenced purlins, the lengths joined by splayed scarfs and some more crudely executed dovetails, below pegged common rafters (Fig. 4). The frame was infilled with cob above a wooden sill resting on a blue lias plinth, the thick south-western cob gable wall incorporating a chimney and re-faced during the Victorian period in brick. The north-east gable was rebuilt in brick following the partial collapse of the cob.

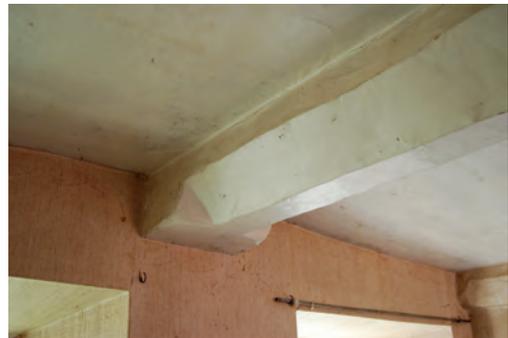
Fig. 6 Bridging beam showing steep chamfers and square stop

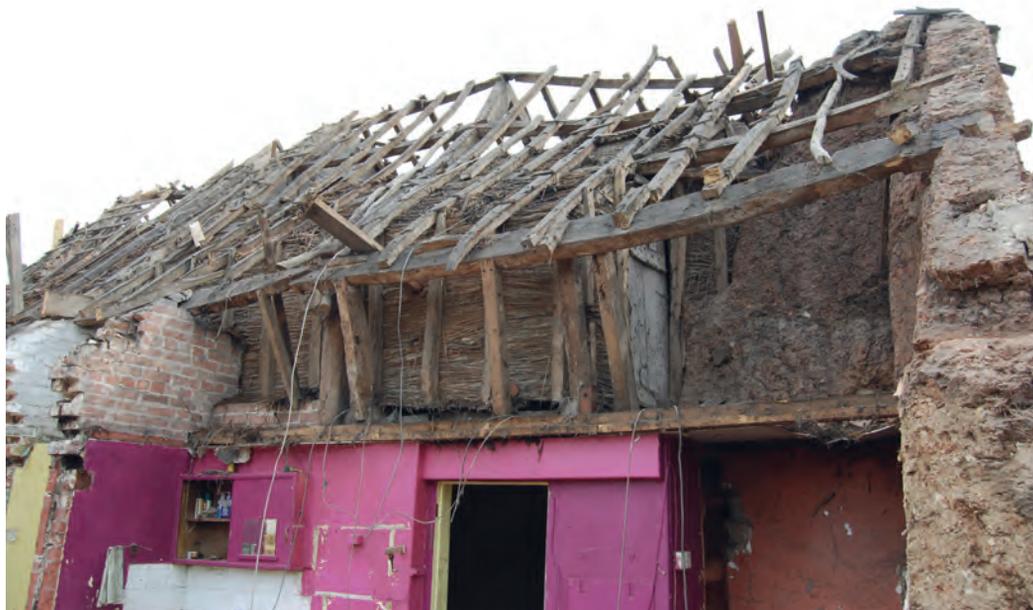
Fig. 7 Rear showing small room with door alongside cob chimney, cob gable wall, additional supports to lower purlin, and later first floor internal stud wall of reed and plaster (looking E)

roof suggesting an outshot, a blocked doorway with dovetail joints providing access from the central hall. The outshot may have accommodated stairs to a small first-floor room at the south-western end alongside the chimney, providing access through a small wooden door (concealed behind later reed and plaster walling) to the first-floor chambers (Fig. 7). Alternatively, the presence of some light sooting within this small room and what appears to be a draught-tunnel may perhaps indicate a drying room for hanging meat, a practice identified in the West Country in the early 17th century (Brears 2015, 103). The presence of this small room on one side of the chimney is reminiscent of a smoke-hood arrangement, in which case the ground-floor fireplace would have been a later reconstruction. In this scenario, the stairs would have been located elsewhere, perhaps within the hall adjacent to the cross-passage.

Later alterations included additional upright supports to the lower purlins, and the insertion of a first-floor wall lining and ceiling comprising reed and plaster constructed against wooden studs fixed to the common rafters. This reduced the width of the rooms, creating a void in the eaves between the studwork and the outer wall. The insertion of the ceiling closed off the roof, which originally would have been open to the timber frame. There were no redundant mortices on the underside of the purlins to indicate wind bracing, however the massive chimney
