Carpentry in Early Dunster Houses

One of the major areas of focus for the Early Dunster Project is the various timber structures and styles to be found within roof spaces.

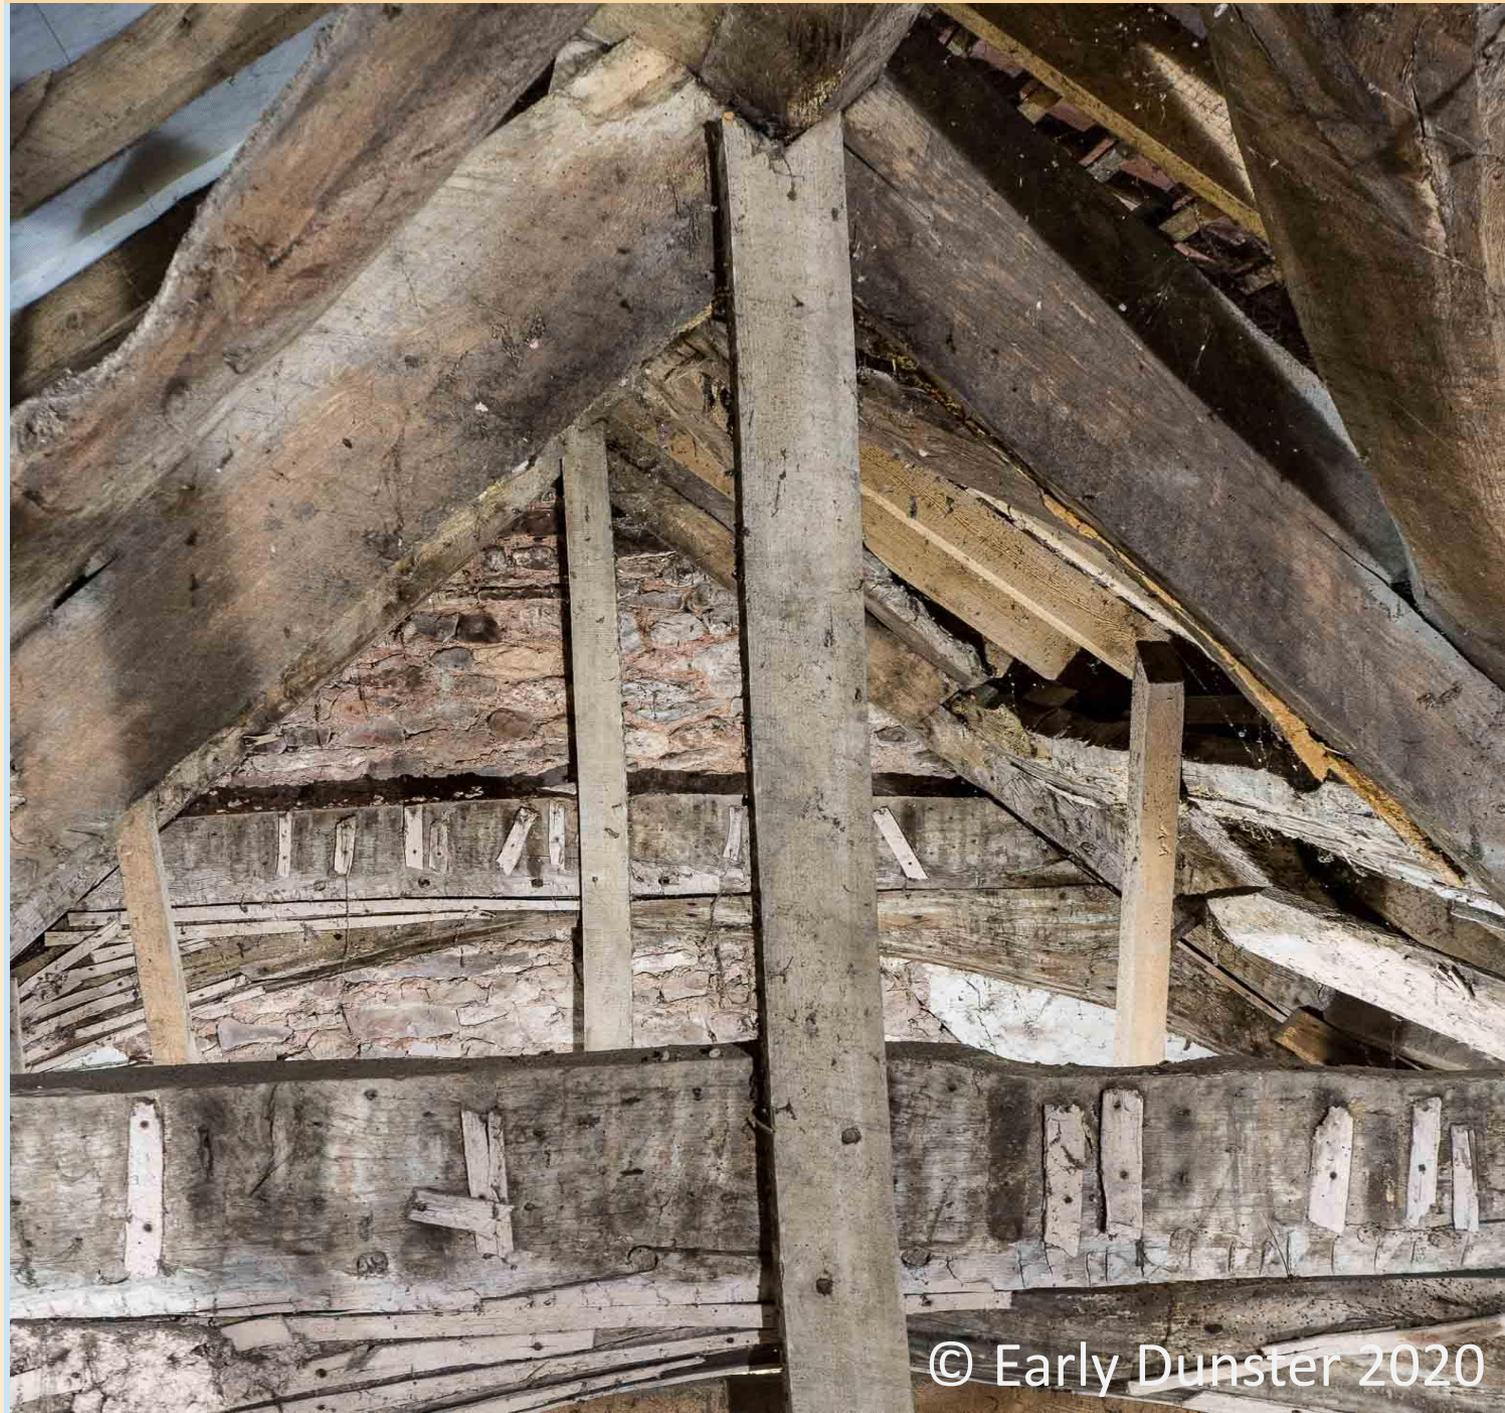
These are the main timber components we find in a typical mediaeval roof

Principal rafters.

The 2 main
"blades" of the
truss

Purlins.

Longitudinal
timbers which
supported
rafters which in
turn supported
the roof
covering

Ridge Purlin

Longitudinal
timber
supporting the
ridge at the top
of the roof

Rafters and battens

Lighter timber
framework to
which the roof
covering is fixed

Collar.

Horizontal
timber bracing
between
principal rafters

Wind Braces

Elegantly curved timbers which helped to brace the structure lengthways. These tended to feature in larger or more prestigious buildings where they would have added some aesthetic value.

Arch Braces.

Additional bracing between collar and principal rafter to prevent distortion of the truss, particularly in larger buildings

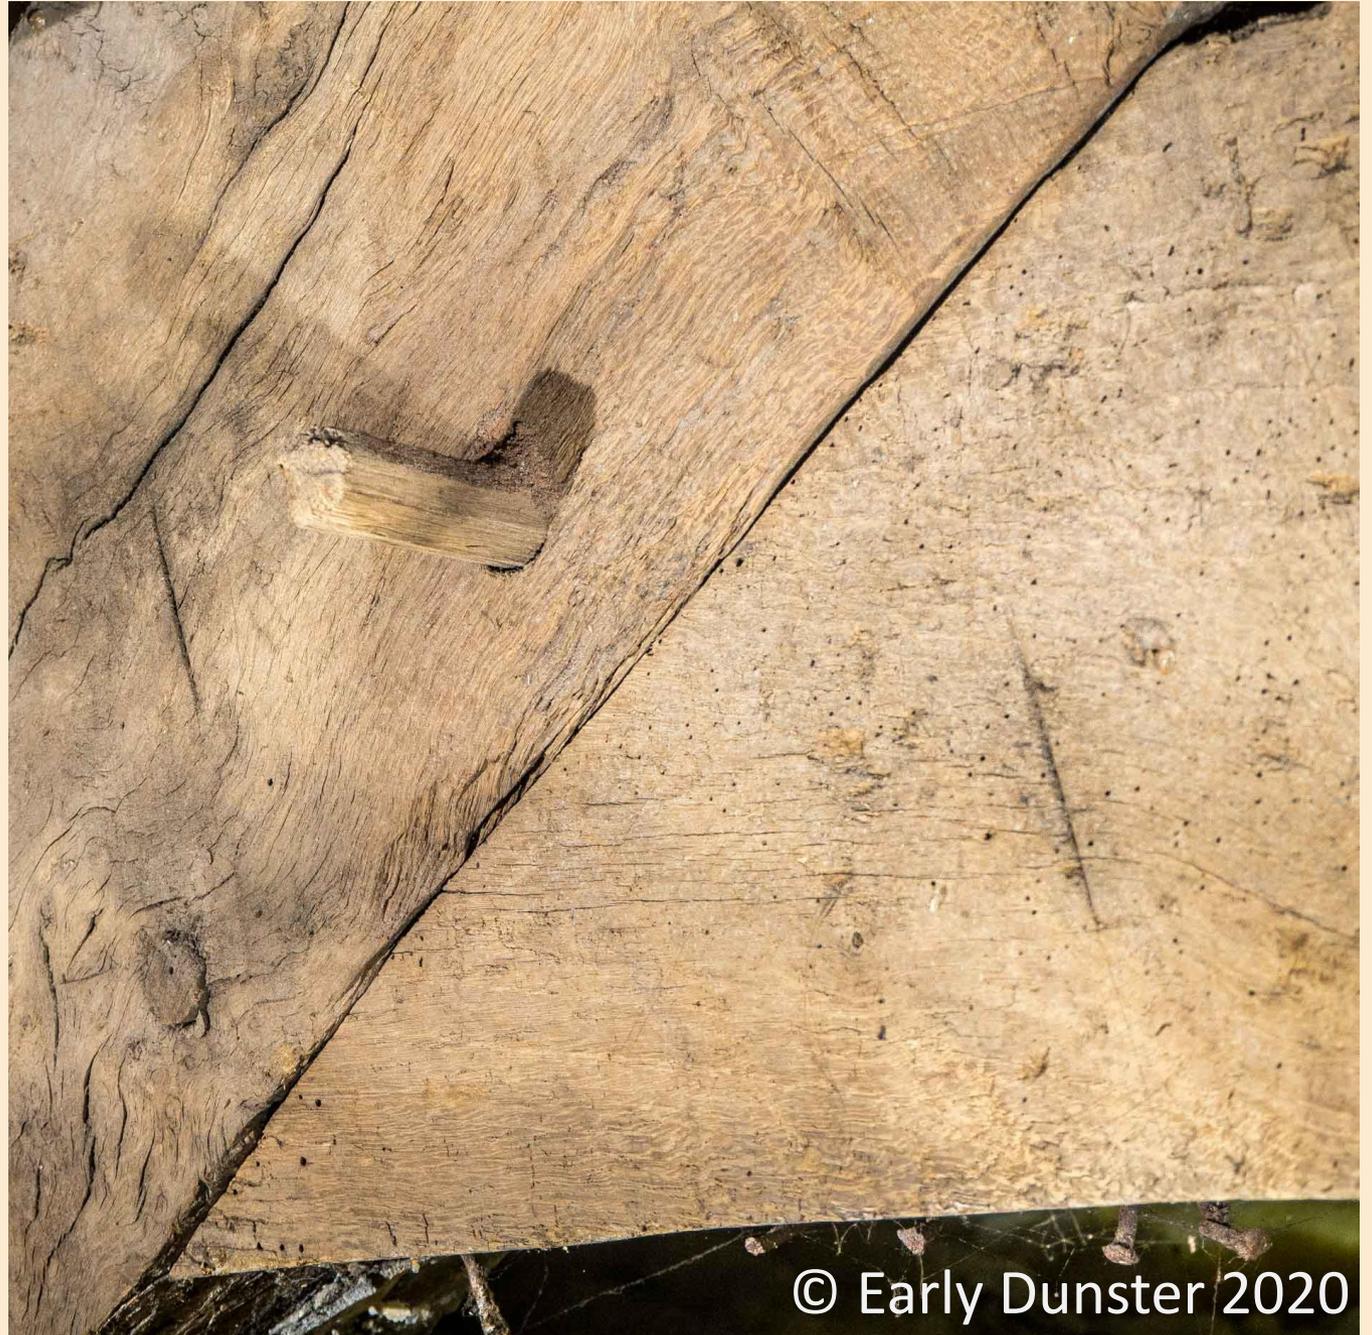
The principal rafters and collar are normally quite large timbers (typically 300mm deep x 200mm wide).

Substantial joints were needed to fix the collar and principals together.

The most common form of collar joint we encounter is a mortice and tenon joint, with tenons on the collar ends fitting into deep mortices in the principals and secured with 2 or more wooden pegs of about 25mm diameter.

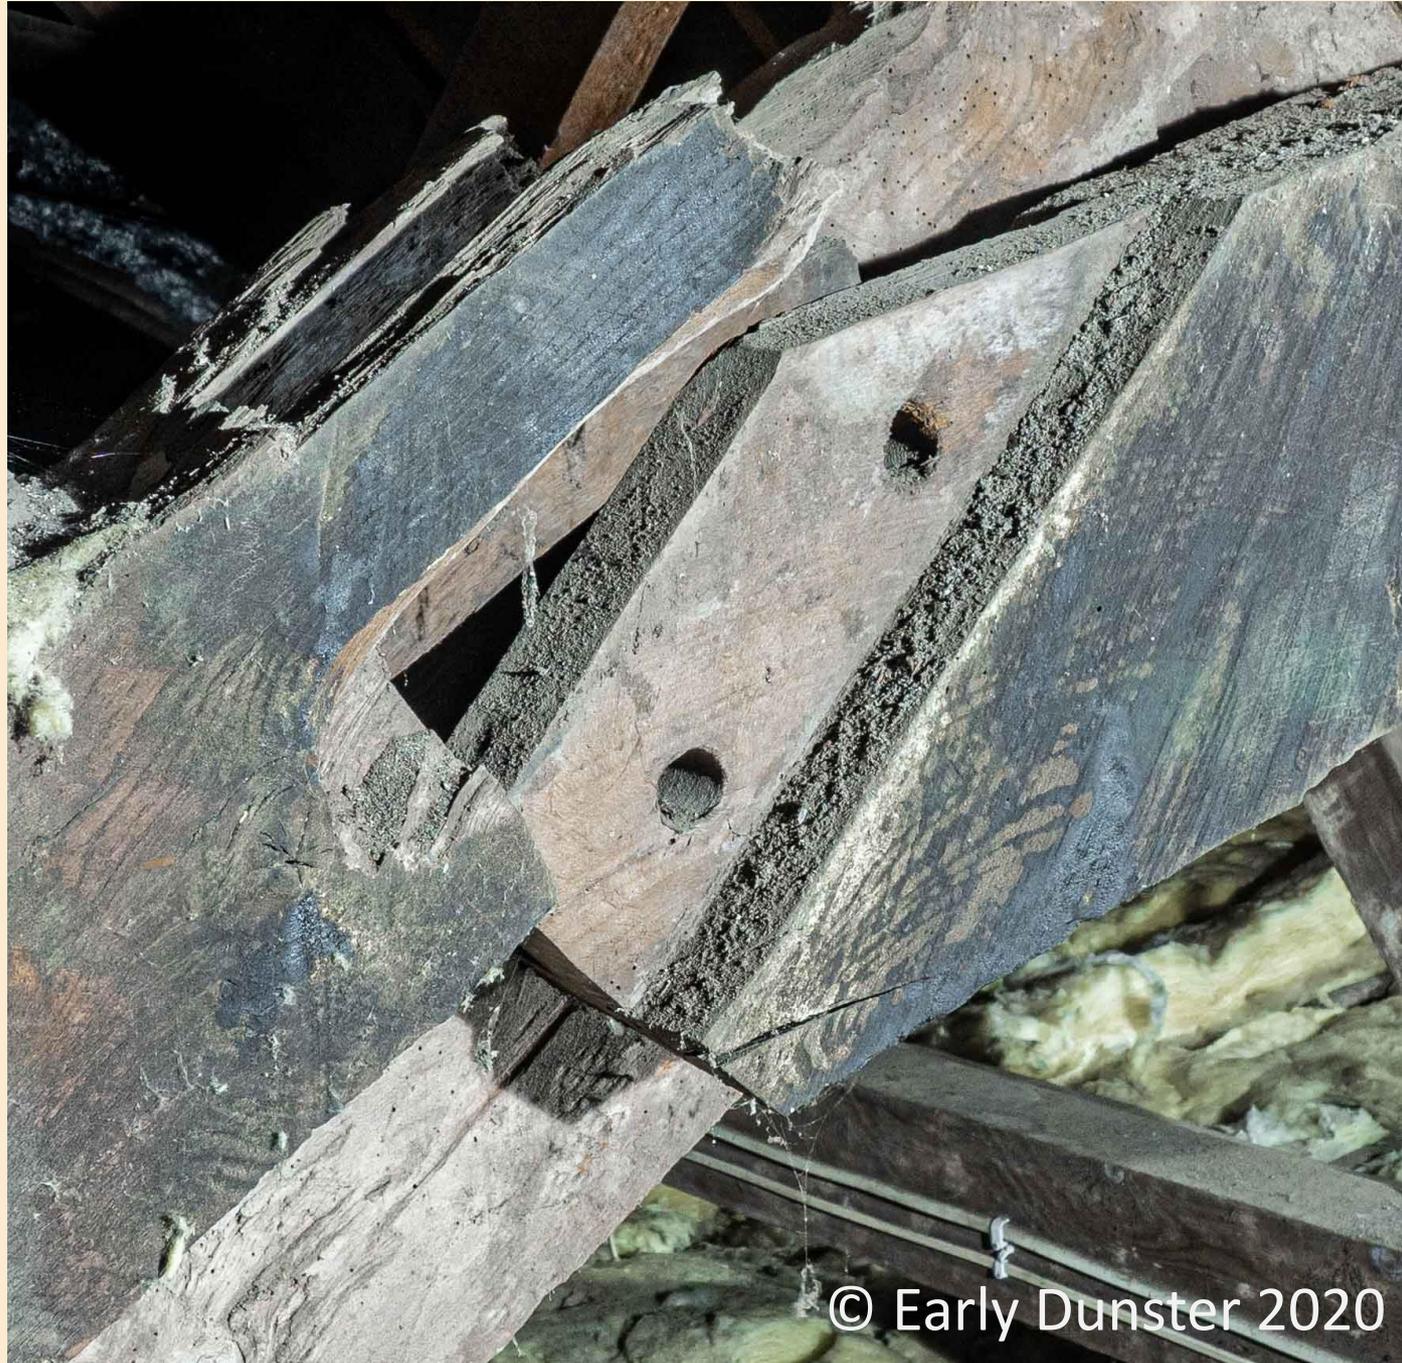
In one of the properties surveyed, we found an original 14th Century truss which has partly collapsed, giving us a rare insight into the shape of the collar tenon.

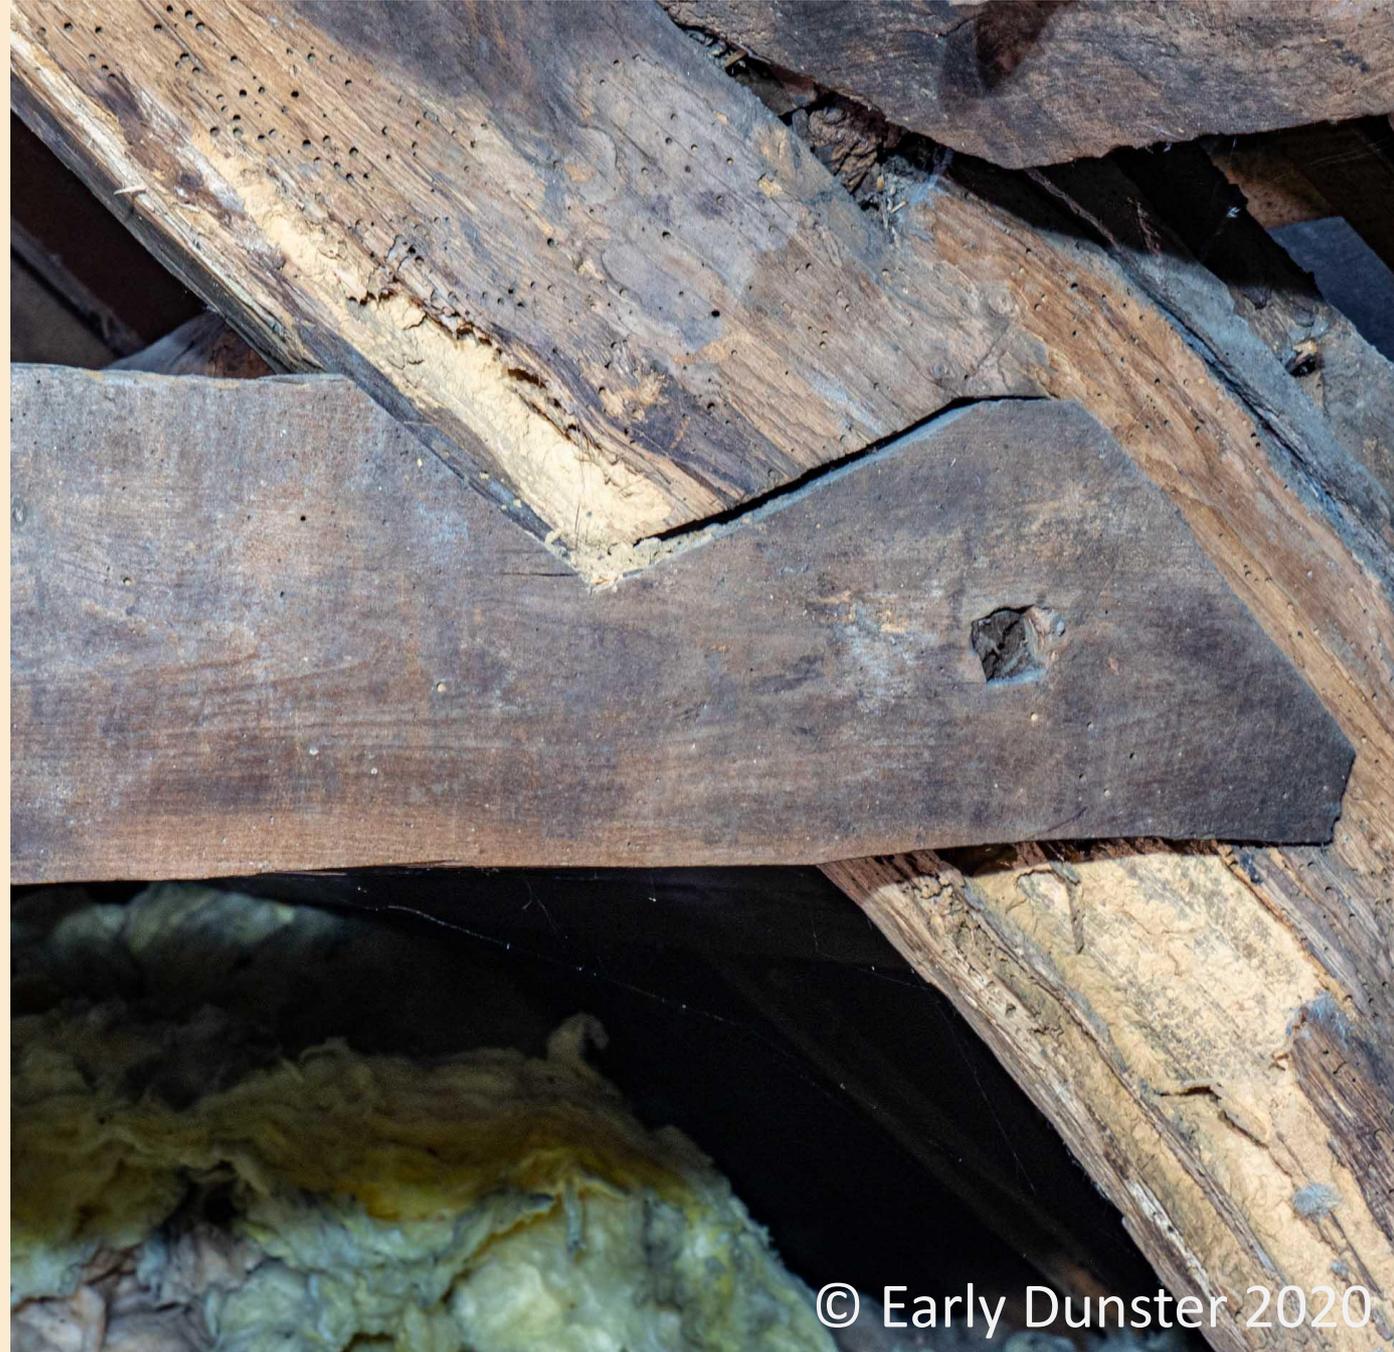
In some later properties, the mortice and tenon form gave way to a notched lap joint form, where the collar is set into the face of the principal rafter, using a dovetail or similar shape to help prevent “spreading” of the truss.

We believe this example dates from the 17th century. Other joints of this form have been recorded in the area from the same period.

Lap-jointed collars appear more prevalent from the 16th century onwards. Some of the later trusses use timbers that are thinner in section, so perhaps the mortice and tenon form would have compromised the strength of these lighter timbers.

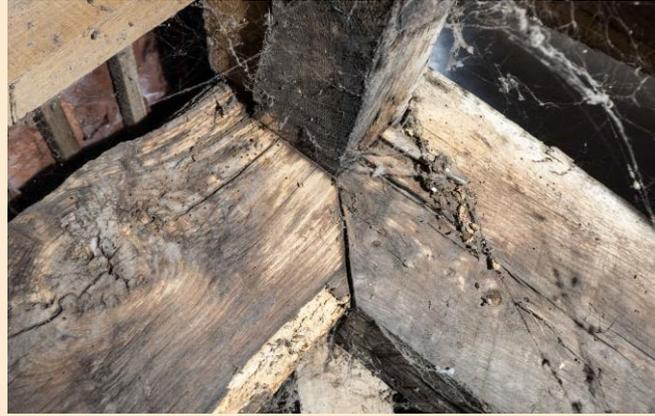
“Type B” : Blades meet vertically with a diagonal-set timber forming the ridge

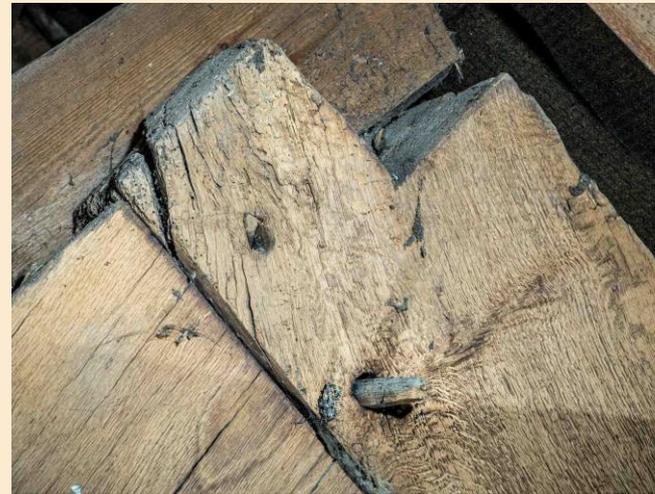
“Type E” : Blades jointed 90 degrees with a diagonal set ridge. (This seems to be the most common form we find in our Dunster surveys and occurs in roofs dated several centuries apart)

The Type E apex appears to be the most common form, consistent with surveys of other properties, certainly in the West Somerset area, and this form has prevailed through many centuries.

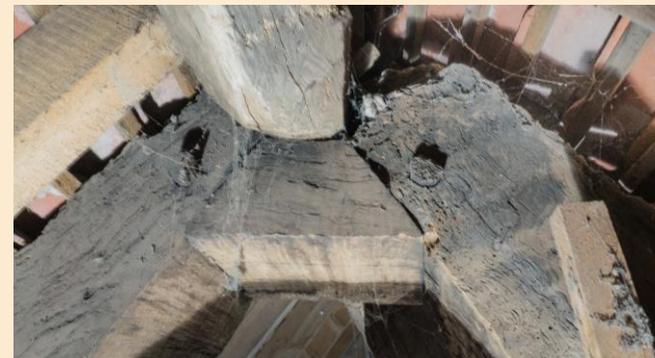
“Type L1” : Blades joined by a central “yoke” directly below the apex, with a diagonal-set ridge purlin above

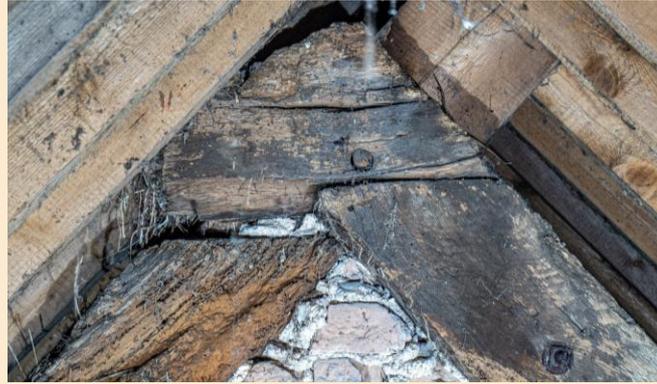
“Type C” Blades joined by a central “yoke”. A longitudinal timber would have been set on top of the yoke to form the ridge. The left-hand blade has partly collapsed, but the right hand side remains intact showing the yoke

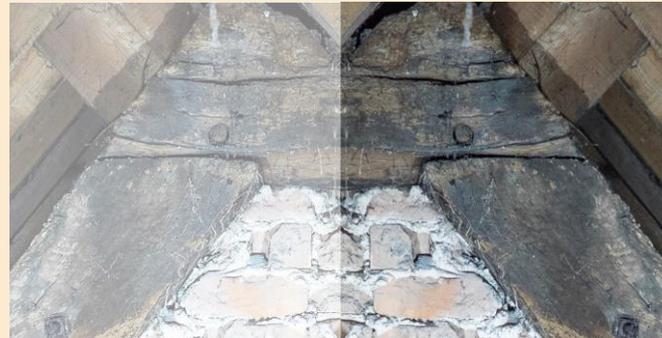
This digitally-manipulated image represents how the apex would have originally looked, (the collapsed left-hand side is replaced with a mirror image of the right-hand side.)

It appears the ridge timber may have been diagonally set, though this may be a result of subsequent alterations.

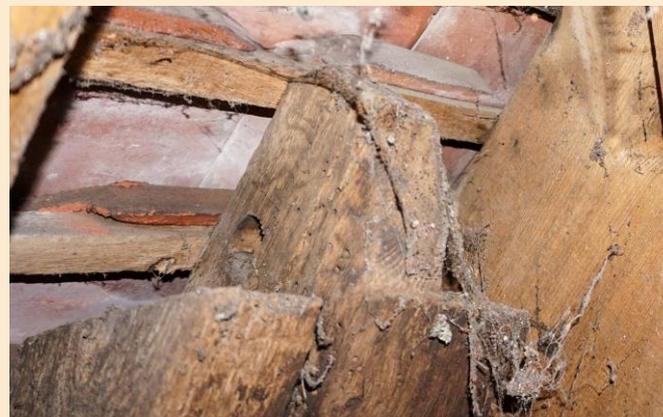
The yoke is missing from another truss in the same roof, showing an interestingly curved tenon.

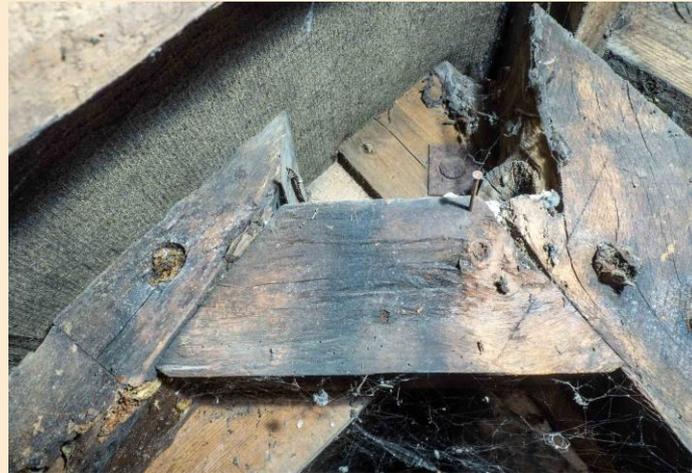
“Type H” : Blades held by a yoke, with horizontally-set ridge plate clasped between the blades above.

This example, in which the left-hand blade has partly decayed, is from roof dated to around 1300. The top of the right-hand blade has also been over-cut, probably during later modifications.

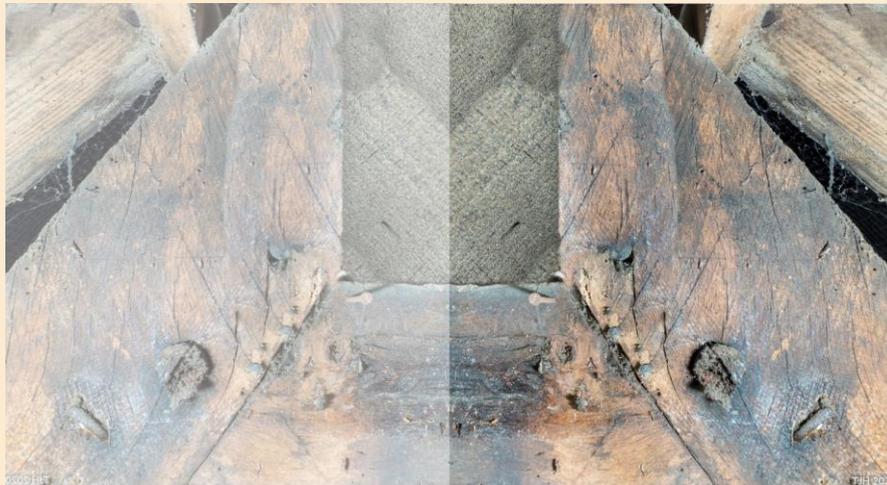
Again using digital manipulation, we can rebuild the left-hand side and fill the over-cut on the right-hand blade, to give a reconstructed view of the original arrangement.

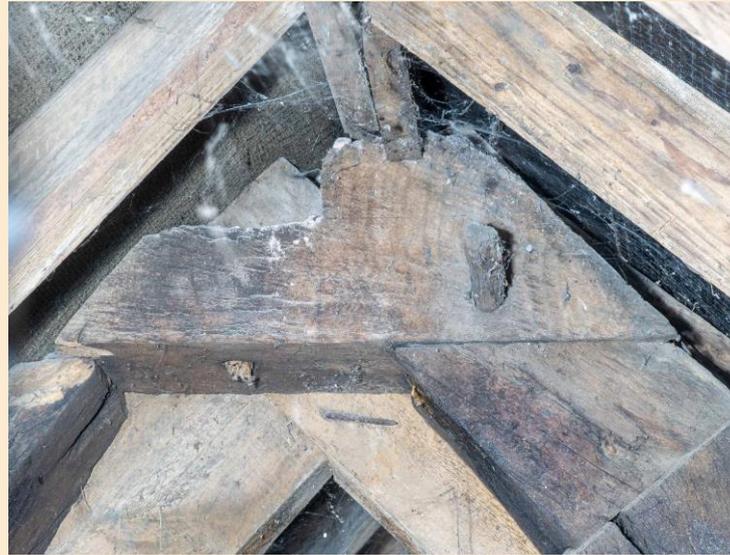
This example is similar to Type C, with the truss blades joined into a yoke above, but the ridge timber was housed into the yoke rather than seated on top.

Again the left-hand side of the yoke and blade are missing as a result of decay and/or later modification.

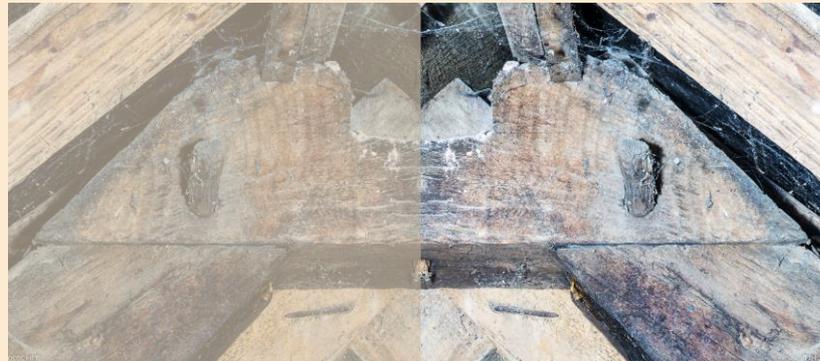
This digital reconstruction shows how the original arrangement may have looked, though the yoke may have been deeper than current.

Not also the peg-hole in the underside. A peg would have been inserted through the ridge timber and into the yoke to secure the ridge

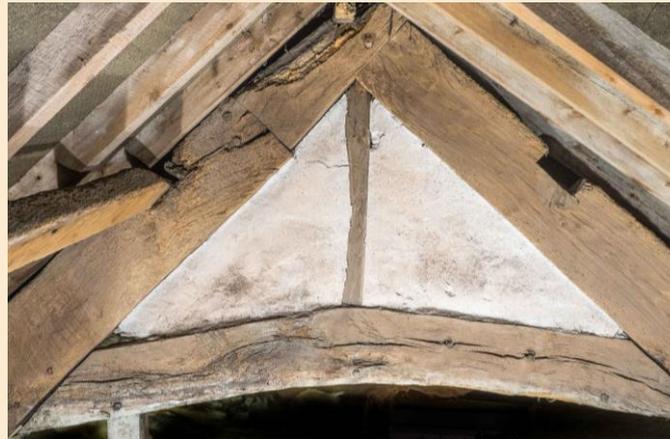
Trenched purlins are perhaps the simplest form – the purlin is located into a matching “trench” cut into the upper side of the principal rafter.

Note the now vacant trench on the right hand blade of this truss

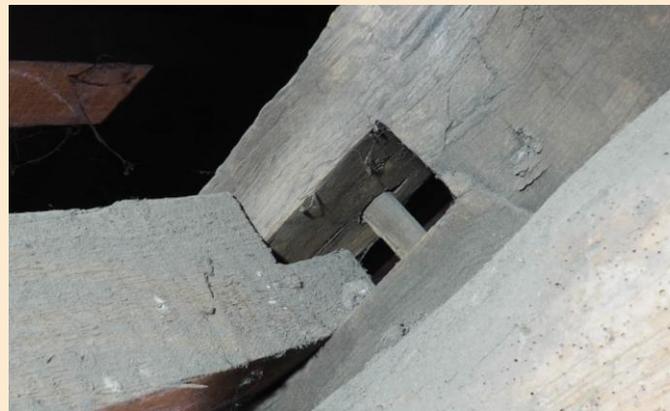
With tenoned purlins, a tenon is cut in the end of the purlin and housed into a matching mortice in the truss.

(In this illustration the purlin is a later replacement. The original would have filled the mortice.)

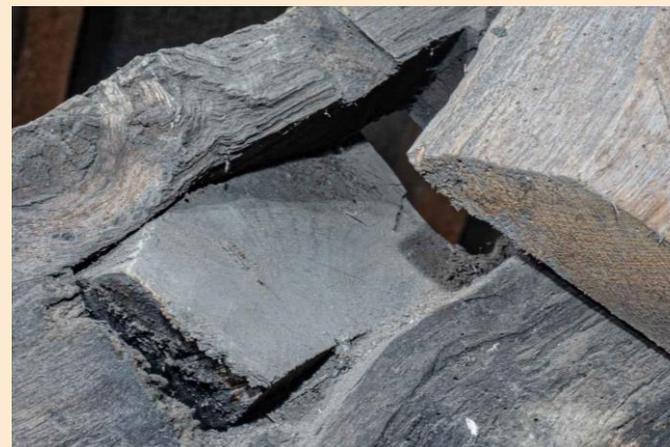
Threaded purlins are similar to tenoned, but the mortice in the principal is the full size of the purlin. The purlins on opposing sides may meet within the mortice in either a splayed (diagonal) or square (butted) arrangement

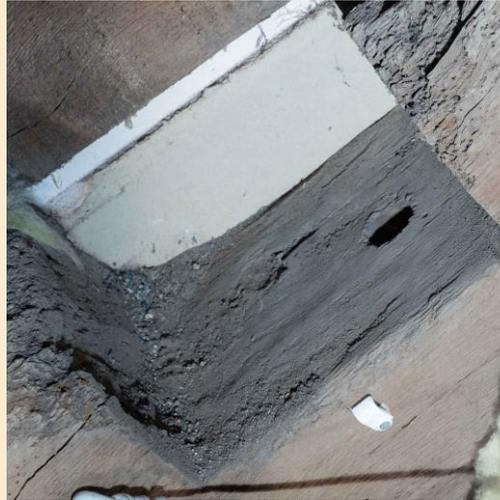
Here a former purlin trench has holes for 2 pegs which would have secured the purlin in place.

(The timber at the rear of the trench is a later addition)

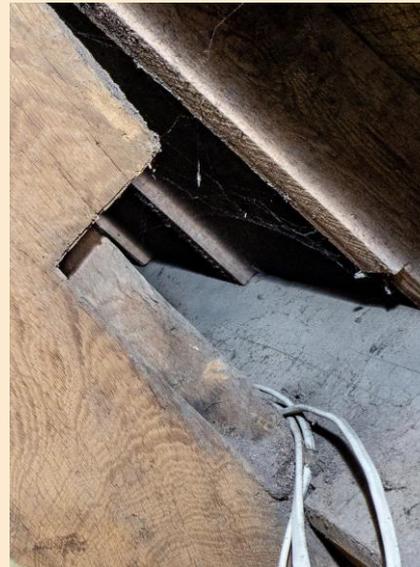
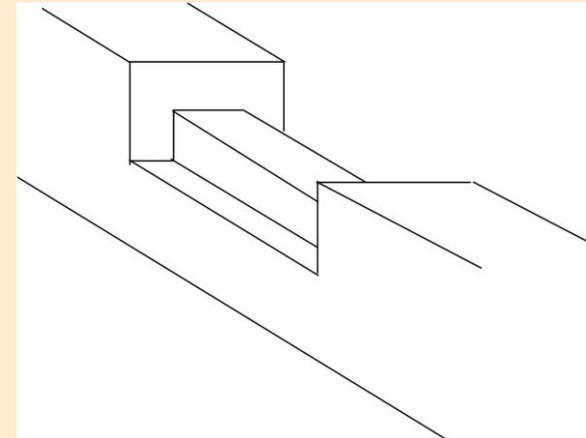
This purlin trench incorporates a locking rib. The purlin would have been notched to locate onto the rib. The rib was quite broad and flat, and would have provided more strength and stability than simple pegs

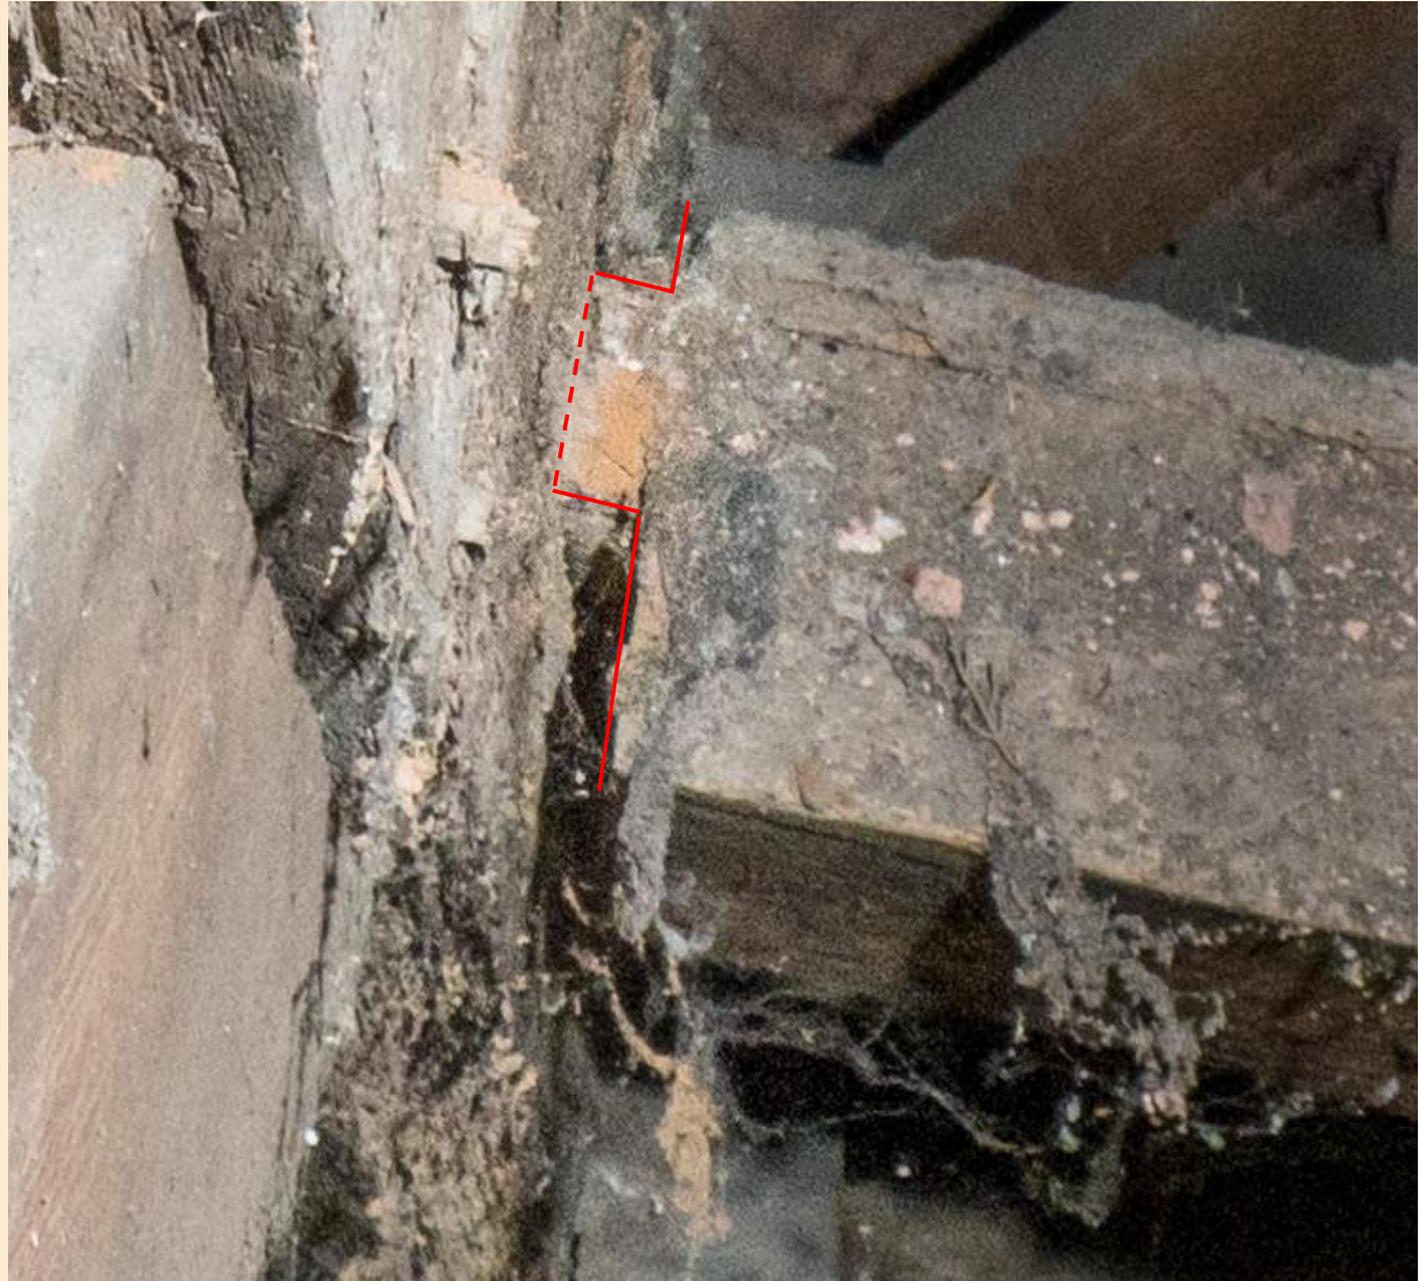
With this type of joint a tenon at the end of the purlin locates into a matching mortice cut into the face of the principal rafter. On intermediate trusses the mortice often penetrated right through the rafter, housing opposing purlins on each side of the truss.

In the example shown here, the joint has partly withdrawn, revealing the shape of the tenon (highlighted in red)

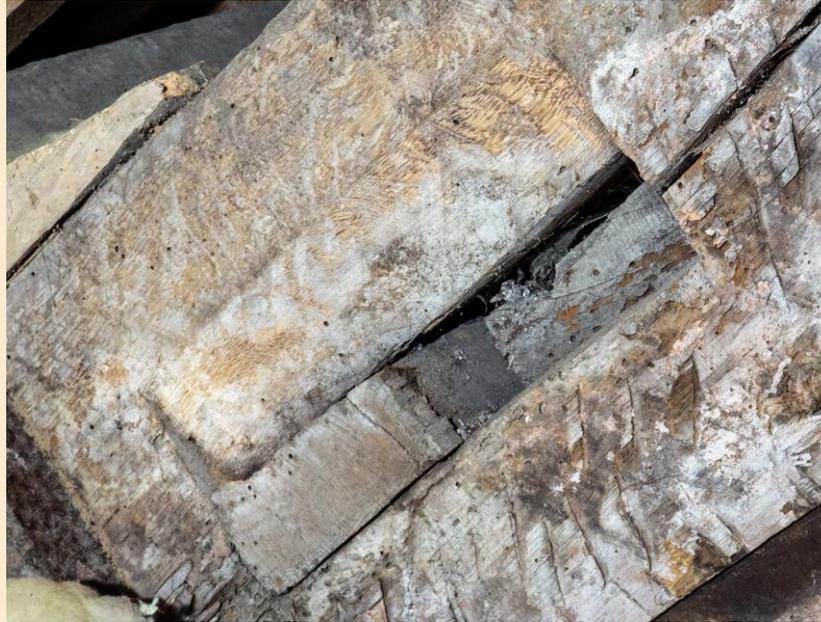
Here the joint has a bevelled shoulder above the mortice, enabling the full cross-section of the purlin, rather than just the tenon, to bear on the rafter

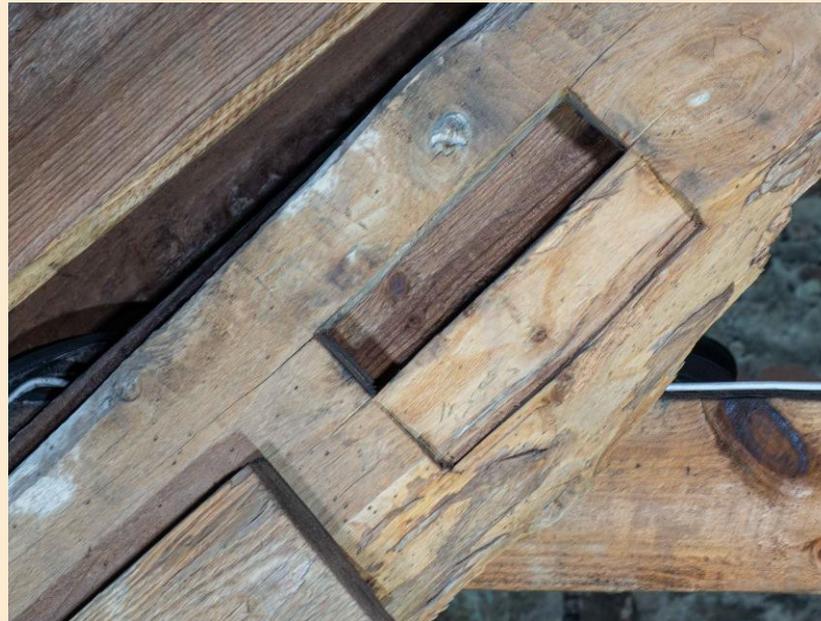
In this later example, a bevelled shoulder is cut below the mortice, providing a housing for the full purlin.

This form of “tusk” tenon is also used for jointing ceiling joists to beams

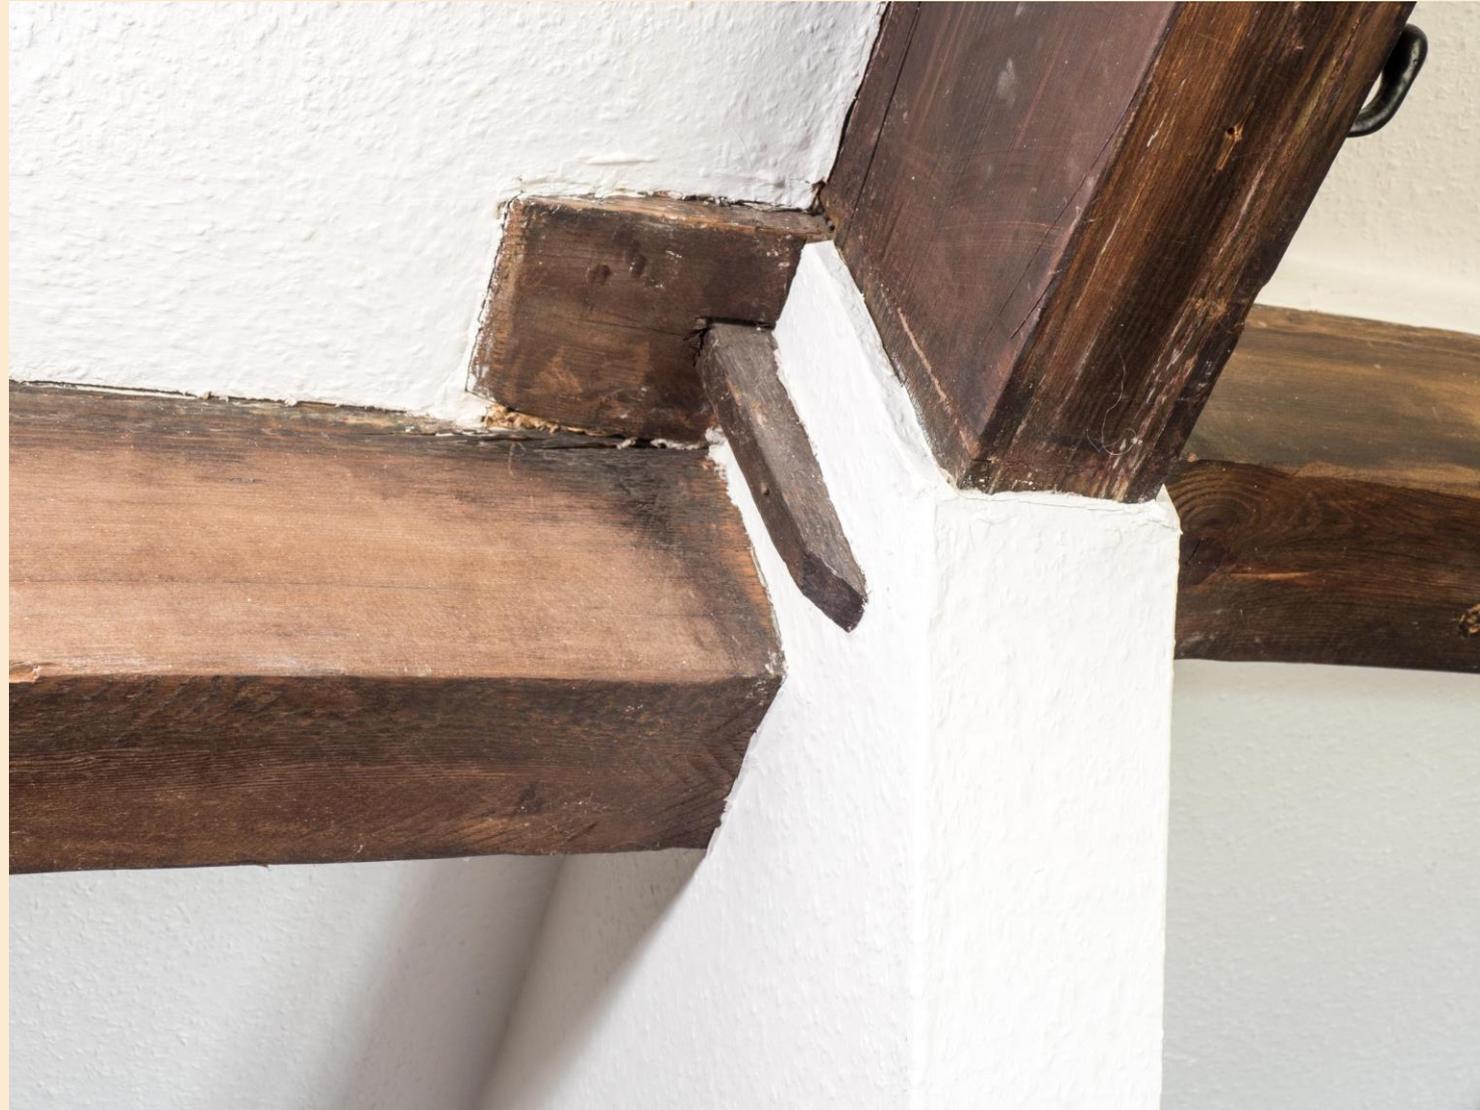
In some later roofs, the purlins on either side of an intermediate truss were positioned at different heights (“staggered”).

In some cases the tenon extended right through and projected beyond the far side of the rafter, and was secured with a “face-peg”

Note the staggered position of the purlins on either side, and although partly concealed by the ceiling and plaster, the wooden face-peg driven through the protruding tenon of the upper purlin.

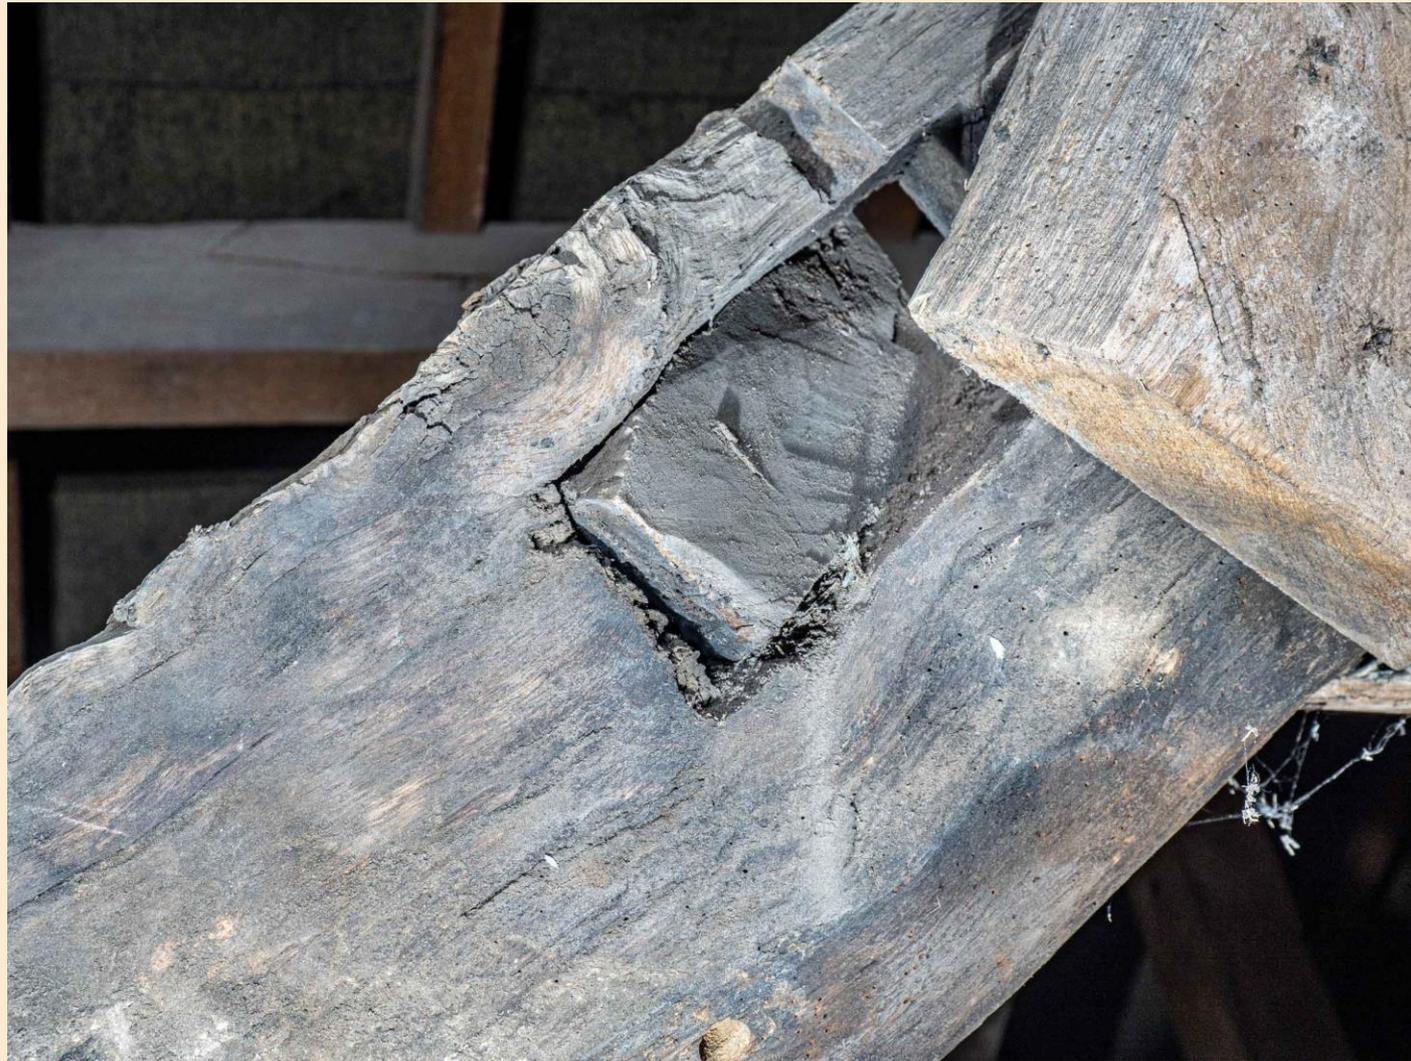
In the example here the purlin ends from either side were angled (“splayed”) and secured with pegs.

Note the splayed end of the far-side purlin seated in the rafter. The additional timber at top right is a later reinforcement but behind it the original peg which would have secured the near-side purlin (now removed) is still in place .

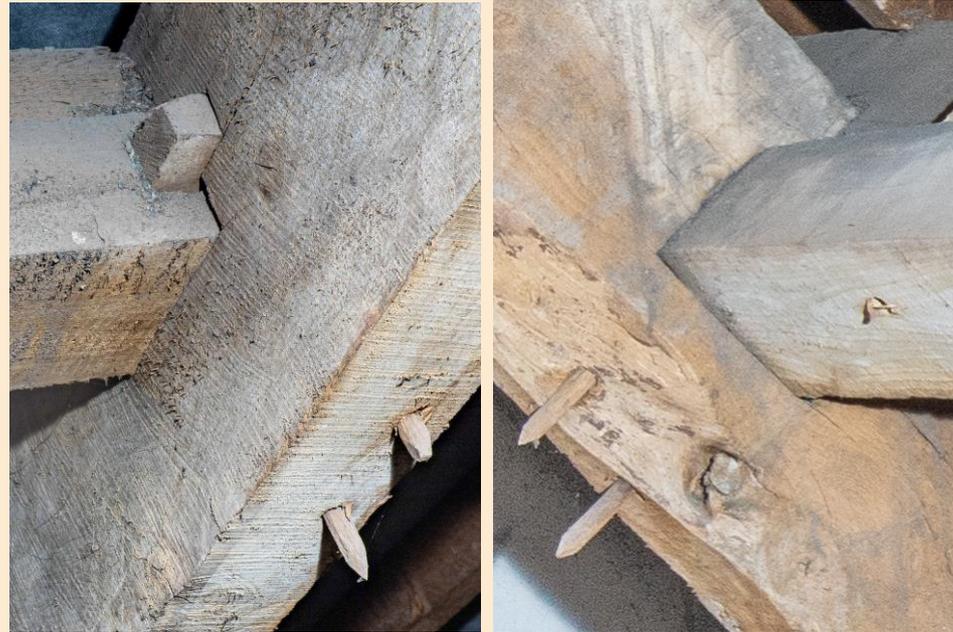
This was found in a relatively late roof, and although unable to inspect the internal joint, we believe it is what could be described as a part-staggered bridled scarf joint – with pegs.

The purlin joint as viewed from each side of the rafter.

Note the slight stagger, and the projecting tenon on the left hand side

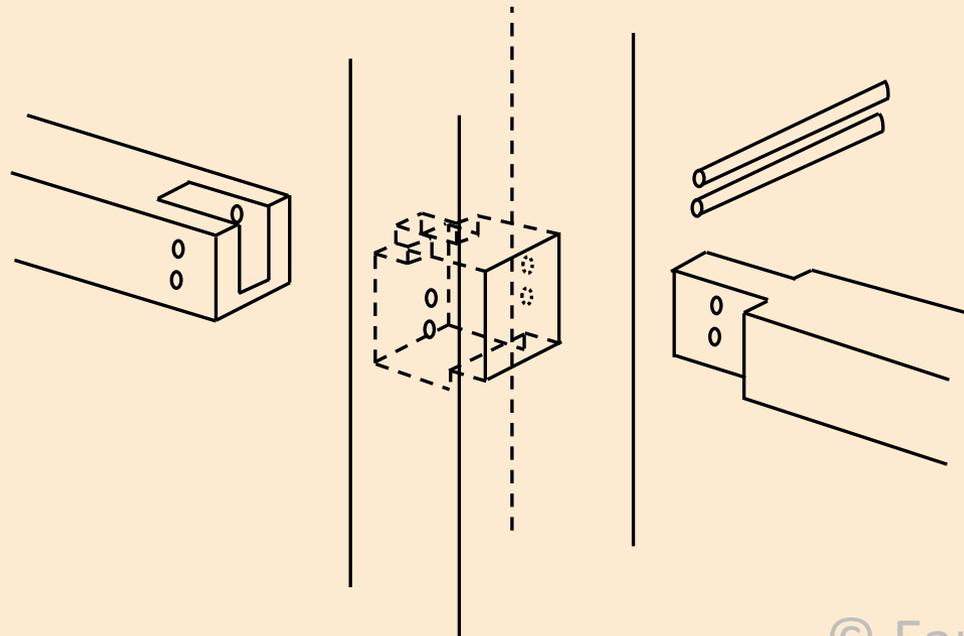
Though unable to inspect in detail, we believe the internal structure of the joint may be of this form.

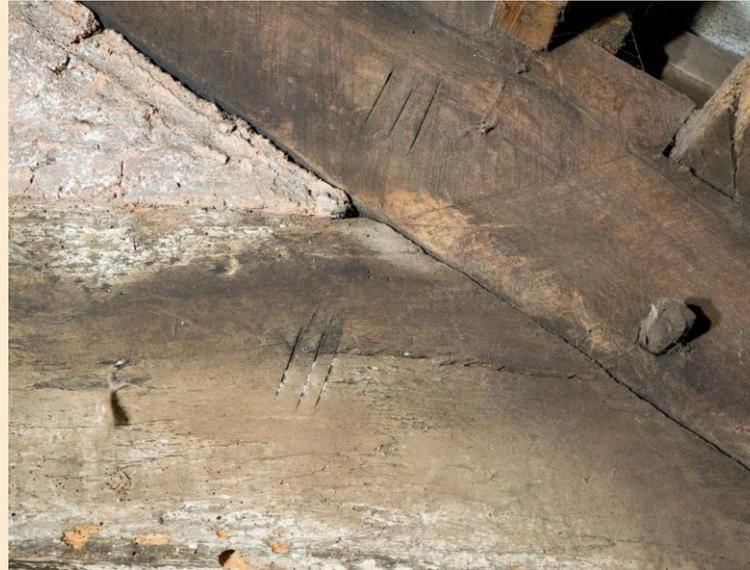
In this early truss, the roman numeral III is used to identify matching halves of the collar joint.

In early work, the marks were typically scored into the surface of the timbers using a mediaeval tool known as a race-knife.

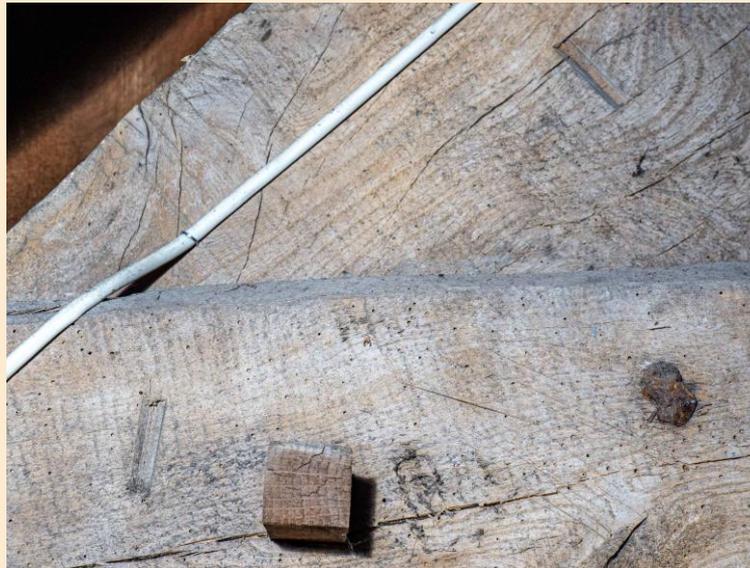
In this example, a few hundred years later, the same principle is being used, but the mark (I) is cut with a chisel rather than scored with a knife.
