Carpentry in Early Dunster Houses

One of the major areas of focus for the Early Dunster Project is the various timber structures and styles to be found within roof spaces.

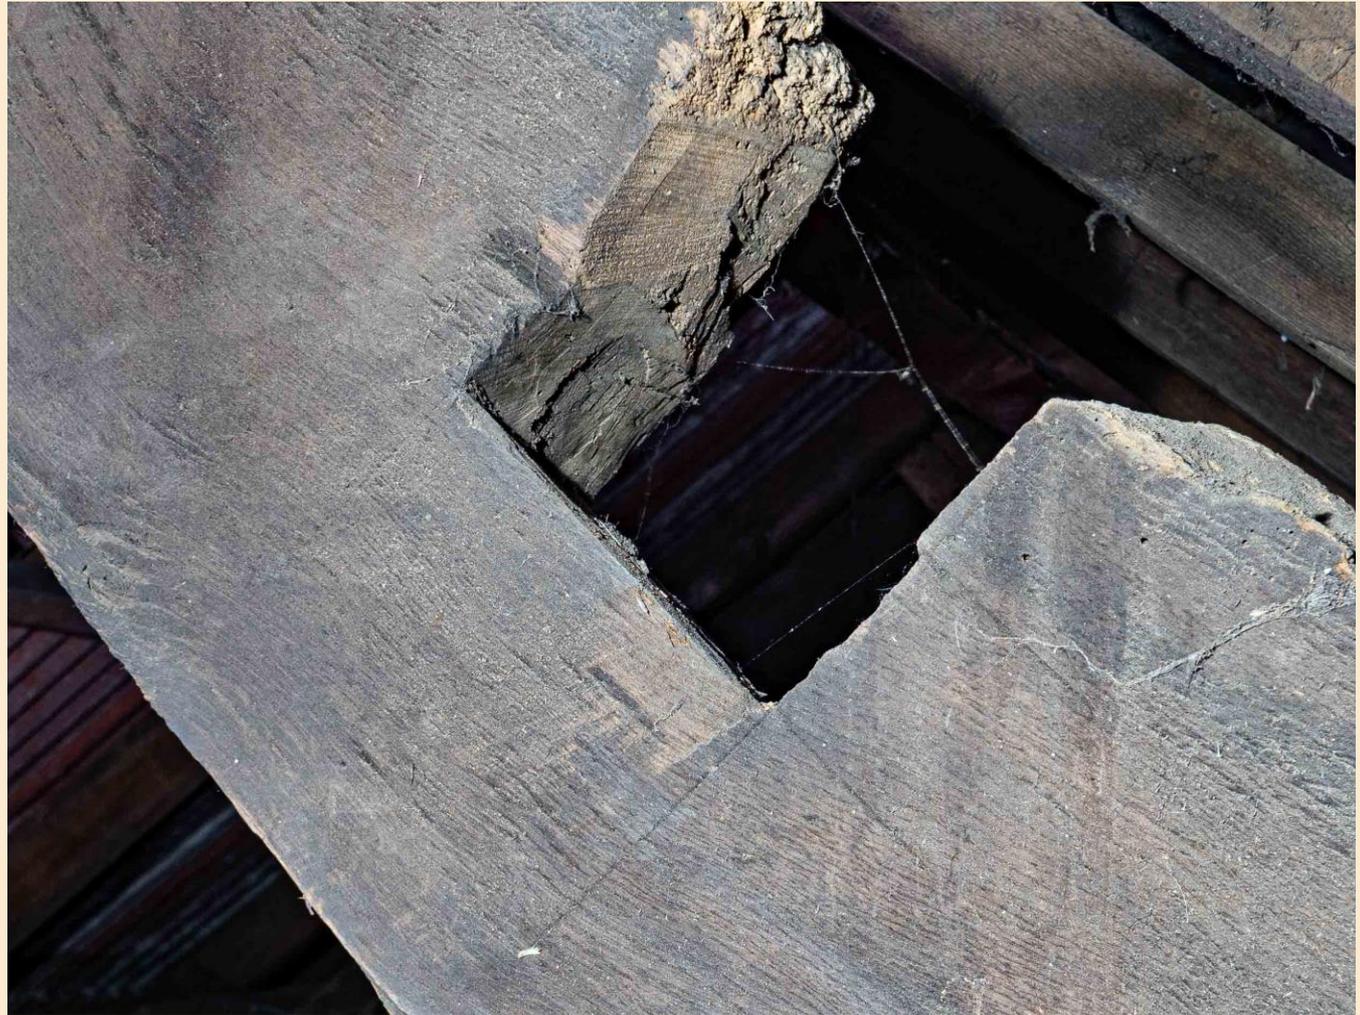
Although the upper side has since broken out, we can still see the perpendicular lines marking out the original purlin mortise in this 13th or 14th century truss

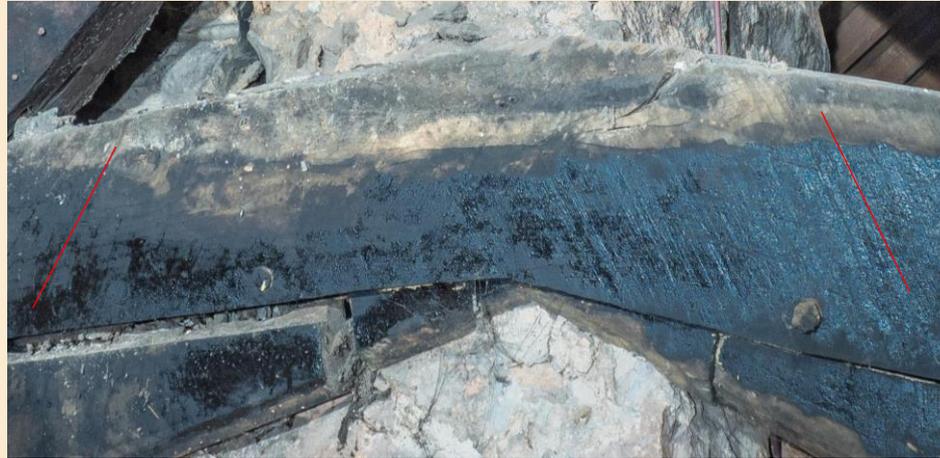
Earlier methods used trestle sawing where one end of the log was raised on a trestle, and the saw was used horizontally. When the mid point was reached, the log was turned and cut from the opposite end. This resulted in opposing diagonal saw marks.

Saw marks on this 13th century collar are diagonal, and are inclined in the opposite direction at each end of the collar, indicating that the piece was trestle sawn

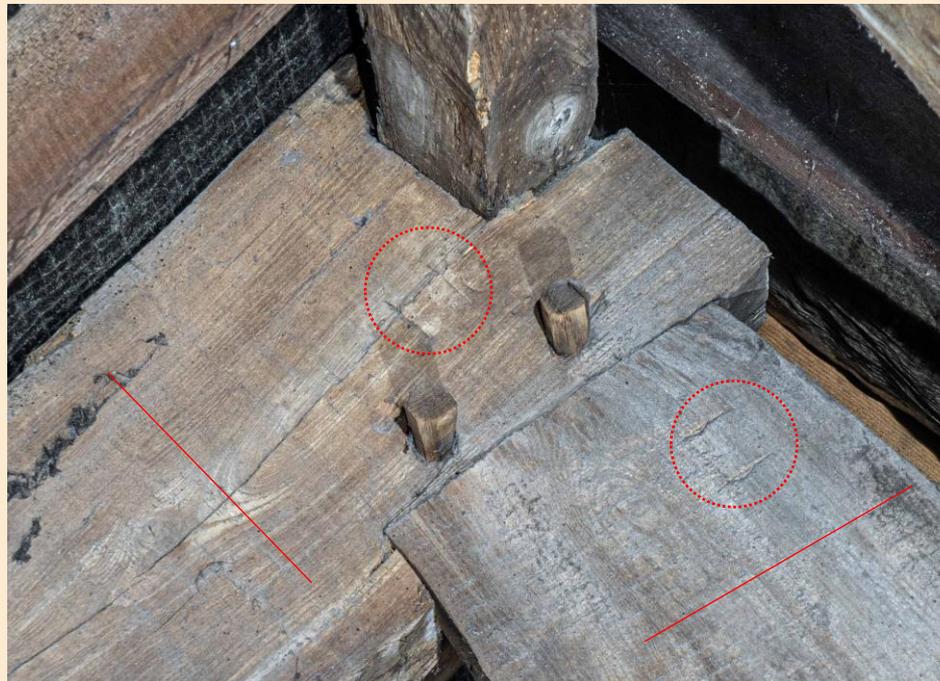
Trestle sawing was eventually superseded by pit-sawing, where the log was placed horizontally over a pit, and the saw used vertically, resulting in perpendicular saw-marks along the whole length.

Perpendicular saw-marks on this later truss indicate pit-sawing.

Note also the carpenters mark II on each half of the apex (circled)
