BUILDING RECORDING IN 2014

SOMERSET VERNACULAR BUILDING RESEARCH GROUP

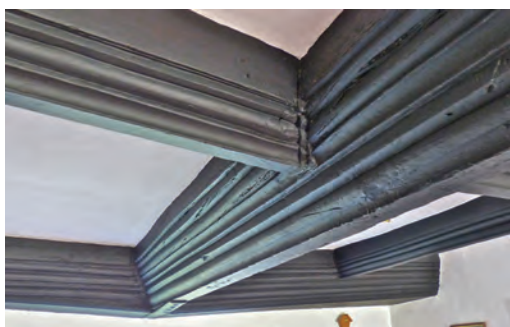
1. Ashill, Thickthorn Lane, Southtown Farm. ST 3203 1604

Fig. 1 Ashill, Southtown Farm: 16th century framed ceiling, two orders of framing

In the 'Hall' a superb four-panel framed ceiling with elaborately carved and jointed beams is believed to have been imported at this time. A slightly shallower half hipped roof now over-lays the original which was set on tie-beam trusses, some apparently re-used; the addition has collar beam trusses with a distinctive curved form of dovetail.

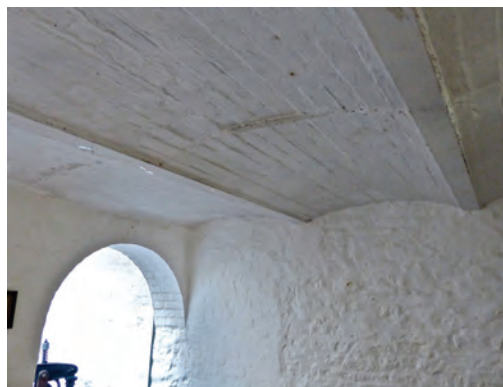
2. Bruton. 27, High St. ST 6825 3485

Fig. 2 Bruton, 27 High St: iron-beamed, brick-vaulted, fire-proof ceiling

Town centres evolve all the time making the property difficult to assess, however, based on door and window features, the front range was probably a shop and dwelling in the late 18th or early 19th centuries. Small dwellings shown on the Tithe Map were removed and the roadside building extended to the rear, in brick, in the mid 19th century. Prior to the 1880 O.S. survey, a workshop was erected beyond the courtyard. This contained a brick-lined barrel vaulted ceiling supported by wrought iron beams. No other example of this appears to occur in Bruton. Research suggests that the structure was used in 19th-century textile mills to be both load bearing and create a fireproof barrier between floors which would be appropriate in this historically 'textile' town.

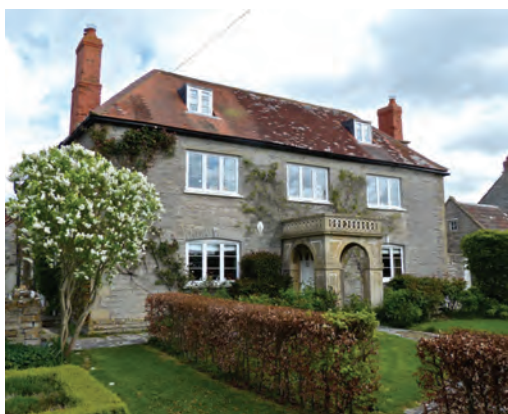
3. Ditcheat. Wraxall. Wraxall House. ST 6058 3618.

Fig. 3 Ditcheat, Wraxall House: House dated 1811 and portico dated 1871

It is constructed of 53 cm thick local lias-stone walls with dressed Doulling stone quoins to the south elevation. Most window heads are shallow arched with a projecting keystone. The oak tie-and-collar beam truss roof is hipped on all elevations and clad with plain clay tiles. The entrance door is set in a pedimented masonry frame of Doulling stone, the tympanum has the initials G above a J and M (Jacob and Mary Golledge) and a date of 1811. A portico, dated 1871, is incised with JCG (John Cary Golledge born 1842).

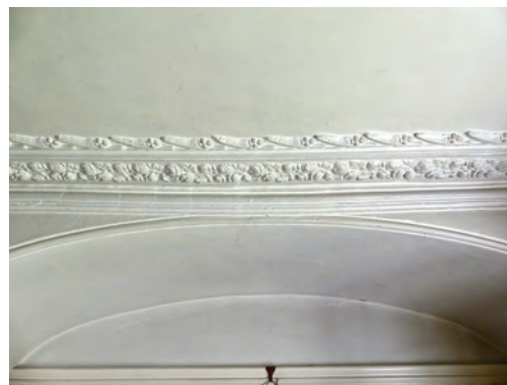
4. Marston Magna. Wick Farmhouse. ST 5920 2243

Fig. 4 Marston Magna, Wick Farmhouse: ceiling border and cornice

The original part of the dwelling was symmetrical and constructed in the late 18th century, as kitchen and parlour, using earlier style windows and doorway on the front elevation. The ceiling of the parlour has a broad border and cornice of decorative plaster. Two of the three first floor rooms were heated. An adjacent barn has a date-stone of 1820 and the initials WPW – Rev. William Provis Wickham, after whom the property is named.

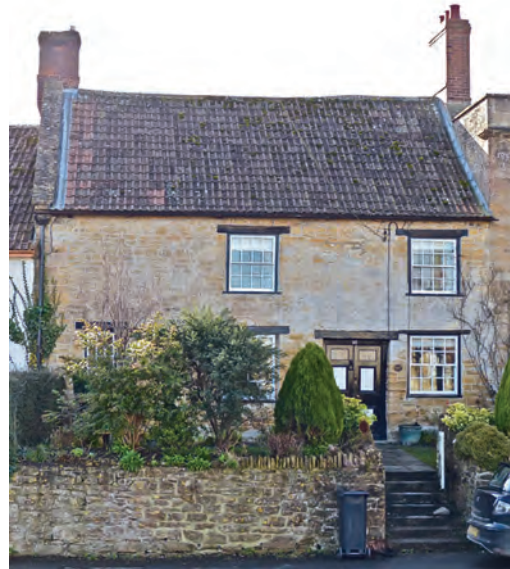
5. Martock. 98, Bower Hinton. ST 4566 1785

This is part of a terrace of continuous housing. Its frontage is constructed of cut and squared local Ham stone set on blocks of very high quality ashlar. The 80cm thick walls have been raised slightly creating two storeys. The 16-pane sash windows do not fit the coursing of the stone work.

The smoke blackened roof, formerly thatched, is carried on two side pegged, axe-hewn, elm jointed-cruck trusses; three rows of trenched purlins with evidence of windbraces and a slightly cambered collar. The smoke blackened roof structure and wall thickness suggest a late 14th- or early 15th-century origin for this truncated building, now comprising two rooms (Hall and Service Room) and a wide cross passage, originally running further east as

Fig. 5 Martock, 98 Bower Hinton

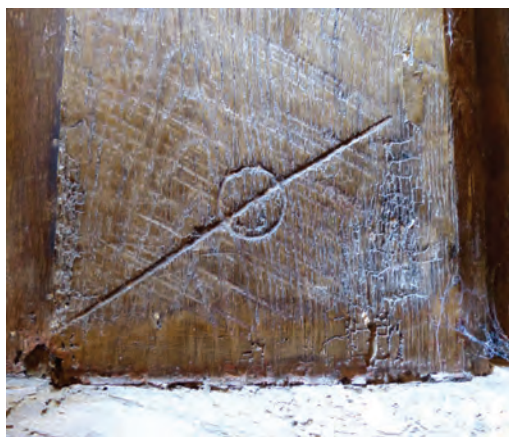
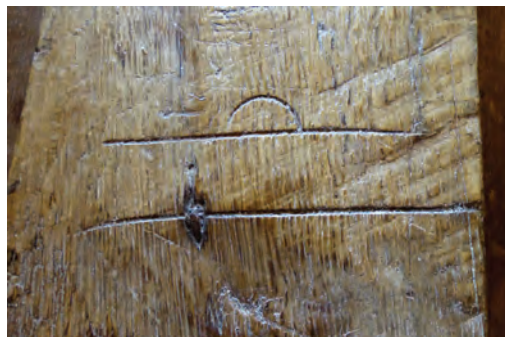
7. Misterton, Newberry Lane, Dry Close. ST 4586 0829

Fig. 6 Misterton, Newberry Lane, Dry Close: carpenter's mark for 1 on partition post

Fig. 7 Misterton, Newberry Lane, Dry Close: carpenter's mark for 2 on partition post

Internal features comprise several substantial hollow-chamfer beams, evidence of a slightly cambered bressummer to F1, a curved wall indicating an earlier stair beside F2, stone hollow-chamfered mullions to some windows and two internal walls of post and panel construction. The latter were probably original to the site but perhaps have been re-set. They rest on sill beams some 30cm from the floor with the former location of a bench indicated by step and run-out chamfers, set 70cm above the floor, and associated 'witness marks'. The posts are individually and sequentially 'carpenter marked', the first panel is inscribed with the date 1654, and a common apotropaic mark is set a little lower.

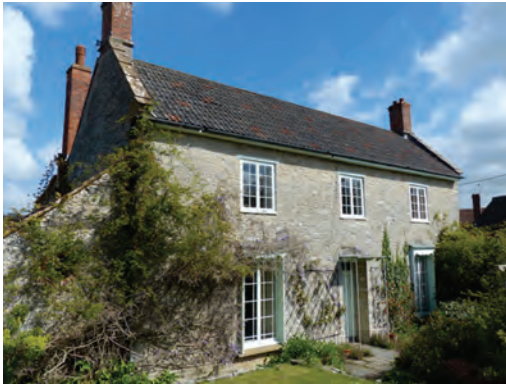
8. Queen Camel. High St. Banksia. ST 5958 2493

Fig. 8 Queen Camel, Banksia; front elevation

The original barn was converted to a dwelling comprising two principal rooms either side of the stair hall divided by brick internal walls. The "front" wall was rebuilt, narrowing the barn and raising the eaves under a retained but modified roof. Brick chimney-stacks were built against the unaligned gables to square the rooms. A north wing with 50cm walls might have preceded the

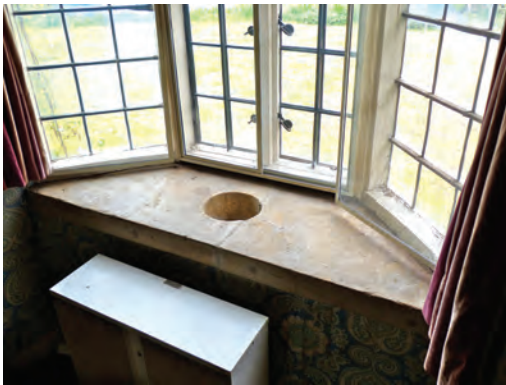
Fig. 9 Queen Camel, Banksia; "stewing stove" in window bay

A late 18th-century map shows the addition of two lean-tos. Another addition under a catslide roof may also have occurred at this time. A two-storey canted bay built over a stone gully confirms that the bay was a late addition to the north wing. A 'stewing stove' in the bay suggests that it was added at the time of the conversion.

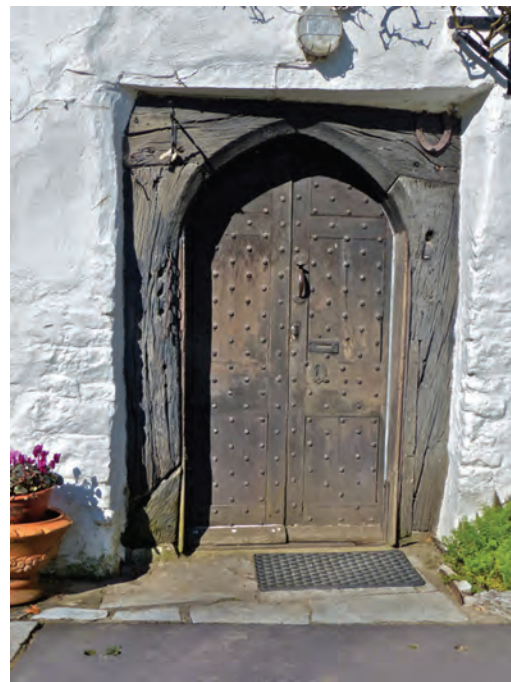
9. Rimpton. Clarkes Cottage. ST 6088 2179

Fig. 10 Rimpton, Clarkes Cottage: early 15th-century door frame

The original build was an early to mid 15th-century three-room cross-passage house with a solar over the inner room. The smoke-blackened roof, an arch-braced truss with, now missing, windbraces and a weathered oak two-centred arched door-frame testify to this. The roof is supported on 5 collar trusses. At least two are jointed crucks, one has holes for a rod and daub partition (the Solar wall) now gone. The purlins are trenced into the principals, the windbraces were halved into the back of them.

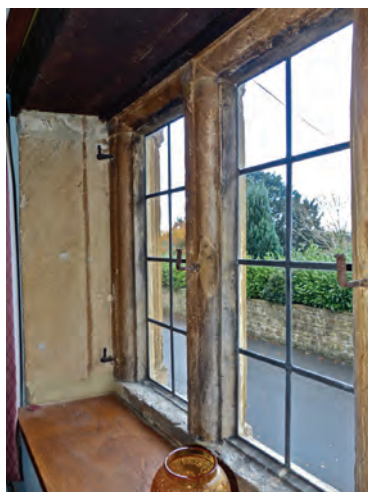
10. South Petherton. Cole's Lane. The Old Granary. ST 4358 1639

Fig 11 South Petherton, The Old Granary: 17th-century ovolo-moulded stone window with shutter pintles and security bar brackets

The main range appears to have been built as a dwelling house in the mid-17th century with ashlar walls facing the road reflecting status. A cross wing was added as workshop space or storage in the late 18th century. A large part of the property was downgraded to barn/stable use in the second half of the 19th century leaving part in habitation, known as 'The Old Groom's Cottage'. In the late 19th century the main range roof was replaced with the present common rafter roof. In 1976 the building was reconverted to full domestic use.

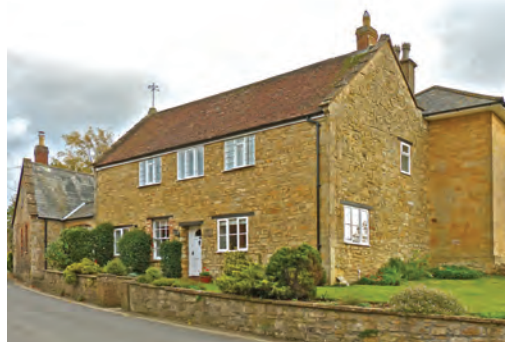
**11. South Petherton, 2 St. Elizabeth's Way,
North Cottage. ST 4345 1684**

Fig. 12 South Petherton, North Cottage, formerly a store or workshop

Evidence of large openings high in the gable walls indicate that it was built as a store or workplace rather than a dwelling. Wall thickness and roof structure, four elm tie and collar trusses, two tiers of staggered purlins and a ridge piece threaded into the notched-tenon apex, suggest that it was built in the mid 18th century. It was owned by John Horsey, a linman, in 1841 so was perhaps used for the flax/linen trade. Several alterations were made over the years and it eventually became a dwelling around the mid 20th century.

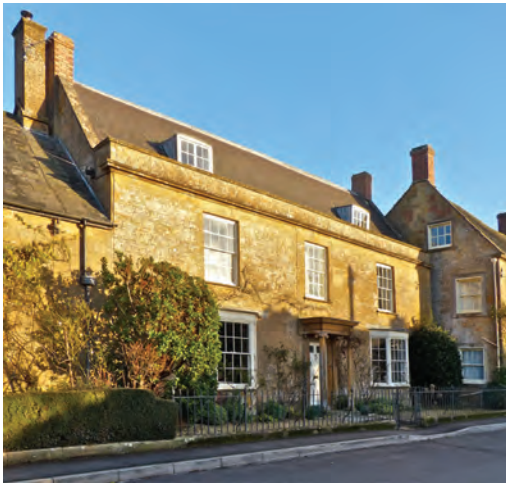
**12. South Petherton. South St. West Hayes.
ST 4361 1668**

Fig. 13 South Petherton, West Hayes: elegant front elevation of house

The dwelling is constructed of local dressed Ham stone with ashlar on the front elevation. The latter is embellished with a string-course, a parapet and a classical portico graces the front door; the windows are 8-over-8 sash lights, those by the roadside set in flat-roofed canted-bays. The gables have raised and coped verges, surmounted by brick-built chimney-stacks. The slate clad roof incorporates two coach-roofed dormer windows. The north gable has a date stone of 1743, initialled J&E surmounted by an E (John and Elizabeth Edmonds). Gable wall thicknesses were not measured as the house abutted its neighbours but the front elevation is 66cm and the north wall of the rear wing 50cm; cob was to be found in the most easterly outbuilding.

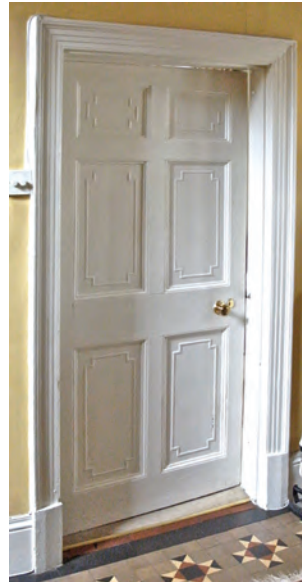
Fig. 14 South Petherton, West Hayes: Georgian period door and Victorian geometric tiles

The O.S. map of 1887 shows the rear wing much as it is today, enabling West Hayes to theoretically function as a self-contained house with its own rear kitchen etc. (In practice the properties remained interconnected until 1975). The rear wing was built during the last half of the 19th century as were the canted-bay front windows. Internally modifications

were made to the ground floor stairs and geometric tiles laid on the hall floor at this time.

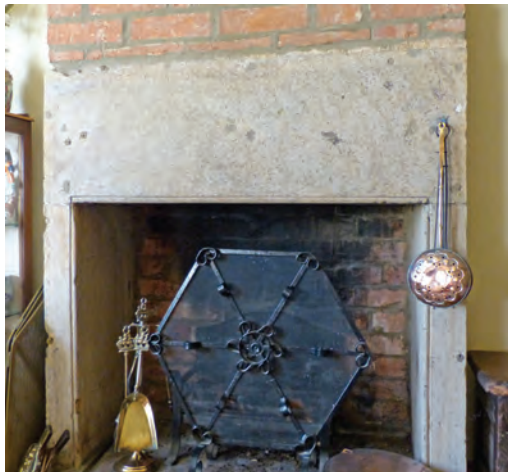
13. South Petherton. 6, Whitehall. ST 4354 1681.

Fig. 15 South Petherton, 6 Whitehall: a simple bead moulding to the fireplace surround

The two-storey, double-pile house has four rooms on each floor and a single-storey extension on the NW. It is built of local marlstone rubble, wall thicknesses of maximum 52cm, with Ham stone ashlar facings to the east and north walls. It has a relatively shallow pitched roof, slate clad with raised and coped verges. Brick stacks rise from each gable. The roof is supported on two elm, tie and collar trusses with two tiers of staggered purlins fixed by pegs. The ridge piece is threaded in to the notched-tenon apex. The single storey wing has pantiles on each flank. Bead moulding adorns, and dates, the original entrance door and the fireplaces.
