BUILDING RECORDING IN 2004

SOMERSET VERNACULAR BUILDING RESEARCH GROUP

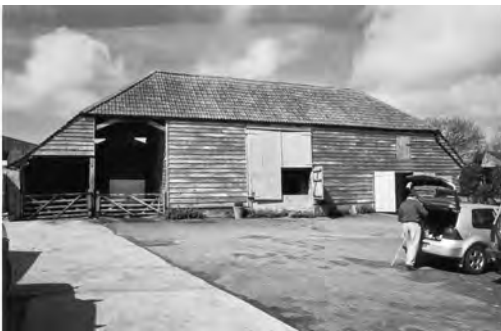
Fig. 1 Barn at Hill Farm, Chilthorne Domer; photograph John Rickard

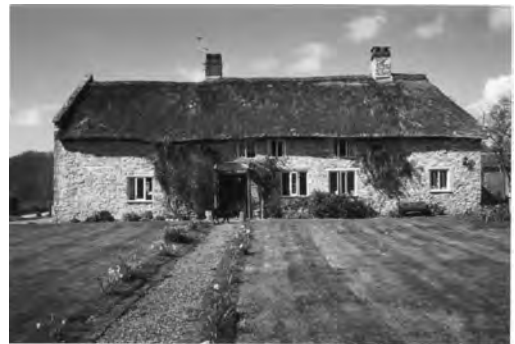
Wambrook, Higher Wambrook, Bartletts House ST 295085 (Fig. 2)

The jointed-cruck truss and smoke blackening indicate that originally there was an open two-bay hall extending from the south end to the present stack. Presumably there would have been a service room or rooms, probably sited in the area subsequently occupied by the fireplace, stack and cross-passage. Based on similar jointed-cruck trusses in Somerset dated by dendrochronology, a date in the 15th century is suggested for the original phase. The house was extended and upgraded in the late 16th century to provide a hall, cross-passage, kitchen, outshut and fireplaces, including a curing chamber. A stair turret to the upper floor was added and the hall and hall chamber provided with mullion windows.

Fig. 2 Bartletts House, Wambrook; photograph John Rickard

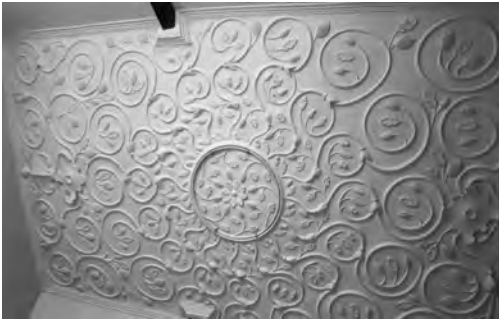
village inhabited in 1327 and probably deserted in the 16th century. The two-storey north wing probably dates from 1583 and was part of a high status house, most of which has now gone. Its impressive plasterwork (Figs 3, 4) is illustrated in *Decorative Plasterwork in the Houses of Somerset 1500-1700* by John & Jane Penoyre (1994). The main range was built or rebuilt c. 1614 and comprised a hall, cross-passage, inner room and kitchen and service stairs rising to the attics. The house was remodelled with the addition of second-floor bedrooms served by a turret stair and the full-height porch dated 1672. Elaborate surviving door surrounds (Fig. 5), doors and door fittings throughout were probably installed at this time. Weston Farm was still thatched when it was recorded in *Country Life* in September 1949. The attached Dairy Cottage probably dates from the early/mid-17th century and the nearby Chapel Cottage (Fig. 6) was originally the late-medieval chapel to the manor house.

Fig. 3 Weston Farm, Wambrook, ceiling of first floor chamber; photograph John Rickard

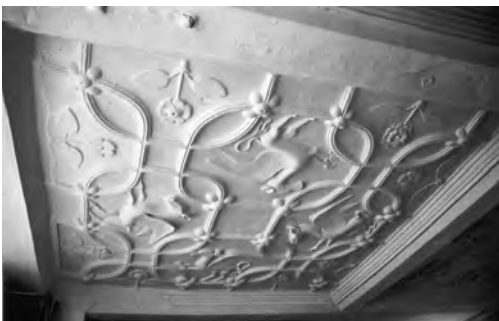
Fig. 4 Weston Farm, Wambrook, one of four ceiling panels in ground floor room; photograph John Rickard

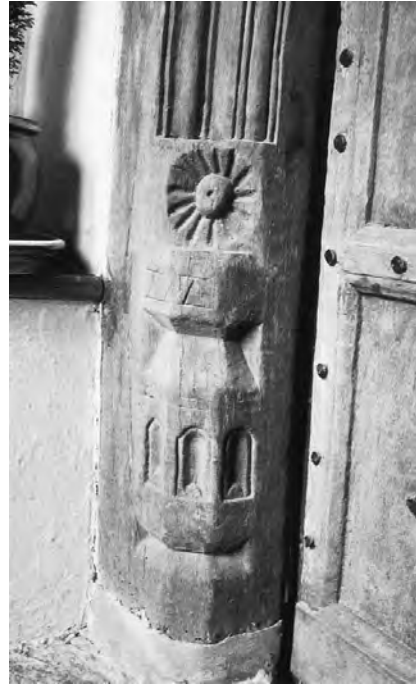
Fig. 5 Weston Farm, Wambrook, door jamb; photograph John Rickard

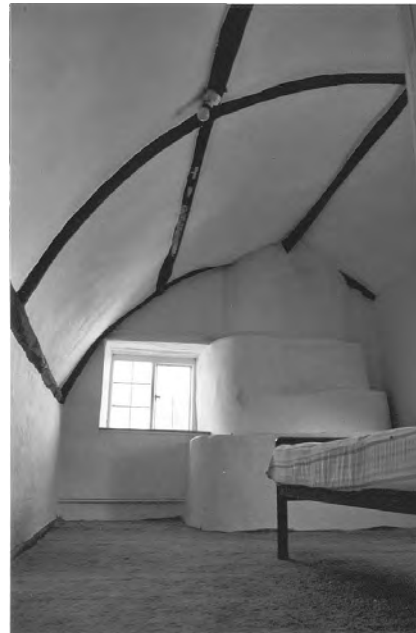
Fig. 6 Chapel Cottage, Weston Farm, Wambrook, ceiling; photograph John Rickard

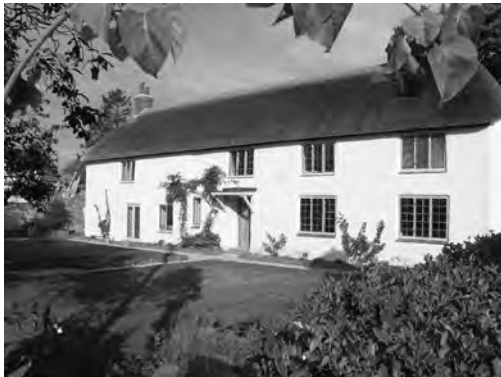
Williton, Long Street, No. 33, Arden Cottage ST 079412 (Fig. 7)

The surviving evidence indicates that this was a single-storey open-hall house, as there is smoke blackening of the presumed true-cruck roof and as this is earlier than the west end a date in the 14th/15th century is suggested. The jointed-cruck truss at the west end can be dated to the 15th/16th century by comparison with similar examples which have been subject to tree-ring dating. The limited amount of smoke blackening in the roof suggested that this part was added, perhaps as a byre, while the hall remained open. The details of the beams indicate that the upper floors were inserted in the early 17th century. At the same time a large fireplace at the west end was installed with a corn-drying kiln and oven. The north wing was added in the 18th century and a large oven was inserted in the former kiln. Its size indicates that this was for a commercial bakery, which necessitated the re-positioning of the kitchen in the north wing. Major work was undertaken in the early 19th century and a further rear extension added in the 1920s.

Fig. 7 Arden Cottage, Long Street, Williton; photograph Paul Upton

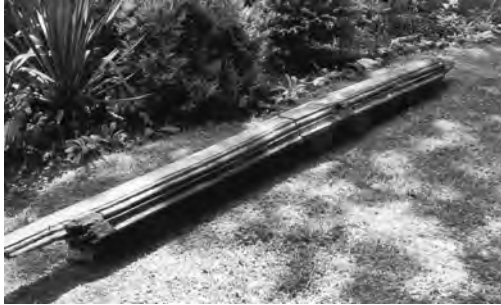
Pudleigh, Ile Cottage ST 317107 (Fig. 8)

The limited evidence suggests a cob-built two-unit house dating from the late 16th or early 17th century. The house was extended in brick in the early 19th century.

Fig. 8 Ile Cottage, Combe St Nicholas, moulded beam removed during the raising of the ceiling height; photograph John Rickard
