SANHS Historic Buildings Group visit to
Little Wilscombe Farm and Raddington church
on Saturday 18th September 2021

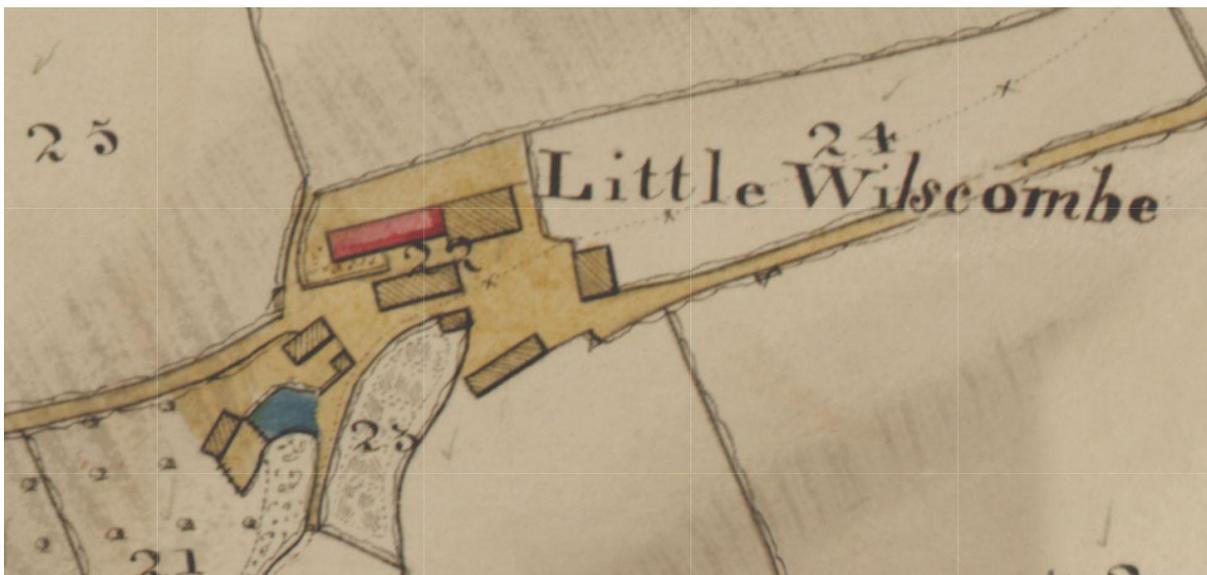
Little Wilscombe Farm: The Tithe Map shows the farm in 1840.

The red building is the main farmhouse, and possibly long house. It is interesting to note that the lateral stack is not shown in this map. That does not mean that it was not there – only that it was not on the map. To the right of it are two farm cottages, which at one time were probably used as a cider house. Across on the opposite side – towards the bottom of the map, is the Linhay. The blue patch is the farm pond.

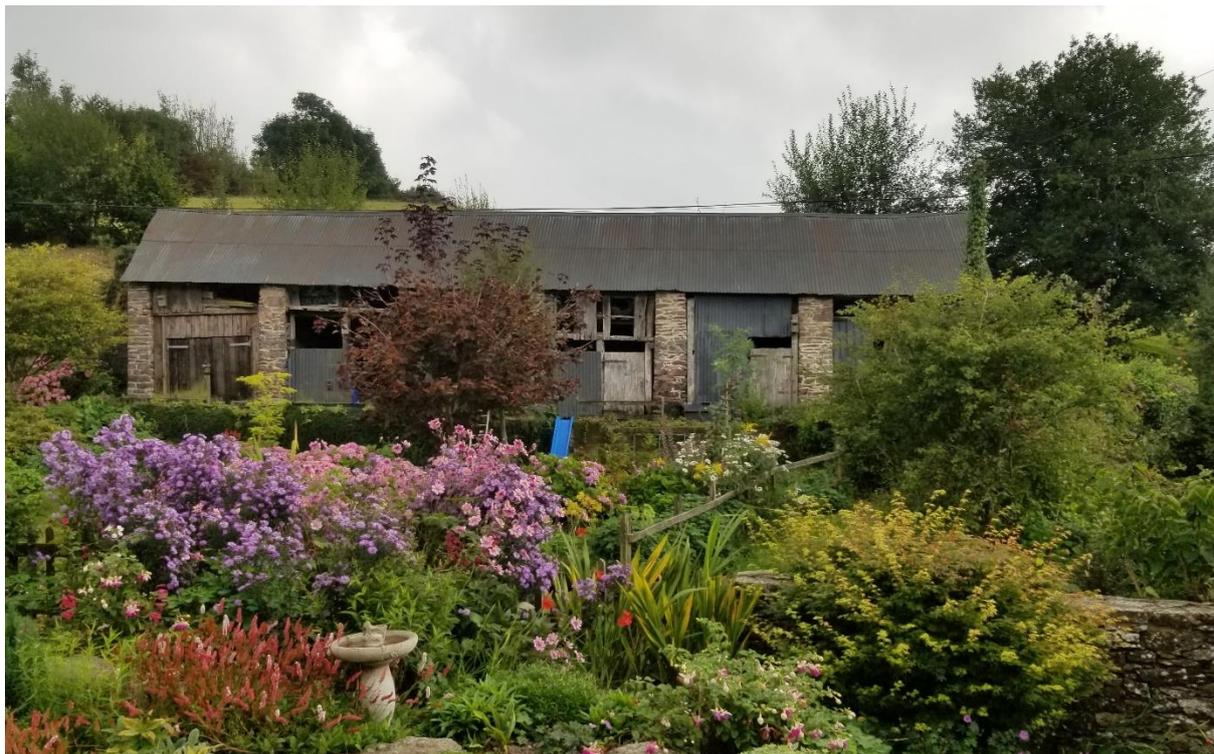
The Linhay. This traditional farm building was in extremely poor condition a few years ago. The land at the rear of the building was pushing it forward and the whole thing was in danger of collapse. Liz's thoughtful and enterprising son made simple but effective repairs by removing the soil from the rear, and then supporting the building by building a breezeblock wall inside to support the roof. A very cost effective and simple repair. Photo by Lizzie Induni

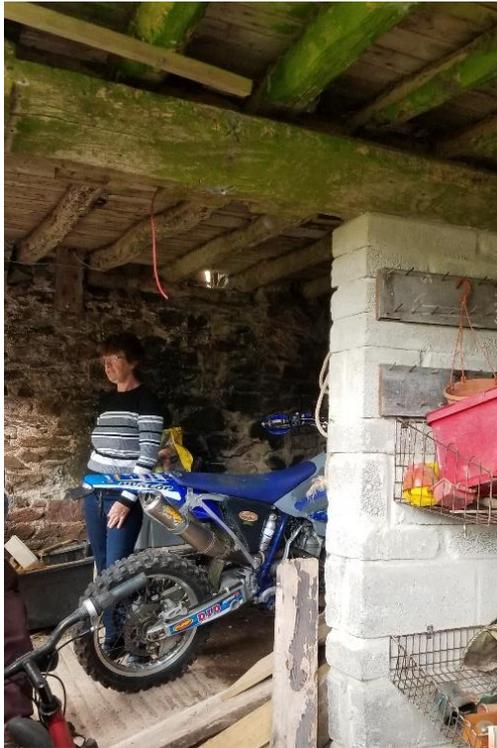
The photograph on the left shows Liz Kilbride in the linhay. The breezeblock wall which supports the roof is on the right. The supported timber beam has a deep chamfer, plus a plain stop and run-out, which suggests it may be re-used from an earlier building. It is, however, only one of a number of similar beams in these buildings which appear to be 16th century. Liz Kilbride kindly showed us a listing of the former owners of the farm, which verifies its existence since at least that time. That would also be suggested by the lateral stack and the thick walls, some of which are 2' 6" deep.

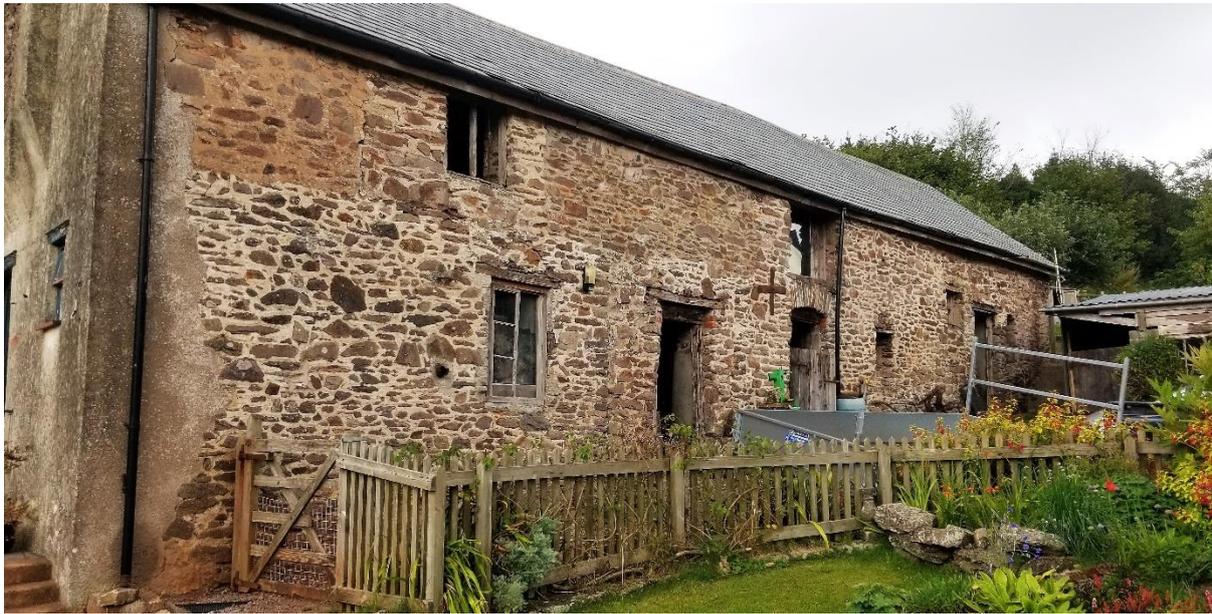
The range of buildings above were probably used as farm cottages, though an earlier map shows the buildings used as a cider house. Photo by Lizzie Induni

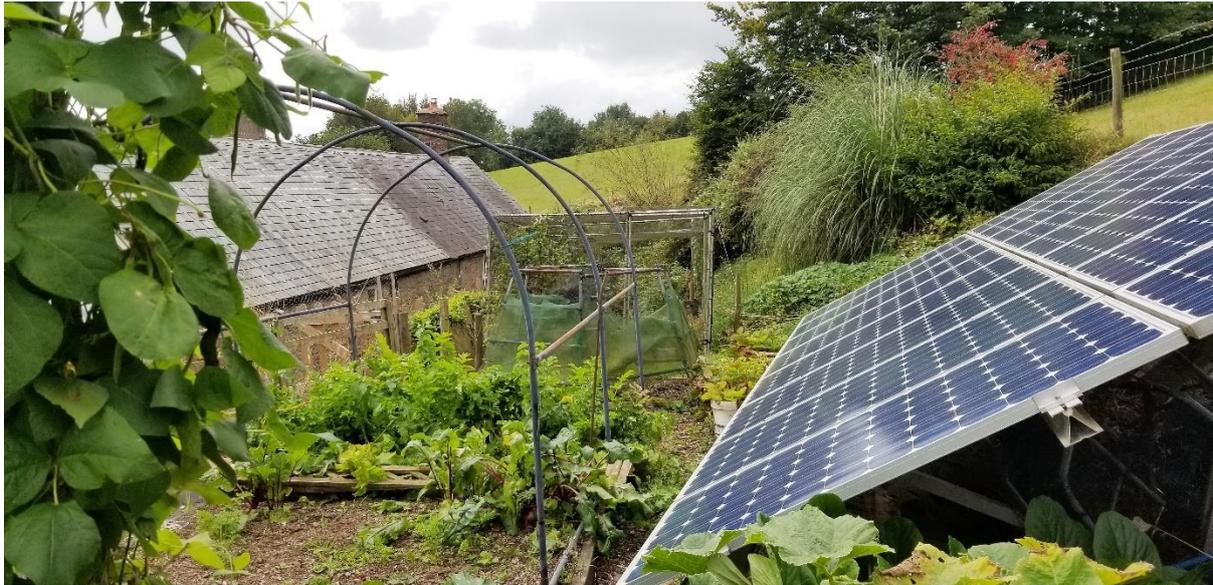
Liz has very sensibly chosen to create a vegetable garden where there is most sun. Alongside are the solar panels, which double up as storage underneath. Photos by Lizzie Induni

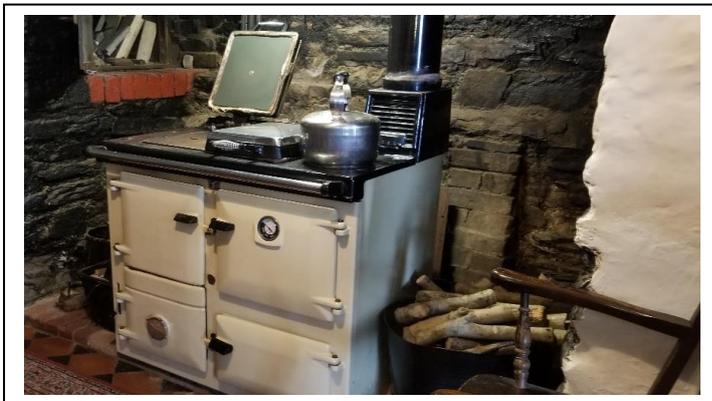
The Rayburn is inserted into the old fireplace. At the top left is the bread oven

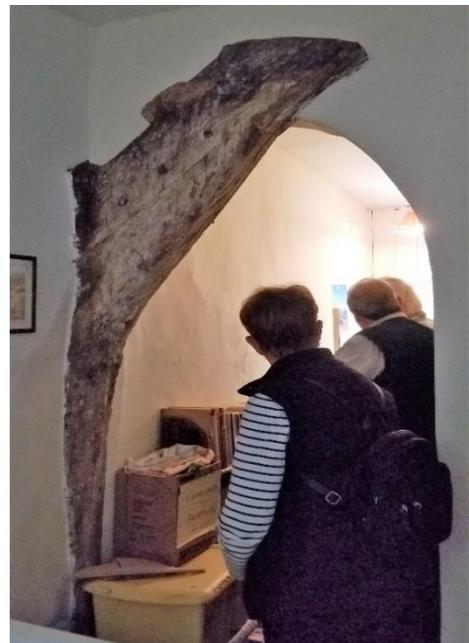
In the photograph to the right, the original, probably jointed cruck which can be seen (next to Chris Jessop).

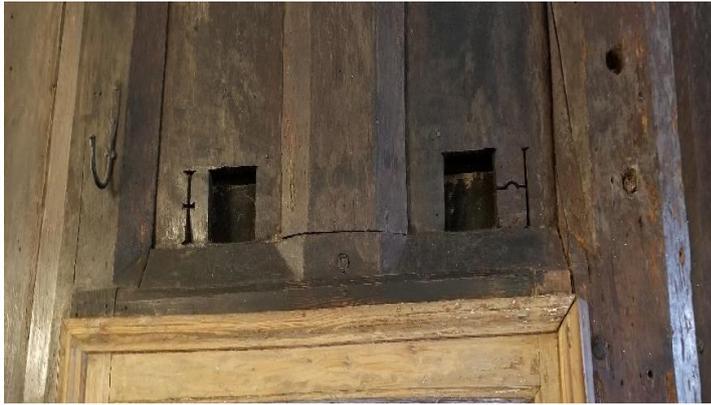
The photograph to the left shows the initials of earlier owners of the building, carved into the plank and muntin screen, which divides the cross passage. The initials are **I** and **H**

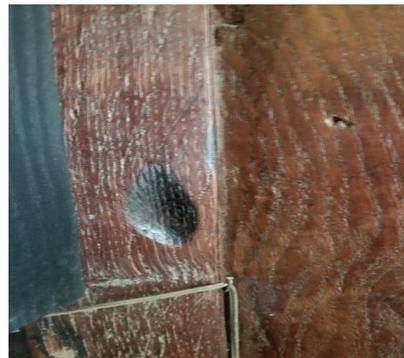
The photograph to the left shows an apotropaic burn mark, deliberately burned into the screen, possibly to bring good luck on the house.

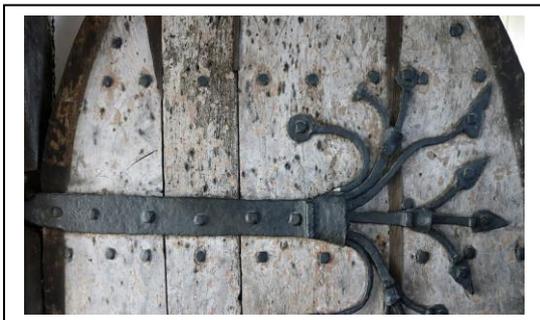
The remarkable hinge of the main door at Raddington church. Photo by John Page

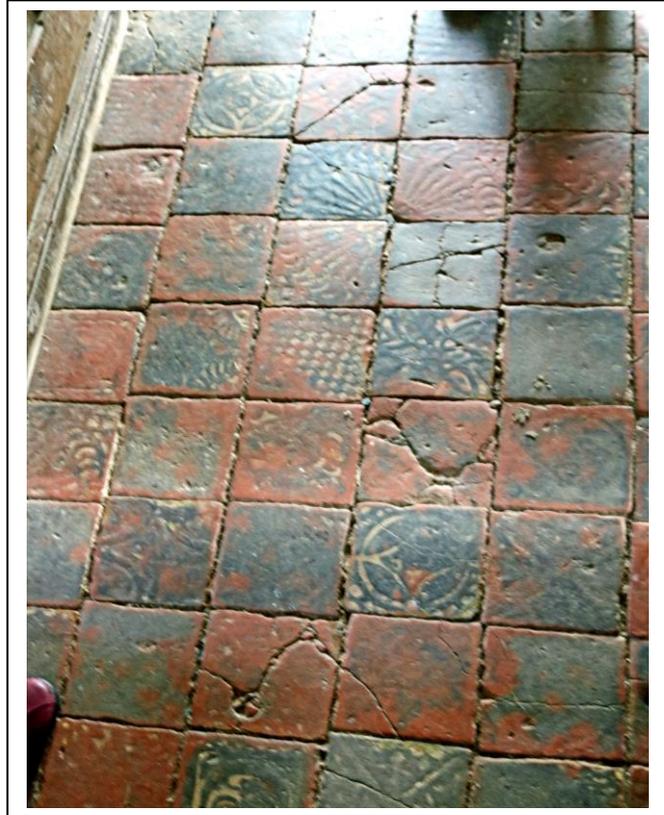
The medieval floor tiles at Raddington. Photo by John Page
