## AN UNUSUAL MEDIEVAL BENCH END IN BROMPTON RALPH CHURCH

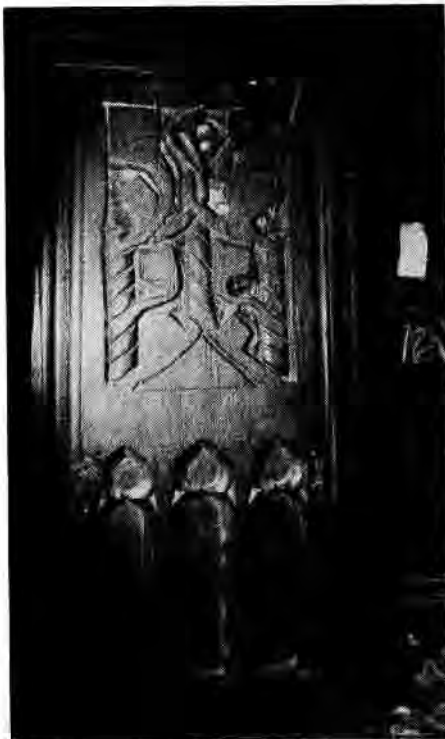
Plate 1

The bench end immediately to the right as one enters the door has the same edge moulding and proportions as the other medieval bench ends but, in addition, is covered with unfinished decoration (Plate 1). The decoration is in two sections, the top containing a half-finished foliage canopy made of plants whilst the bottom, which seems to be more or less complete, has a triplet of simply cusped blank lancets.

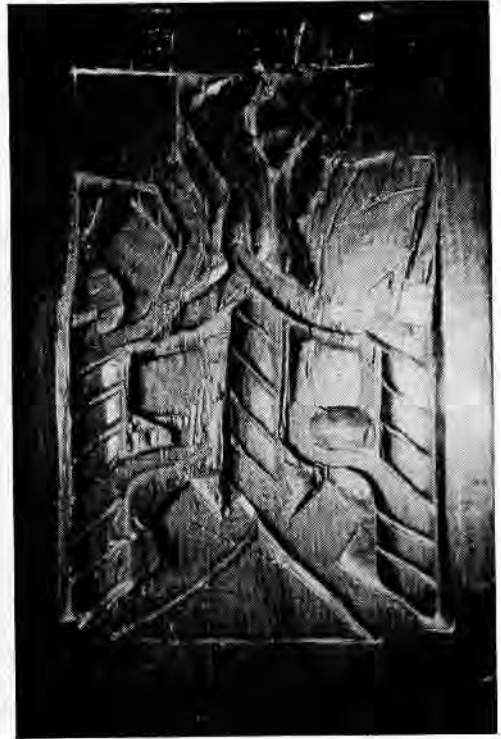
Plate 2

The foliage canopy (Plate 2) consists of two twisted stems which rise on either

side of the panel and then branch inward and intertwine into a central finial, apparently comprising two overlapping leaves. The space within the canopy is divided into two by a further twisted stem formed from two stems which originate in the two bottom corners of the panel and meet about one quarter of the way up in the centre. This stem meets the other two in the central finial but it is not clear whether it actually combines with them at this point.

The foliage has diamond shaped leaves, clearly incomplete; from the parallels cited below these would probably have been crude approximations to a vine leaf. From the left half of the panel, where all the background has been cut away but no detail has been filled in, one can see that there were to be three small leaves springing from the various stems, one big one in each of the top corners, plus the central finial of two overlapping leaves. On the right hand side of the panel even this basic work is unfinished. The bottom of the uppermost small leaf is clear, as is the stem and lower half of the top large leaf but otherwise the leaf shapes have only been outlined with deep grooves on the wood. A large chunk of the surface is missing in the corner. As the top moulding of this bench, a recent replacement, is intact here, one can surmise that the damage is ancient.
