**Building Recording in 2020 and 2021**

*SANHS Vernacular Building Research Group*

# BUILDING RECORDING IN 2020 AND 2021

The Early Dunster Project (of the SANHS Building Recording Group) was launched in September 2018, sponsored under Historic England's 'Early Fabric in Historic Towns' initiative. Training followed, and some very able volunteers developed skills in different areas including surveying with recording; a major web-based event in 2020 provided opportunity for learning new skills. The work started energetically but has of necessity been slowed down by the pandemic. Nevertheless, 28 properties have been surveyed including the Old Priory, Lower Marsh Manor and the Castle Gatehouse (for the last, see Richardson 2021). Dunster owners have been extremely encouraging and helpful and at present about 53 properties are being considered. The amount of early fabric – particularly roof structures – is extraordinary, although suspected from earlier surveys by Commander Williams of SANHS Historic Buildings Group (all copies held at the Somerset Heritage Centre) and more recently by dendro-dating work carried out by Time Team (Ainsworth *et al.* 2019), which returned many dates fr

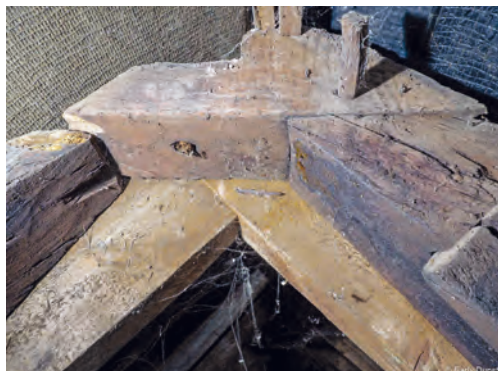
This is a three-room cross-passage house with four bays and dendro-dating by Andy Moir of Tree Ring Services (Moir 2018, 125) on behalf of Time Team, gives a felling date range of between 1299 and 1321. Two of the trusses are true or raised crucks and two of the principals are extended; one of these extensions at least appears to be original, but it is hoped to clarify that with further dendro-dating. The third truss (t1) is a jointed cruck, joined at the elbow in the usual way, but it has been replaced above first-floor ceiling level. The trusses have cranked collars but not arch braces as stated in the tree ring report. Wind bracing, however, is in evidence over what would have been the open hall. The two trusses t2 and t3 have different apex types (Figs 1 and 2). Truss t2 has a Type C apex,

*Fig. 1 Truss t2 apex*

with yoke above the principals, which are tenoned into the yoke and pegged. Truss t3, by contrast, has a Type H, with yoke below the principals, and the principals extending upwards to enclose the square set ridge purlin on three sides (Alcock 1981). The south blade of t2 has an inscribed hexafoil. Truss t2 has remnants of rush-based plasterwork infill above first-floor ceiling level, probably dating to when the house was divided into two properties with staircase inserted at each end. It is now all one house again.

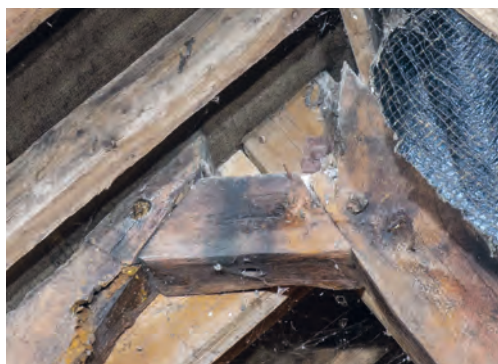
*Fig. 2 Truss t3 apex*

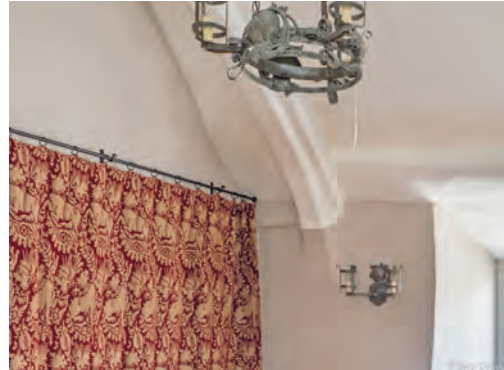
In the first floor and loft of no. 14 can be seen a fine open arch braced truss (t2) shown in Fig. 3; the other truss (t3) has its lower part in the first floor of no. 14 with the top of it being visible only in the second floor of no. 12 (Fig. 4). The trusses have been dated by Tree Ring Services on behalf of Time Team to 1322/3 (Moir 2018, 125). Truss t1 is mostly buried in later masonry. This and some other timbers show evidence of smoke blackening, notably on t2, west purlins and on the ridge purlin at the north end. The apex (Fig. 5) is thought to be type L1, with yoke below the principals and a diagonally set ridge, although the ridge timber at this point is irregular in shape and seating in the truss has been cut to accommodate it.

The elbow of the principals cannot be seen, but the bases of the trusses are both visible in the first floor of no. 14 (Fig. 3). There are remnants of rafters (7 x 9cm) laid flat over original purlins.

Fig. 3 Lower section of arch braced truss

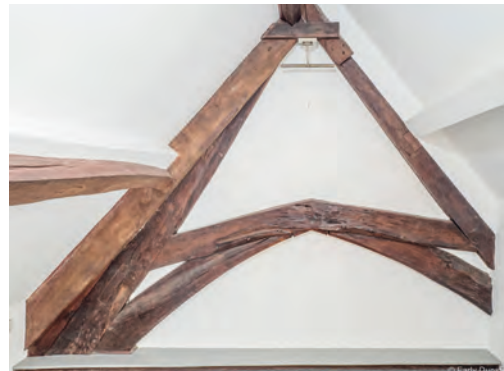
Fig. 4 Top of arch braced truss

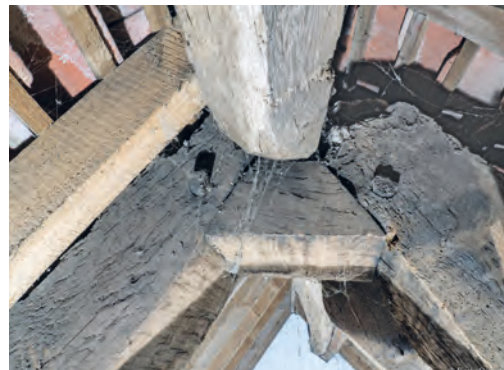
Fig. 5 Apex with later ridge purlin

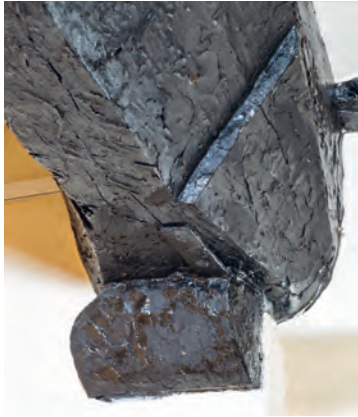
The plan of no. 14 includes the open hall and inner room of the original burgage plot. A huge (36 x 40cm) beam supports the first floor and was altered at the east end when a lateral stack was inserted in the back wall (Fig. 6). A similar, but smaller, half beam is now partly against an inner wall. Major alterations were made in the 17th century, including a new entrance door opening, door and frame and runs of ovolo moulded windows to each side of the party wall.

*Fig. 6 Floor beam in no. 14*

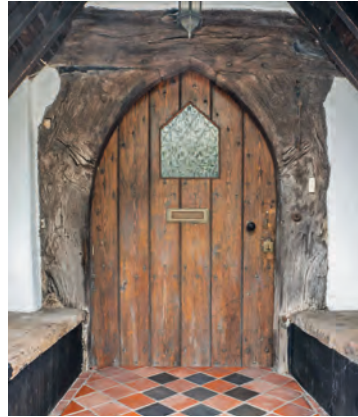
The cross-passage is now in no. 12 as was the outer room. A fine medieval door frame may be original to the house (Fig. 7). On entering, there are remains of a screen between the cross-passage and the former

*Fig. 7 Medieval door frame*

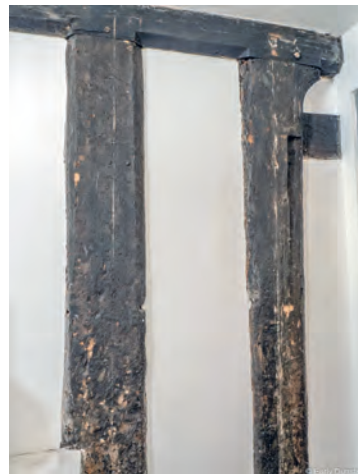
open hall (Fig. 8). In the framing is a small section of a formerly shoulder headed door frame which would have led into the open Hall.

*Fig. 8 Remnant of shoulder headed door frame in former screen*

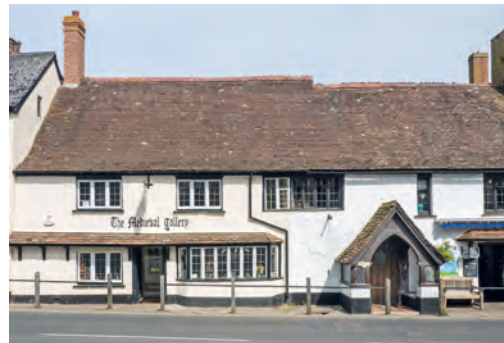
Little else remains of the earlier structure on this side of the building which, from roof construction appears to have been rebuilt in the 19th century. The only other indication of earlier structure is the continuation of a long row of ovolo mullioned windows from no. 14 to no. 12 (Fig. 9).

*Fig. 9 Nos 12 and 14 High Street*

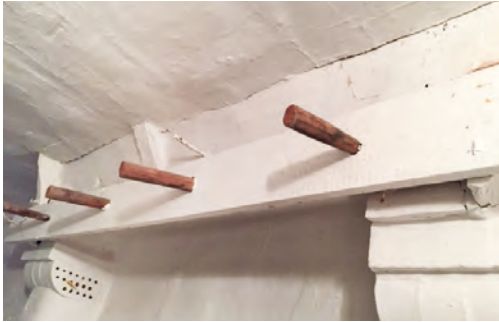
This is another commercial property at the north end of the High Street and is known to have been the Packsaddle Inn in the early 18th century, and became a saddlery in the early 19th century. The shop front is early 20th century when the name was given as 'Dyers' after the then proprietor. It continued as a leather goods shop until 1970. Old maps suggest that boundaries have been altered many times and this is borne out by the odd remaining elements of early fabric. Essentially no. 30 is formed of three separate blocks of differing periods and of two and three storeys. An alleyway to the north may have been necessitated by the saddlery business as it gave access to yard and stables at the rear of the property, but was once a part of what is now the main shop as evidenced by matching beams. The foot of one of these overhangs the first floor where the wall is canted with a fireplace and stack, the hearth for this being supported from below by two pillars of bull nosed bricks in the alleyway (Fig. 10). Stonework has been corbelled out in the attic to support the top of the truss t1 (Fig. 11).

Fig. 10 Brickwork in alleyway

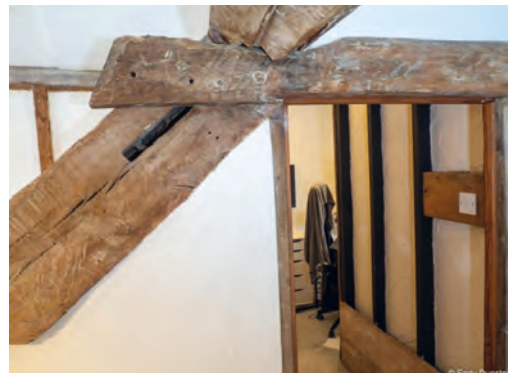
walls. The foot of truss t2 is visible in the second floor and has a mortice for missing wind brace (Fig. 12). However, evidence of pit sawing on the principals suggests that the property is not as old as others seen in Dunster and indicates a date seemingly too late for internally decorative roofs – a bit of a conundrum.

Fig. 12 Reused timber stair support

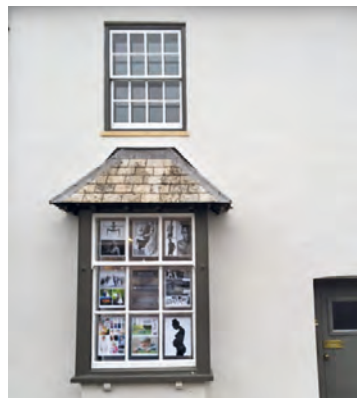
The next block on the High Street to the south (two storeys), has a comparatively modern roof which was probably built at the same time as the rebuilding of the former market house to the south (late 19th century). This block has a little bay window with pent roof on the front elevation (Fig. 13). A wide opening was knocked in the now internal wall between the two blocks on the ground floor front, this now forming a larger shop. The access to the rest of the premises (a dwelling) is in this second block.

Fig. 13 Ground-floor bay

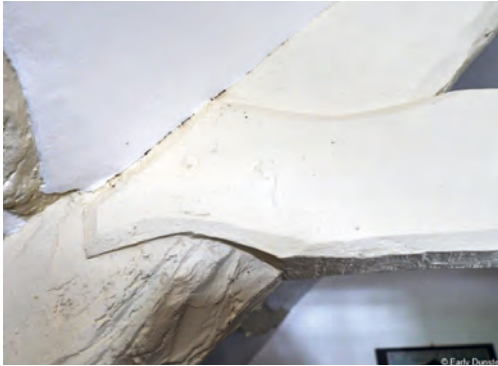
His survey here only covered no. 8, but the presence of a thick rear wall in no. 6 confirms his conclusion that this was a three-room cross-passage house with rear lateral stack to the service room as at 15/17 Marsh Street. Features in no. 8 suggest that it was raised to a three-storey height in the 17th century. The roof for this has a notched half lap joint comparable to others found in Somerset at that time (Fig. 14).

*Fig. 14 Notched half lap collar joint*

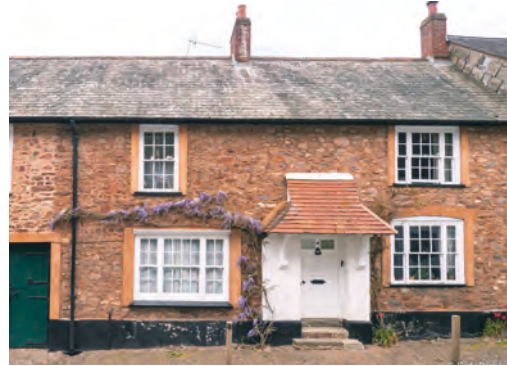
No. 18 has an appearance and internal details which would fit with this period of the early 19th century, but a blocked opening and doorway are indicated in the front elevation by brick arches (Fig. 15). Other signs of rebuilding are clearly visible in the front of no. 20. At the rear of the covered walkway to the left of Fig. 15 there is, in the stonework, a door jamb and cut off lintel remaining from an earlier opening (Fig. 16). This is in a wall of 72cm which continues into no. 18 although less obviously here due to later rebuilding. It is possible that the jamb indicates the location of an earlier cross-passage. The roof to nos 18 and 20 was renewed at the same time, probably when the house was rebuilt or refronted in the 19th century. Internally there are some good features of this period including a staircase with unusual balustrade quite unlike any other seen (Fig. 17). It has pegged joints and may date from this period or, showing little sign of wear, perhaps from the Arts and Crafts trend, from which other features have been noted around Dunster.

*Fig. 15 Front elevation of no. 18*

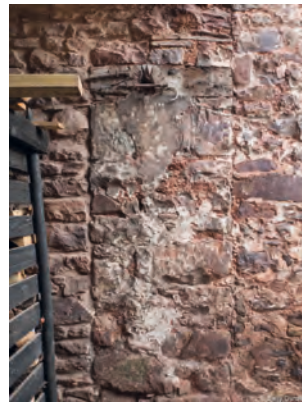
*Fig. 16 Former door jamb*

rear of no. 16 faces directly on to the garden of no. 18 and it has been completely rebuilt and extends beyond the earlier site. No. 20 has the main rear wall mentioned above (as in Fig. 16) running through it, although the stonework has been extended to the rear to accommodate a kitchen. Internal lintels suggest former wider openings with later adaptations to make a separate house. There is a flying freehold over the walkway to the back gardens. In the rear garden is a small barn which is now divided into two between no. 20 and no. 18.

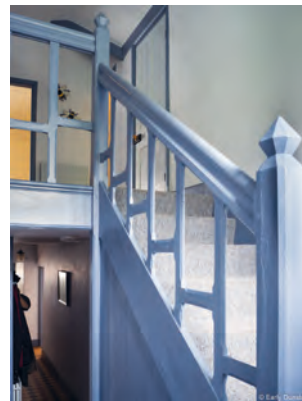
*Fig. 17 Staircase details, no. 18*

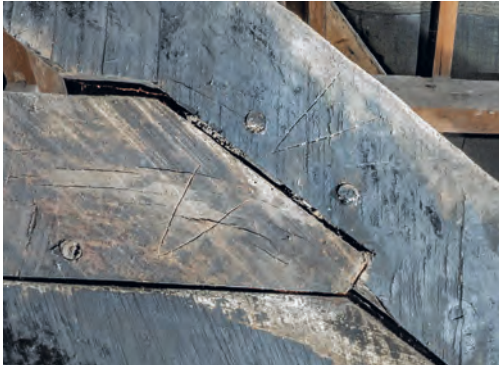
*Fig. 18 Collar joint cut into principal, truss t1*

In no. 22, there are two original arch braced trusses which have been dendro-dated to 1377 (by Tree Ring Services, as before; Figs 18 and 19). This range ran at right angles to West Street so may have formed an original L-shaped property with what is now no. 20. The front is rendered with a later roof extending from no. 18 and across no. 20. The early roof timbers are heavily smoke blackened, with a shiny surface in some places, possibly indicating a house fire. Both trusses gave dateable samples, but differ in that in t1 (to the east), the collar is housed into the principal timber (Fig. 18 – a feature not yet found elsewhere in Dunster), whereas with t2, the joint is flush (Fig. 19). Otherwise, the arch braces seem to match. The apex to t2 is a notched diagonal joint with diagonal set ridge purlin (type E - Cruck survey), very common locally. The other apex is missing.

Truss no. t1 has carpenters marks in the form of relatively long, scored Roman numerals and are sequenced per joint, ie III at N-blade principal to arch brace; V at N-blade principal to collar (Fig. 18) and II at S-blade principal to collar.

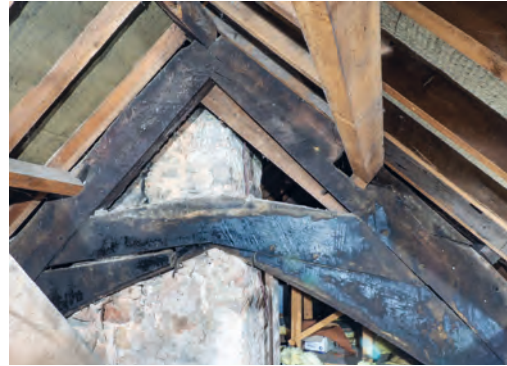
*Fig. 19 Truss t2*

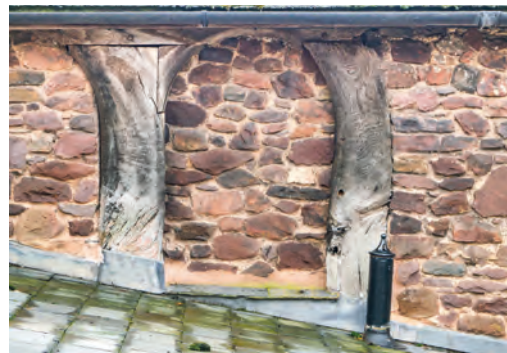
Another interesting feature is a remnant of external framing above the rear extension roof of no. 20 at what was the junction between the two ranges (Fig. 20). The curved heads are reminiscent of a doorway in an external timber framed house in Kent (Banwell

*Fig. 20 Extant external framing*

and Adams 1994, 19) and also of arcaded first floor walkways to medieval inns (as at The New Inn, Gloucester). Here, it may have been either, providing access to a stair turret set in the corner between the two ranges or, alternatively, may have been part of a
