# BUILDING RECORDING IN 2009

SOMERSET VERNACULAR BUILDING RESEARCH GROUP

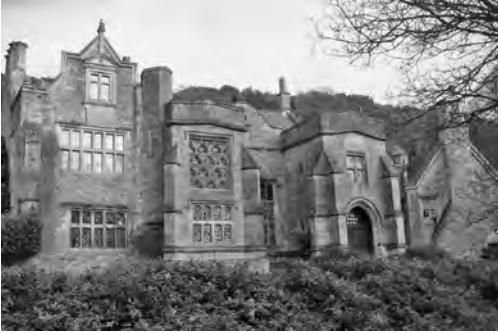
The house has a particularly complex plan, but may be described as being of three major elements. In the centre is the great hall with porch and oriel projecting to the south (Fig. 1) and the screens passage with buttery and pantry to the east. To the west of the hall is a solar block which has a slightly different alignment (north-west/south-east). To the east of the hall a kitchen and tower have a different alignment again (north-east/south-west), the kitchen still more pronounced. To the north of the hall there is a north porch and a stair turret to the north-west. In former times a substantial west wing had been added, but this was destroyed by fire in 1882 and although rebuilt was demolished in 1960. Documentary sources reveal that the manor was held by the de Clevedon family from around 1150 and that they owned a manor house on this site. It is thought that about 1320 John de Clevedon built the core of the present house and incorporated parts of the former buildings. The layout of the pre-1320 site

*Fig. 1 Clevedon Court, south front (photo John Rickard)*

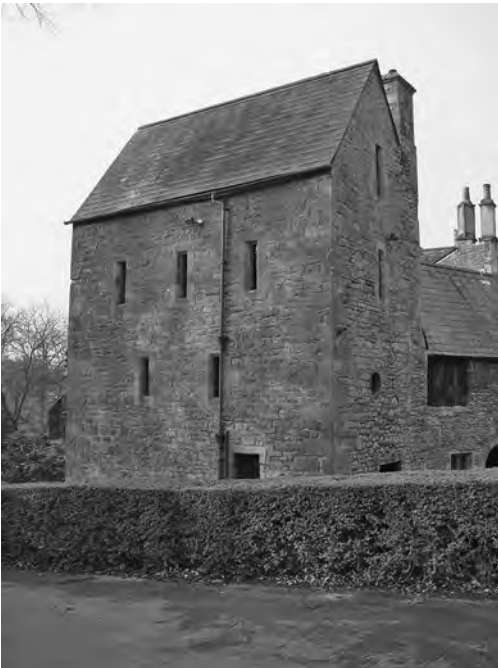
is conjectural, but it appears that the western solar block and the eastern kitchen and tower are survivals from that period. In particular the very thick walls, narrow windows and proportions of the tower strongly suggest a guard tower (Fig. 2). The kitchen is usually referred to as the old great hall, but this is more likely to have been a detached kitchen, with the original hall standing further to the west. The dating of this part has been confirmed by

*Fig. 2 Clevedon Court, tower (photo John Rickard)*

archaeological excavation in 2001, which showed that the footings predate the 14th-century construction of the central part of the house and may date from the 13th or possibly even the 12th century. To the west, the solar block is slightly misaligned with the otherwise fairly rectilinear 1320 hall, suggesting that it already existed, possibly as a two-storey chamber block. The platform on which the house and its immediate buildings stand is quite small, thus the new hall seems to have been squeezed between the retained earlier buildings. The two-storey west wing (now gone) was added in 1570 and the solar was raised to three floors. The above account highlights the recent discoveries and conclusions and is only a much abbreviated summary of the report, which also includes detailed arguments about the form of the original roof structures.

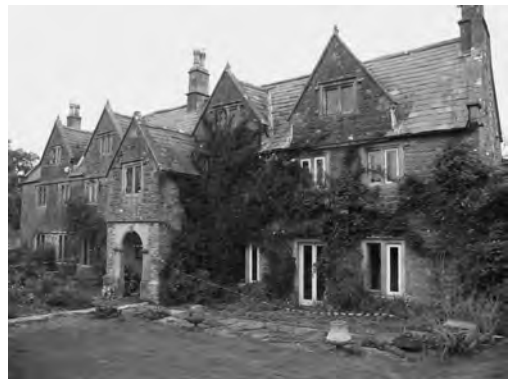
The house has been much altered and extended but the original south range (Fig. 3) is a symmetrical seven-bay block with a central two-storey porch dated 1637 with the initials of the builder Richard Mogg. Built of squared and coursed rubble with stone dressings, it is two storeys with attics, the attic windows in gabled dormers with apex finials. The house then had a U-shaped plan, confirmed by an estate map and survey of 1795, which described the holdings of the Prince of Wales in Farrington Gurney (the estate having belonged to the Crown from the early 14th century). The rear courtyard was infilled probably in the 18th century and the east wing was added in the 19th century. The Manor House descended in the Mogg family until 1930.

*Fig. 3 Farrington Gurney Manor House (photo John Rickard)*

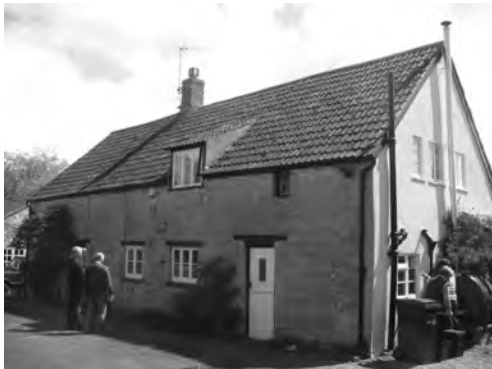
The house is of one-and-half storey with three rooms in line (Fig. 4). A building date in the late 15th century is suggested, based on the beams of the inner room, roof construction (including one jointed-cruck truss) and the smoke blackening of the timbers. The house then comprised an open hall and an inner room with a solar chamber over. Traditionally the entrance would have been at the low end of the hall and there may have been a service room beyond. It is conjectured that in the early 16th century there may have been a smoke hood in the service room, based on the evidence of soot deposits. Around 1600 an upper floor was inserted over the hall, together with a fireplace and stack. The inner room then became a parlour. It is further conjectured that the service room was upgraded to a kitchen with a fireplace, oven and curing chamber in the east gable. Also a cross-passage was created. For some reason, *c.* 1700 the kitchen was destroyed (perhaps as a result of a fire) and to compensate an oven was built next to the hall fireplace. Around 1800 the east end was rebuilt with a loft above. The 1886 OS map shows that a building had been added at the east end of the south elevation and, as in 1841 the property was a small holding of about 24 acres with three orchards, it seems likely that the 'new' building was a cider house and cellar.

*Fig. 4 Fivehead, Spring Grove (photo Mike Hargreaves)*

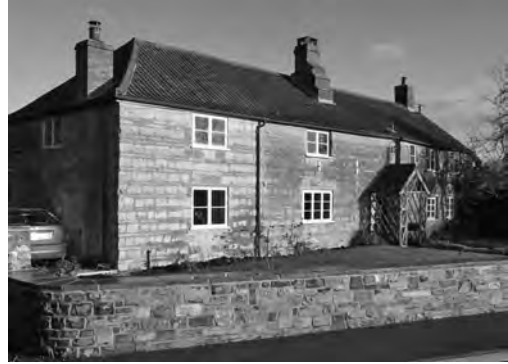
The house (Fig. 5) comprises three rooms in line with a cross-passage and the misalignment of the end room together with variations in wall thickness indicate at least two periods of building. The first phase includes the part to the east of the cross-passage and, based on the details of the beams (Fig.

*Fig. 5 High Ham, Hillbourne (photo John Rickard)*

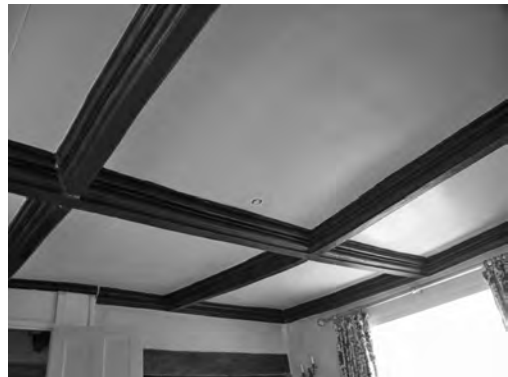
6) and the jointed-cruck truss (Fig. 7), a 15th-century date is suggested (compared with similar dendro-dated structures in Somerset). There is evidence for the existence of a smoke-bay, which implies that originally this was the service end of a larger house, although the full extent is not clear. Later in the 16th century the hall and cross-passage were built and the smoke-bay was superseded by a fireplace. The roof structure is also supported on jointed-cruck trusses. The house then comprised two units, as the inner room may have been a single-storey lean-to, raised to full height probably in the 18th century. An adjoining 19th-century shop was demolished in recent years. The house was originally part of a farmstead, with two barns surviving – one converted into a house and the other being an early 19th-century threshing barn, much altered in the 20th century. The Tithe Map and Apportionment of 1841 shows that the holding was a mixed farm which warranted the substantial threshing barn and other buildings which existed at that time.

*Fig. 6 High Ham, Hillbourne, framed ceiling (photo John Rickard)*

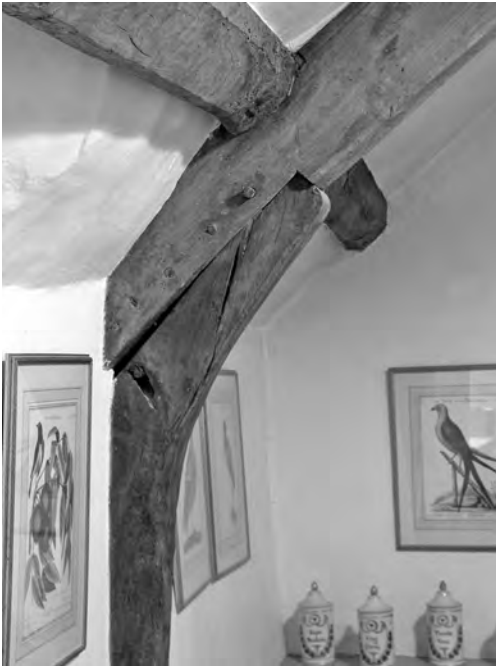
*Fig. 7 High Ham, Hillbourne, jointed cruck (photo John Rickard)*

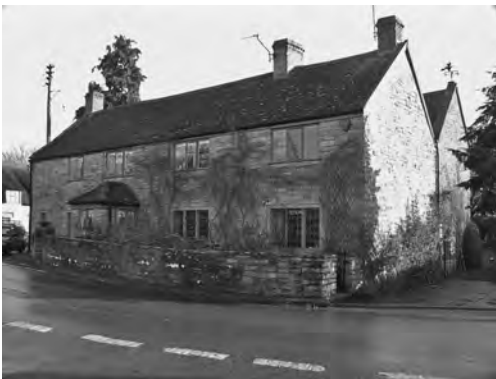
The house (Fig. 8) is of two storeys with three rooms in line and an entrance/stair hall and additions at the rear. Based on the surviving details, the date of building appears to be *c.* 1600. At that time it comprised a hall, with framed ceiling and a fireplace

*Fig. 8 Muchelney, Parsonage (photo John Rickard)*

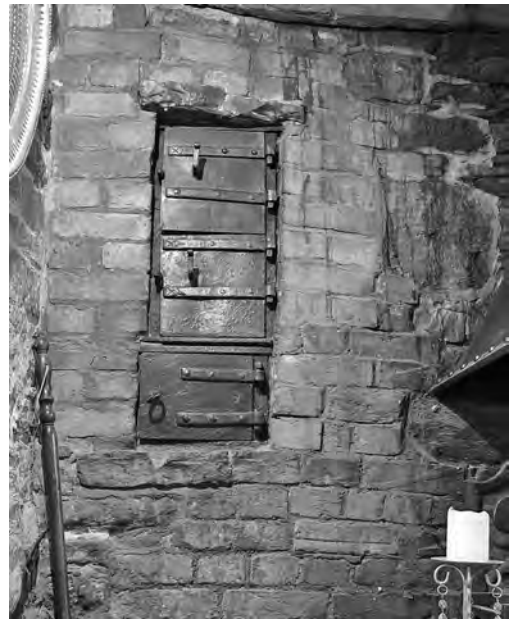
with curing chamber and oven, cross-passage and an inner room, then unheated. The details of the roof trusses indicate that the house was substantially altered in the mid-18th century (perhaps when it became a parsonage). The curing chamber became disused and service stairs complete with lantern window were inserted; a new fireplace and stack were inserted in the hall; the original stairs were removed and new stairs built creating a stair hall; the inner room became a parlour with the addition of a fireplace; and the walls were raised and the roof rebuilt. Late in the 19th century the two-storey additions were built, perhaps as a dining room and cellar/pantry. The summer oven in the kitchen may also date from this period (Fig. 9).

*Fig. 9 Muchelney, Parsonage, summer oven (photo John Rickard)*

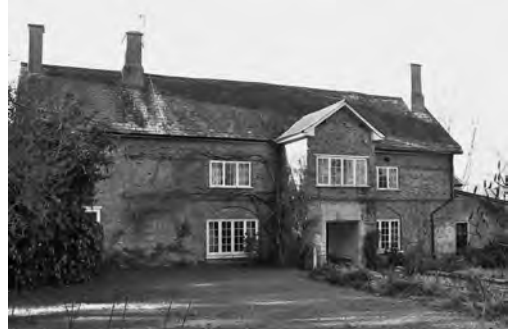
The farmhouse (Fig. 10) is part of a large farmstead and comprises a two-unit plan with central cross-passage with a two-storey addition on the south gable end and lean-to additions at the rear. The form of construction and the details indicate a date in the late 17th century. Built of brick in Flemish bond, there is no evidence to suggest that it is the cladding of an earlier building, as proposed in the Listing description. The original plan would have been kitchen, cross-passage and parlour with two gable stacks and first-floor rooms and attics. The parlour ceiling was formerly divided into four equal parts, three of which have decorative plasterwork – an eight-pointed star-shaped pattern with fleur-de-lis

*Fig. 10 Stoke St Mary, Haydon Farm (photo John Rickard)*

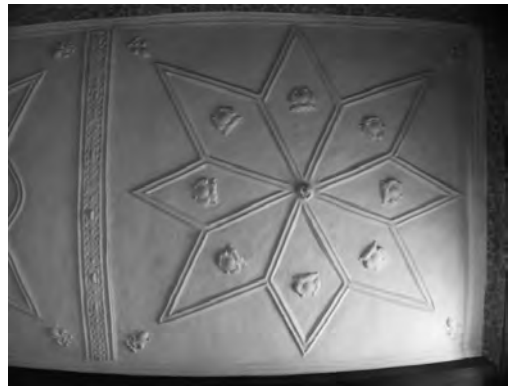
mouldings (Fig. 11). The pattern and details suggest a late 16th-century date, but presumably it is an example of a plasterer following an archaic style. The undecorated panel is probably the result of alterations to the fireplace. The lean-to service room, perhaps a dairy, and the two-storey addition date from c. 1800. A further addition to the kitchen was built before 1887 (when it appeared on the OS map). A comparison between the Tithing Map of 1840 and various OS maps – together with the structural evidence that survives – indicate that much of the farmstead existed by 1840. The size and variety of the buildings show that this had been a large mixed holding from the early 19th century with an emphasis on dairying and cider production. Interestingly teazles were also an important crop. Among the more significant farm buildings are a cider house, formerly with a press, horse-gin and apple loft, a threshing barn, hay barn, stables, cart shed, wagon house, trap house, sheep houses, calf houses and cow sheds.

*Fig. 11 Stoke St Mary, Haydon Farm, parlour ceiling (photo John Rickard)*

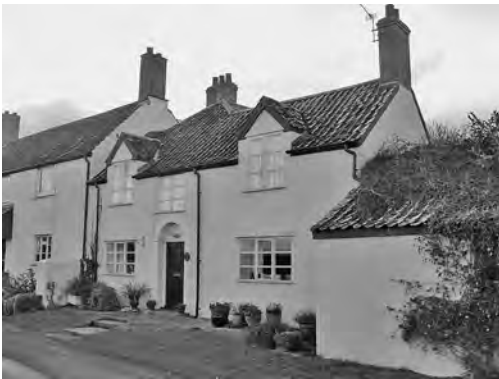
The two-room plan has a central entry into a stair hall and additions at the rear. The front range (Fig. 12), comprising kitchen, stair hall and parlour, dates from the 18th century. However, what appears to be the remnant of an earlier roof truss suggests that the property may be a rebuilding of that time. Also the proximity of the truss to the present party wall indicates that the property originally extended further to the south and was demolished when the adjoining cottages were built. A single-storey extension to the north was added in the mid 19th century, probably as a carpenter's workshop, as the house was occupied by a carpenter at the time of the 1841 census.

*Fig. 12 Stogursey, Burton, Knighton Cottage (photo Mike Hargreaves)*

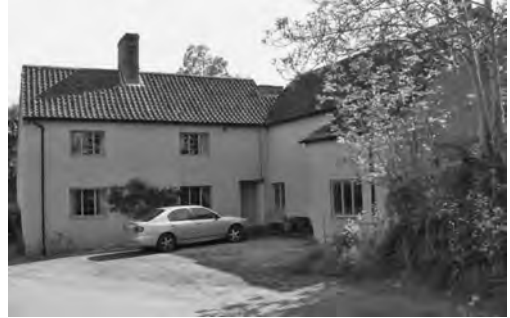
The mill is situated north of the castle and utilises the water system supplying the castle moat and the overflow from St Andrew's Well along the rear of the burgage plots. The leat runs north from the moat in an open channel along the rear of the mill and was diverted south via the launder (trough) onto the waterwheel. The mill is a two-storey building (Fig. 13), attached to the Mill House, with a single-storey extension on the front elevation and an iron overshot wheel (Fig. 14) on the northern gable. The ground (or meal) floor houses the timber hurst frame (Fig. 15) which carries the pit wheel, wallower (gear), spur wheel and the two stone nuts. These nuts drive two pairs of millstones at first-floor level (Fig. 16). The upright shaft also drives a lay shaft at this level, via the crown wheel and pinion, which powered the sack hoist and flour grader or dresser (no longer present).

*Fig. 13 Stogursey, Castle Street, Town Mill (photo Mike Hargreaves)*

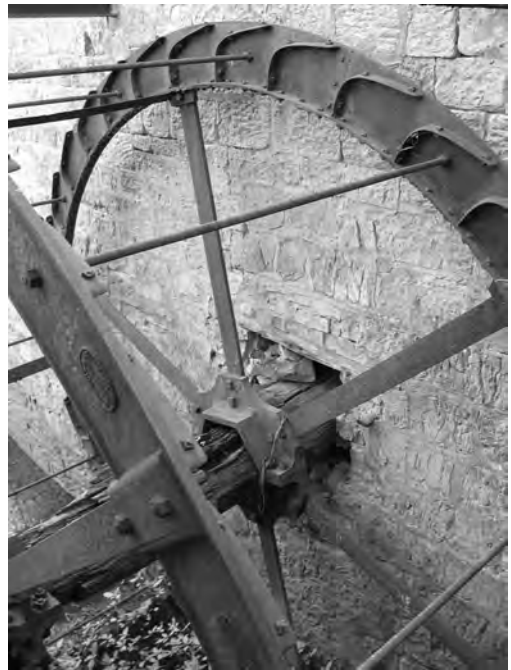
*Fig. 14 Stogursey, Castle Street, Town Mill, wheel (photo Martin Watts)*

In the loft, most of the sack hoist survives and the remains of the timber launder have been stacked at the far end of the loft. The surviving evidence suggests that the present mill building dates from the mid 18th century and that the extension was added in the 19th century. Of the mill machinery, the vertical shaft and some of the gear wheels are probably 18th century, whilst the wheel, cast by

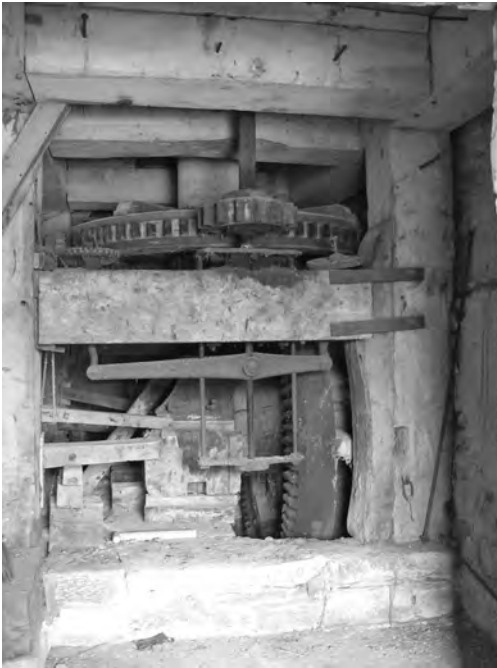
Fig. 15 Stogursey, Castle Street, Town Mill, hurst  
(photo Martin Watts)

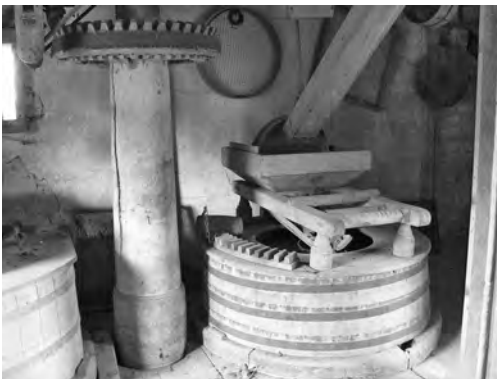
Fig. 16 Stogursey, Castle Street, Town Mill, stone-  
floor (photo Martin Watts)

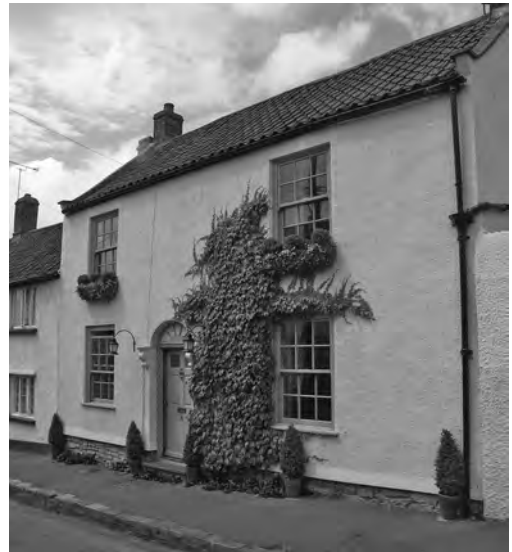
The house (Fig. 17) has two rooms with a central passage and a lean-to extension to one side at the rear. A former workshop was situated on the other side of a yard. The evidence of structural and internal details (Fig. 18) suggests that the house was built in the early 19th century and then comprised two rooms with an outshut, used as a scullery. An extension to the rear covering part of the yard was added probably in the second half of the 19th century and the lean-to raised to provide an additional first-floor room. The stairs were also relocated at this time. In recent years the workshop has been incorporated into the living accommodation.

Fig. 17 Stogursey, Castle Street, No. 8 (photo John  
Rickard)

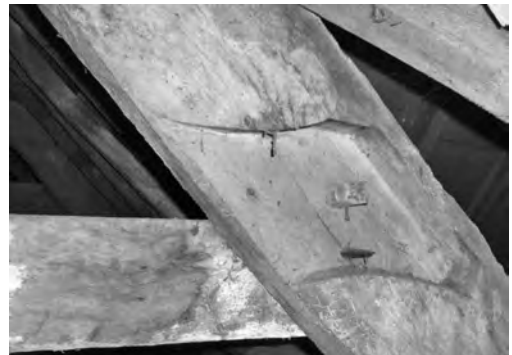
Fig. 18 Stogursey, Castle Street, No. 8, reused roof  
timber (photo John Rickard)

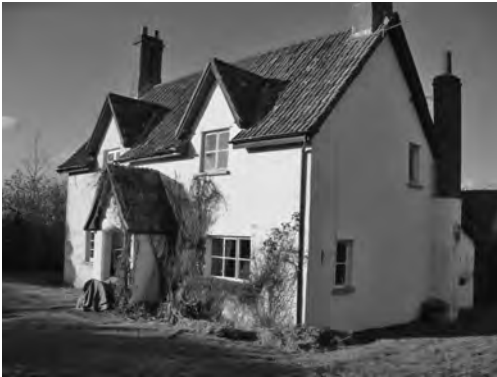
The house (Fig. 19) has a two-unit plan with a central entry into a staircase hall with a lean-to at the rear. There is a detached single-storey utility building at the rear. Originally built *c.* 1800, the house then comprised parlour and living room/kitchen with two service rooms in the lean-to used as a scullery and perhaps a dairy.

*Fig. 19 Stogursey, Colepool, No. 41, Webber's Cottage (photo Mike Hargreaves)*

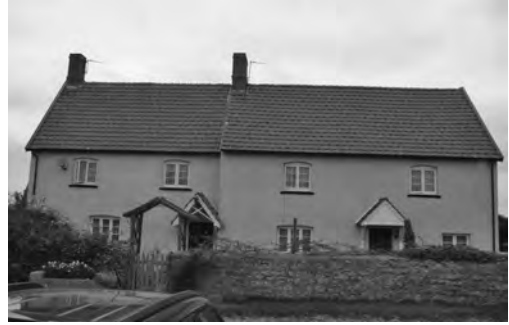
The house (Fig. 20) is detached and overlooks the farmstead. It is three rooms in line with cross-passage and turret stair, with substantial additions on the north side. Documentary records indicate that the house is on the site of Farringdon manor house, but no evidence has been found of an earlier structure. The misalignment of the front wall and the change in roof pitch suggest that there were two building

*Fig. 20 Stogursey, Farringdon Hill Farm (photo Mike Hargreaves)*

phases. The eastern part appears to date from the late 16th century and comprised hall and inner room with access at what was then the gable end. Access to the first floor at that time would have been by a winding stair alongside the stack. The west end was added *c.* 1600 and comprised kitchen, cross-passage and stair turret. In the mid 19th century additions were built along the north elevation comprising the single-storey kitchen and perhaps a dairy. The irregular alignment of two interior walls corresponds with the line of a boundary wall at the rear, shown on the 1886 OS map and which suggests that the east end of the additions could have been part of an earlier structure. At the same time the main house was updated and the roof of the front range rebuilt. The 1841 Tithe Map shows that there were some farm buildings on site, but the 1886 OS map illustrates that there had been substantial rebuilding in the intervening period. The farmstead then appears to have comprised three yards with two cattle sheds, bull pen, calf pens, stables, granary and threshing barn with a horse-engine outside in the rick yard. Of these buildings only the basic structure of the threshing barn and stables survive. The documentary history of Farringdon Manor is recorded in the Victoria County History (*Somerset*, VI (1992), 141).

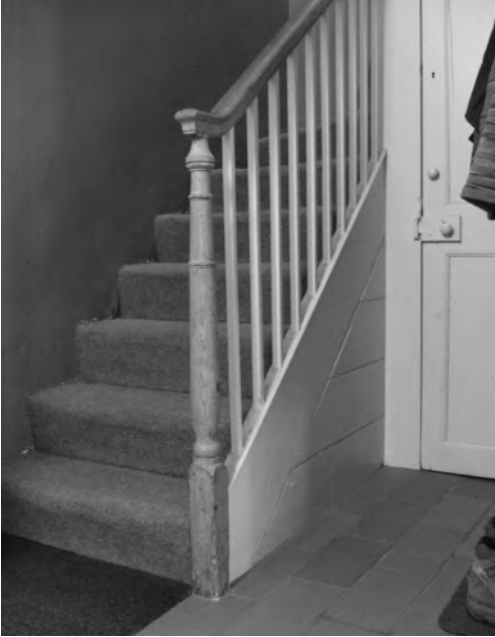
The house has a roughly rectangular plan with an extension to the front (south) and a longer extension to the north. It appears to have been built in the early 19th century (Figs 21, 22 and 23) and the front elevation with the extension and canted bay window is of one build. The rear extension was probably a former workshop that has now been incorporated as part of the living accommodation.

*Fig. 21 Stogursey, High Street, No. 2, stairs  
(photo John Rickard)*

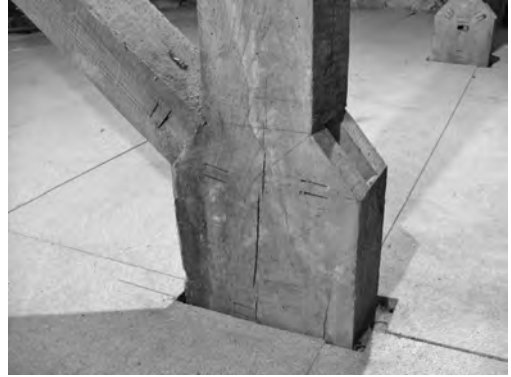
*Fig. 23 Stogursey, High Street, No. 2, carpenters' marks  
(photo John Rickard)*

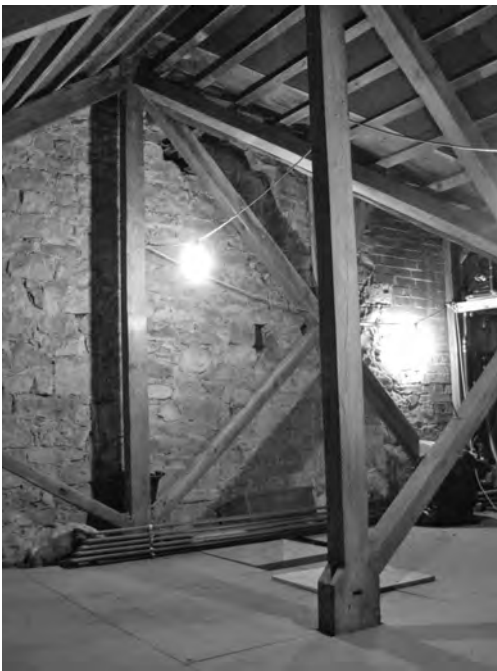
*Fig. 22 Stogursey, High Street, No. 2, king-post truss  
(photo John Rickard)*

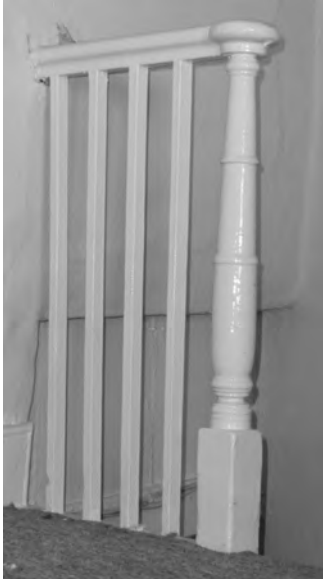
The house is one room deep with a small off-set extension to the rear. A newel stair gives access to the first floor (Fig. 24). The thick front wall and the form of the door suggest a 17th-century date and parts of the roof structure may also be of this period. The relationship of this house with its neighbour is unclear, as the upper floor front wall thickness indicates 19th-century construction and this, together with the similar wall thickness of the adjoining house, may imply reconstruction or adaptation of non-domestic buildings.

*Fig. 24 Stogursey, High Street, No. 15, stair newel and balusters (photo John Rickard)*

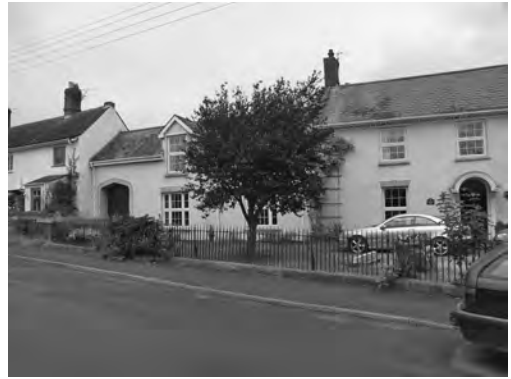
The house has a principal block of rectangular plan fronting the street (Fig. 25), but has a complex history with additions to the rear and sides. An unusually thick wall in one room may be the relic of a medieval structure, but no other evidence survives. The roof structure, wall thicknesses and beams indicate that the main house was built at the end of the 16th or the beginning of the 17th century. It would then have been of one-and-half storey with, probably, a single-storey lean-to at the rear. Alterations, perhaps in the 18th century, included raising the roof. Major changes, probably in the early 19th century, involved the construction of the cat-slide roof and the addition of a second storey at the rear, together with internal fittings throughout. This phase also included the building of barns to the north and west of the house. The building of a separate one-and-half storey dwelling with gabled dormers and a carriage entrance to the south of the barns at the west end of the site occurred sometime between 1841 and 1886 as may be deduced from the maps of those dates. Possibly at the same time a narrow extension was built attached to the east gable end to enable easier internal circulation. The two properties have since been merged.

*Fig. 25 Stogursey, High Street, No. 46, Quantock House (photo John Rickard)*

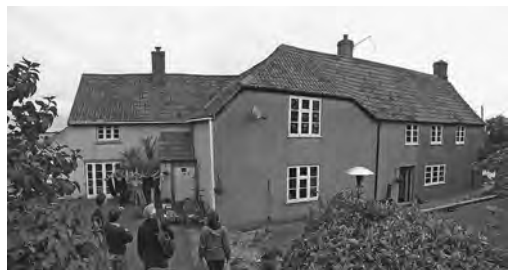
The plan form of the building is of two east–west ranges (Fig. 26) which are misaligned and overlap each other, the southern range being slightly larger overall. This range is set to the east of the other and has a barn range projecting northwards at its eastern end. The land falls away steeply on the north side of the north range, which is one-and-half storey with a single-storey lean-to at its western gable. Originally of two-room and cross-passage plan, the central passage has porches added front and rear. The south range is also one-and-half storey with a two-room, cross-passage plan form. However, over the west room the roof is aligned north–south and both ground and first-floor rooms have higher ceilings. The chamber ceiling has moulded plaster decoration and

*Fig. 26 Stogursey, Higher Monkton Cottage (photo John Rickard)*

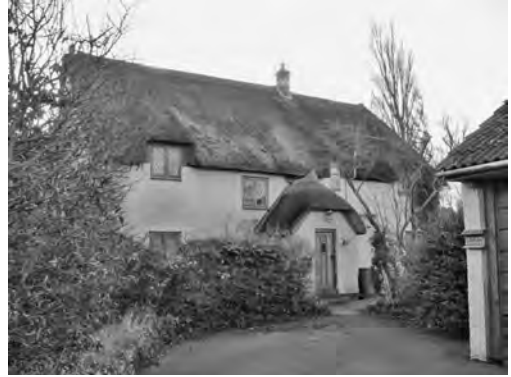
The wall thicknesses, roof structure and details suggest that the house (Fig. 28) dates from the early 18th century and was then one-and-a-half storey comprising living room/kitchen, and a service room, with access directly into the living room. The fireplace lintel has the remnants of inscribed circles, which are probably witch (apotropaic or ritual) marks. The lean-to rooms at each end are probably contemporary. There have been modern additions.

*Fig. 28 Stogursey, Knighton, Eton Cottage (photo Mike Hargreaves)*

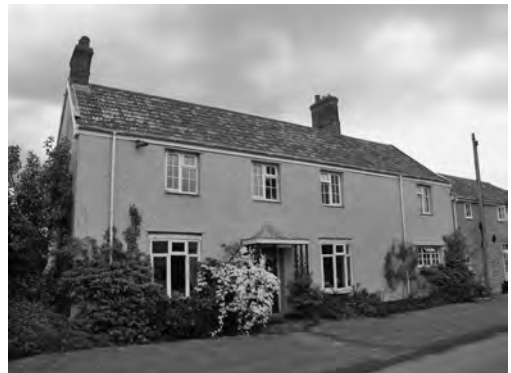
The house (Fig. 29) has three rooms in line with an addition to one side and shallow additions at the rear. The roof structure and other details indicate an initial date of construction at the end of the 18th or beginning of the 19th century. Then it comprised two rooms with an entrance hall between. The original stair probably rose from the hall and there may have been a lean-to scullery at the rear. Prior to 1886 the house was extended by the addition of another room. The stairs may have been relocated to their present position at the same time. Access directly from the added room to the adjoining 'barn' appears to be of long-standing. There were additions at the rear in the 20th century and the barn has been incorporated into the living area.

*Fig. 29 Stogursey, Knighton, Glebe House (photo John Rickard)*

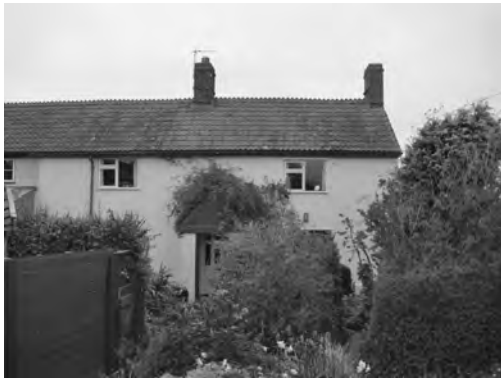
This is a two-storey end of terrace cottage (Fig. 30) with two front rooms divided by an entrance passage with a lean-to addition at the rear. Dating from the early 19th century, originally it comprised one ground-floor room with a room above, with either a front or end-gable entry. By the time of the 1886 OS map it had been extended and later in the 19th or early 20th century the roof and lean-to were raised to provide additional accommodation.

*Fig. 30 Stogursey, Knighton, Hill View (photo Mike Hargreaves)*

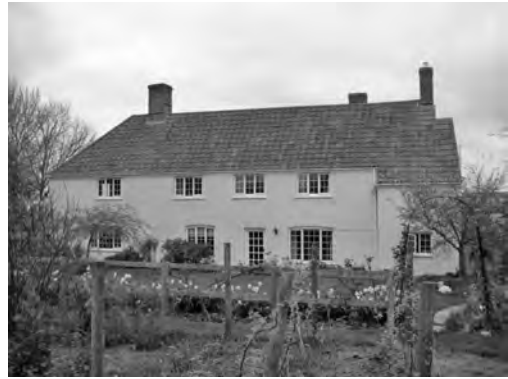
The house (Fig. 31) is part of a working farmstead with an adjoining cottage, formerly a granary. The main house has a two-unit plan with central entry/cross-passage and a later wing at the rear. The wall thicknesses of the main range (perhaps cob) and the structural details of the roof trusses suggest a late 16th-century date. Probably in the early 17th century, the house was remodelled which included the insertion of fireplaces and cob stacks (visible in the roof space) and the partitions either side of the cross-passage. The hall fireplace bressumer has a number of holes cut through which suggests that it may have held a spit-jack. The house then comprised hall, cross-passage, kitchen and turret stairs. A small room off the kitchen may have been a corn-drying kiln and for malting barley. The structure shows that it had a flue rising through the first floor and joining the main stack at high level. The 1841 Tithe Map shows the former granary, but the north wing did not appear until the 1886 OS map. It was later described as a kitchen with pantry off, back kitchen,

*Fig. 31 Stogursey, Peadon Farm (photo Mike Hargreaves)*

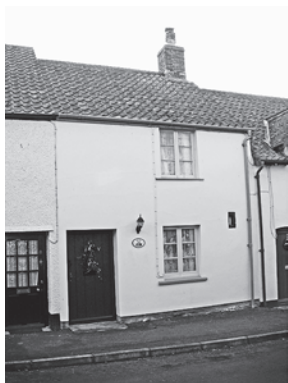
St Andrew's Road (formerly Back Street) is situated in the centre of the village and the house is one of a row of terraced cottages (Fig. 32). The entrance lobby leads to a front room which provides access to a rear kitchen and the stairs. From the limited evidence available it appears that the front range, which then comprised a one-and-a-half-storey unit, perhaps with a lean-to outshut, dates from the early 18th century. A map of 1795 appears to show the property as part of the Fairfield Estate and joined to No. 5. The 1887 OS map shows that the kitchen extension had been added in the mid-19th century and it is likely that the front part of the house was upgraded at the same time.

*Fig. 32 Stogursey, St Andrew's Road, No. 6 (photo Mike Hargreaves)*

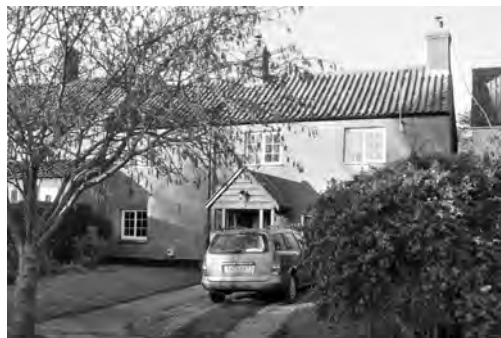
The house (Fig. 34) has a two-unit plan with a central-entry cross-passage and lean-to additions at the rear. Structural and decorative details suggest an early/mid 16th-century date for the original build. The house was then of one-and-half-storey and comprised a hall, cross-passage and kitchen with a large fireplace incorporating an oven and curing chamber. There may have been a small outshut at the rear of the kitchen. This plan form is relatively rare in Somerset, although it is similar to the plans of Myrtle Farm and Fisher's Cottage, both in Shurton (see *SANH* 151 (2008), 196 and *SANH* 152 (2009), 239). Perhaps in the early 19th century the curing chamber became redundant and a second staircase was installed in its place and at about the same time the walls and roof were raised to create two full storeys. Later in the 19th century the rear outshut was removed (it appears on the 1887 OS map) and soon after new stairs were inserted and a rear lean-to built. Interesting survivals are two salt or spice cupboards, one alongside the kitchen fireplace and the other next to the fireplace on the first floor above the hall.

*Fig. 34 Stogursey, Shurton, Bishop's Cottage (photo Mike Hargreaves)*

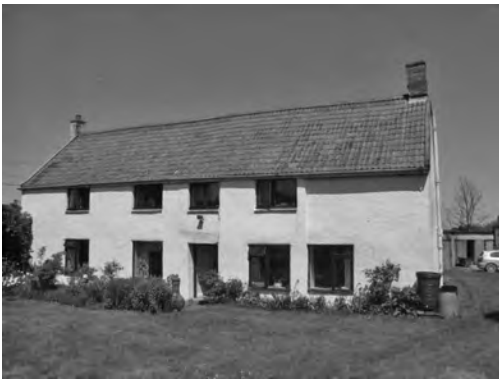
The house (Fig. 35) was the subject of an earlier survey by R. Gilson in 1983. It has a main range of two rooms, one each side of a passage. The room to the west of the passage has been extended and there are additions at the rear. The roof structure is indicative of a date in the early 17th century and the position of the three trusses suggests that at least one more bay existed to the west. This would suggest a three-room and cross-passage plan. However, the common arrangement of the hall heated by a fireplace backing onto the cross-passage is not borne out in the roof structure, as there is no interruption to accommodate the stack. A possibility suggested by Gilson is that a fireplace was sited on the north wall. Also he recorded that the south wall immediately east of the passage was thicker and thus may have been part of an even earlier structure. In the 18th century an outshut was added at the rear and in the late 18th or early 19th century the west gable was removed and the house extended. On the 1886 and 1904 OS maps the property is marked as a beer house and Gilson reported that it had been known as the First and Last Inn.

Fig. 35 Stogursey, Shurton, Lower House Farm  
(photo John Rickard)

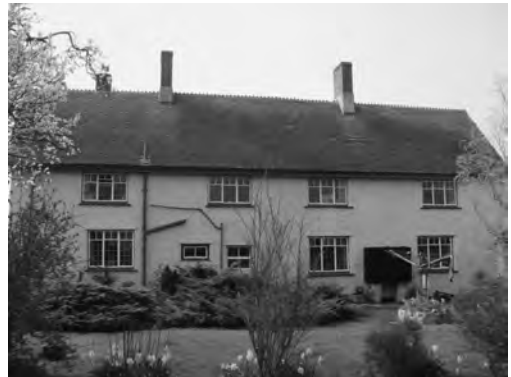
The large farmstead stands in an isolated position at the eastern end of the parish close to the boundary with Stockland Bristol. The farmhouse (Fig. 36) was severely damaged by fire in the early 20th century and only part, comprising three rooms, survived, subsequently much altered and with substantial additions. Historically this was the capital messuage of Woolstone Manor, the descent of which is detailed in the Victoria County History (*Somerset, VI* (1992), 145). The farm buildings have also been extensively adapted, but originally included a linhay, barn, cowshed and piggery. A substantial two-storey granary survives and on the 1886 OS map appears to have a wheel pit, which probably had a supply of water from the pond to drive a wheel for milling, grinding, etc.

Fig. 36 Stogursey, Stolford, Woolstone Farm  
(photo Mike Hargreaves)

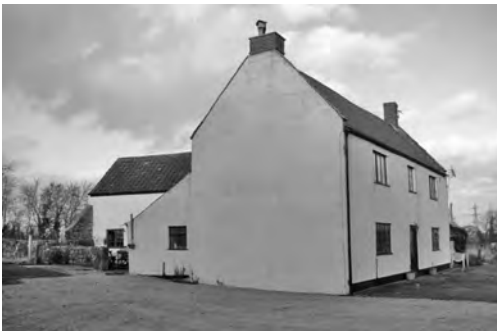
The house (Fig. 37) comprises a two-room plan with a wide central stair-hall and an outshut at the rear. A long rear wing beyond has an inner room, which may always have been domestic, and the outer room is reputed to have been a granary with storage below, now converted to domestic use. The beams, roof construction and fireplace design suggest a date in the late 17th or early 18th century for the front part of the house. At that time the stair-hall may have been an unheated service room, but if so the original position of the staircase is unclear. The rear wing is likely to have been built in the later 18th century with the staircase rebuilt at that time and the service room relocated to the wing. The parlour may have been updated at the same time. The rear lean-to may have been added as a scullery/wash-house at this time or in the early 19th century, as it appears on the 1841 Tithe Map. A full history of the farmstead has been compiled from documents in the Somerset Record Office, which indicate that in 1609–14 it was part of the Earl of Northumberland's estate and a contemporary survey map shows the house with an adjacent octagonal dovecote. A surveyor's report of 1869 list other farm buildings including a barn, linhays, stables and a wagon house.

*Fig. 37 Stogursey, Wick House Farm (photo Mike Hargreaves)*

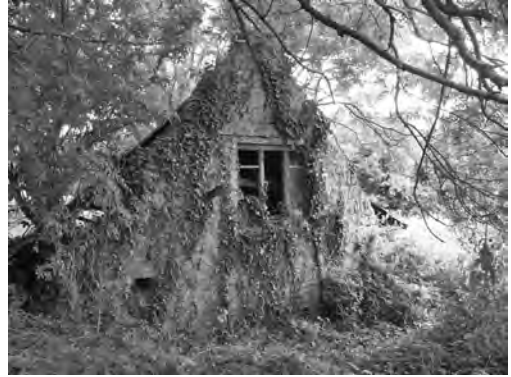
The building, which may date from the 17th century, is in a ruinous state (Figs 38 and 39), much overgrown, and the corrugated-iron roof (probably constructed about 50 years ago to protect the machinery) and half the south wall have collapsed. The documentary history of the mill has been compiled by Susan Shaw and there is a full report on the machinery by Martin Watts. In summary, the

*Fig. 38 Stogursey, Wick Mill (photo John Rickard)*

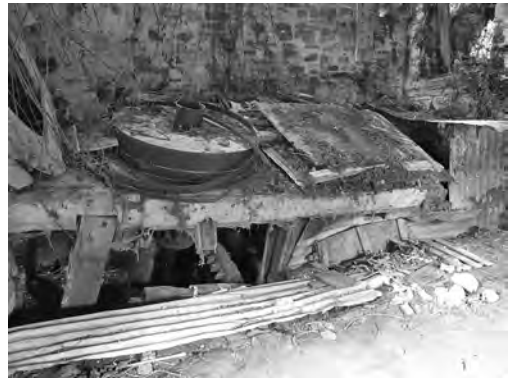
*Fig. 39 Stogursey, Wick Mill, interior (photo John Rickard)*

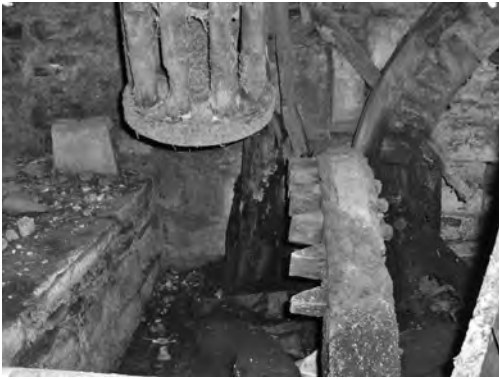
site is an ancient one and can be positively identified as existing in 1301, and the mill appears on the survey map compiled for the Earl of Northumberland between 1609 and 1614, which shows the watercourses in the same positions as those appearing on the 1841 Tithe Map. The wheel-pit has been backfilled, but it is possible to determine that the wheel was over-shot. A photograph of 1975 by Derrick Warren of the Somerset Industrial Archaeology Society, who made a measured survey, shows the machinery in surprisingly good condition for its apparent age, which would be considered early from its archaic appearance, being made entirely of wood (Fig. 40). However, documentary evidence indicates that the gear was renewed in 1887, but this must have involved replication of the existing machinery. That this archaic form of machinery, which is typical of medieval water mills, survived into the 20th century is exceptional and presumably results from a long tradition of continuous economic repair.

Fig. 40 Stogursey, Wick Mill, gearing (photo Martin Watts)

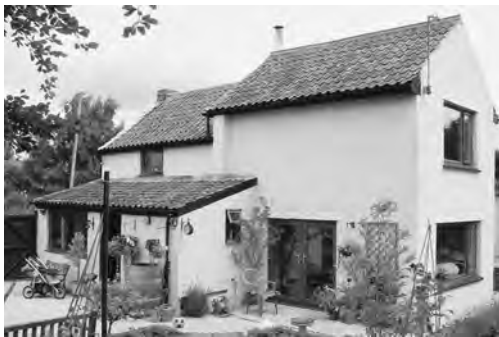
The L-shaped plan comprises two rooms with a lean-to addition at one side and a rear wing (Fig. 41). The limited evidence available – the plated-yoke roof trusses with the tusk-tenoned purlins and other details – suggests that the two front rooms were built c. 1800. At that time it is likely that the cottage was either a two-unit dwelling or formed an integral part of the adjoining property and may have been a workshop. The large rear wing was added within the last 50 years. For the derivation of the unusual name see *SANH* 151 (2008), 197.

Fig. 41 Stogursey, Wick, Zine Cottage (photo Mike Hargreaves)

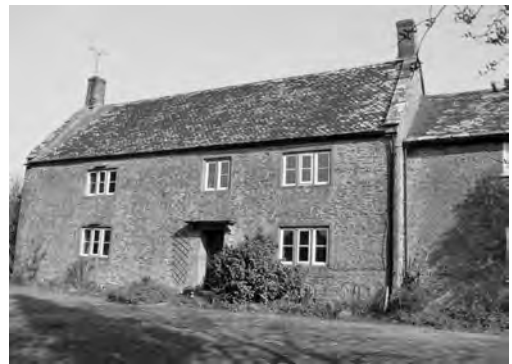
The house is detached and no longer part of a farmstead (Fig. 42). It has three rooms in line and a cross-passage plus additions on the east gable with other minor buildings. There is a blocked first-floor pointed-arch window with tracery on the west gable, which together with the wall thicknesses and the remnants of the arch-braced trusses (on which there is no smoke blackening) indicate that this was a high-status house dating from the 15th century. It is conjectured that then it comprised a hall, incorporating a lateral fireplace and winding turret stair, and a screens passage along the west side of the hall with a pantry and buttery. There may have been a detached kitchen. The first floor contained a hall chamber and one or two rooms at the west end – the room lit by the elaborately traceried window may perhaps have been a chapel. In the mid 16th century the lateral stack and stair turret were removed and stacks were inserted at the gable ends, blocking the west window. The cross-passage was re-sited and the central service room created. The south front wall was rebuilt with new windows in the mid 17th century. In the early 19th century the two-storey kitchen wing was added on the east gable and new stairs were inserted. According to *The Annals of West Coker* (1957) by Sir Matthew Nathan, the property was known as 'Penneys tenement' and the Pennys were a West Coker family from the early 14th century and in the 15th century were tenants of Glastonbury Abbey.

Fig. 42 West Coker, Barton Farmhouse (photo Mike Hargreaves)
