THE VICTORIAN AND SECOND WORLD WAR ARTILLERY BATTERIES ON BREAN DOWN

C. J. WEBSTER

SUMMARY

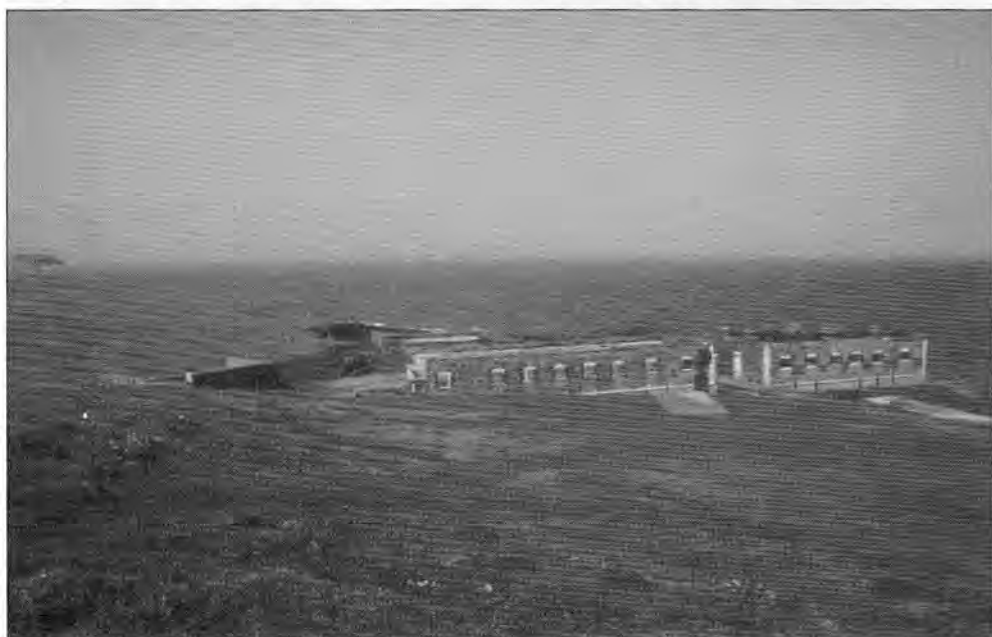
Fig. 2 The landward appearance of Breandown Battery in 1996 with Steep Holm in the distance; photo Somerset County Council

In the early 1950s the Down was purchased by local authorities; the battery by Weston-super-Mare and the rest by Axbridge Borough Council who presented it to the National Trust. Sedgemoor District Council inherited the battery when local government was reorganised in 1974. Over this period the military structures have slowly decayed, punctuated by programmes of 'eyesore' clearance, safety works and demolition training (Figs 2 and 3).

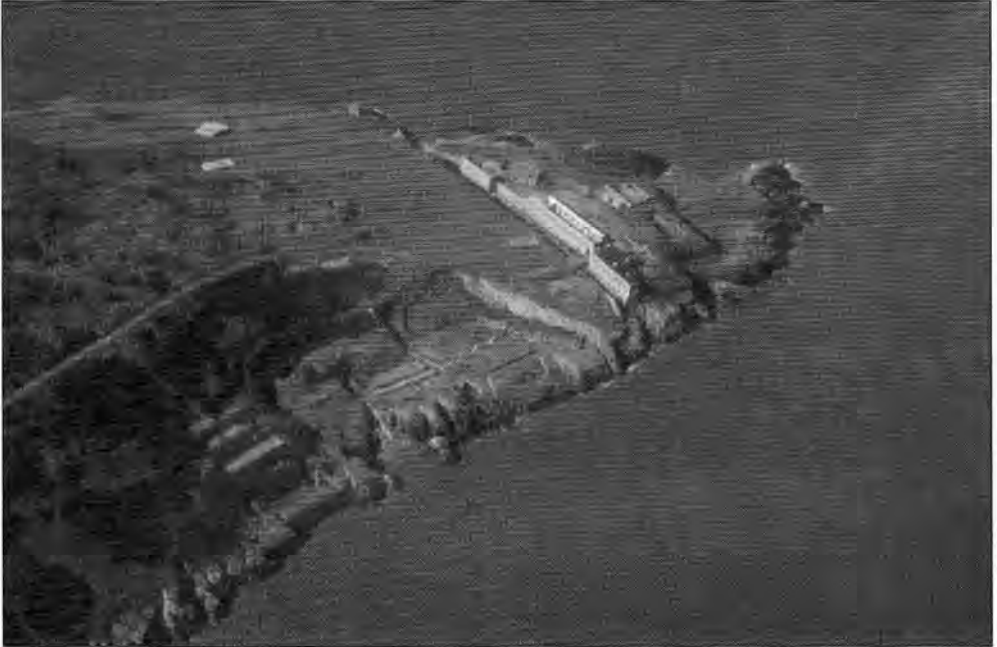
Fig. 3 Aerial view showing the Victorian fortifications (right), additional Second World War accommodation constructed in the quarry (centre), and the observation post (top left); photo Bill Horner, Devon County Council, copyright reserved

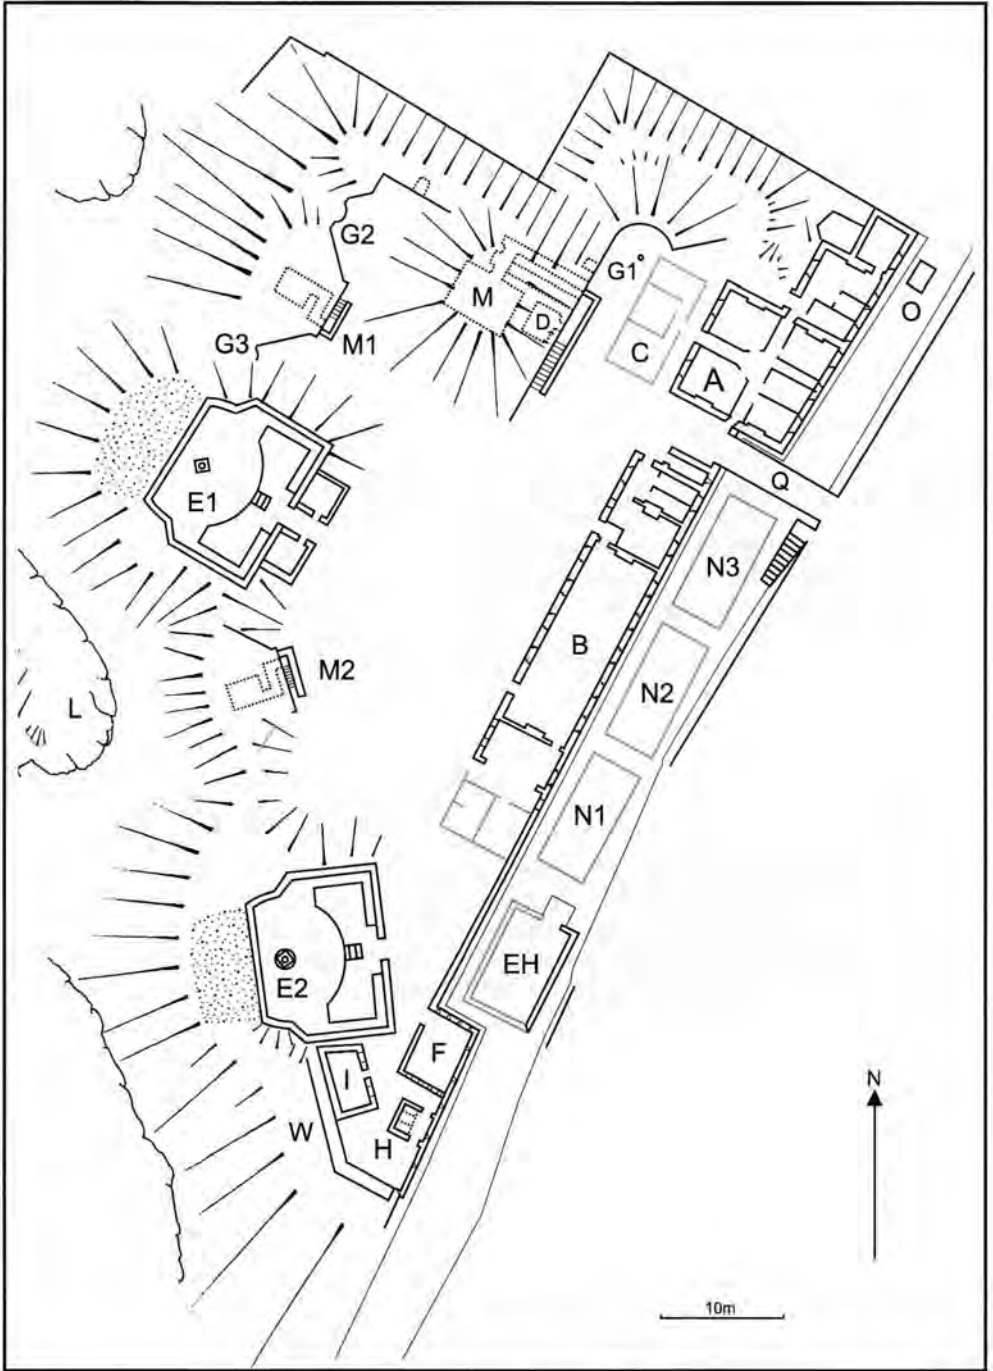
Fig. 4 Plan of the battery in 1995

The following description is based on inspection of the structures in 1995 (Fig. 4) with additional information from documentary sources, including Victorian plans (Fig. 5), and more recent observations, where appropriate.

This Second World War building survives as a concrete foundation platform but photographs and the wall scars indicate its form (Fig. 4). It was single storey with brick-walls rendered in concrete and a flat roof. There was a single door facing the door to building A. This led to a passage and thence to three rooms each with a fireplace. There were three windows in the west wall but none in the south. The building survived until at least the mid 1970s.

One RML was mounted here on an 'A' pivot (Fig. 4). This mounting was based around two semi-circular racers and allowed the gun to pivot around the muzzle, which therefore required only a small opening through the parapet. A stone half-drum 1.3m high, over which the gun fired, forms the centre of the position. From this retaining walls rise to a height of 1.85m supporting a protective bank of earth. There is a shell locker (No. 2) in the north wall and two iron rings for mounting the gun. During the Second World War the area was used as a coal store and remains of this can be seen where the grass has eroded.

A short flight of stairs leads to the entrance of this magazine and a further flight to the magazine itself (Fig. 4). One of the upper stairs is cut away to allow the provision of a window to light the lower stairs. The magazine is similar to M, although smaller (3 x 2.4m). The Victorian plans show this as 'Expense Magazine' and state that it could hold 32 barrels or 152 cylinders. The expense magazines would be under magazine conditions (only entered wearing special clothing etc.) and it is likely that the space at the bottom of the steps acted as the shifting lobby.

This is a large concrete structure of a type similar to that known from other Second World War coast artillery positions (Fig. 4). A wall 0.6m thick and 3.4m high surrounds three sides. At the front a lower wall encloses a platform on which the gun was mounted. In front of this is a concrete apron studded with stones and also iron rings to facilitate mounting of the guns. The gun was an ex-naval 6" weapon, which was fixed to the platform using a ring of bolts. The rear of the platform is curved and steps run down into a well at the back of the emplacement. The curving rear wall of the platform contains six lockers and another eight are located around the well, each originally with two steel doors. At the rear a wide door leads to a passage through a single storey building. To either side of the passage is a small room entered through a door with an adjacent window into the passage. Each room was provided with a stove and provided accommodation for the gun crew. A thick cast-concrete flat roof covers both rooms and passage.

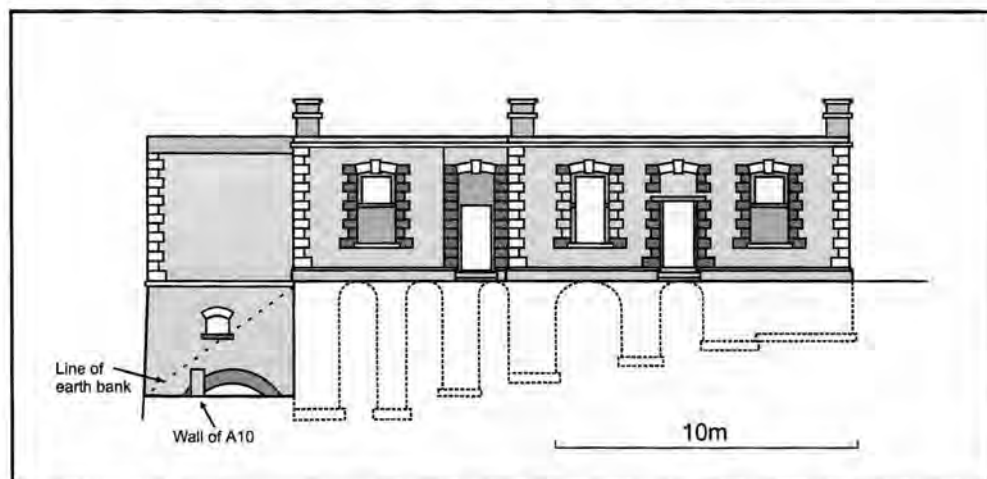
Fig. 7 West-facing elevation of Building A in 1995 with foundations from the Victorian plans

The southern block (rooms 1–5) has an original door to the west flanked by two large windows (Fig. 7). The doors and windows are of similar design to those overlooking the ditch with white limestone arches and window cills. The sides, however, are formed from rusticated blocks of sandstone with the exception of the window to room 2, which has sandstone blocks only at cill and arch level, with grey limestone between. There are some hints that the walling around this has been rebuilt. The edges of the limestone are finished with a distinctive combed tooling, visible in many places in the battery. Pre-war photographs show that the windows were originally glazed with two six-light hung sash frames. Both windows were reduced in size during the Second World War to accommodate 3ft square metal framed windows although the northern window has subsequently been broken out (probably vandalism). The window infilling is in brick with pebbledash exterior. The door has been similarly reduced in height and width and an area above the door has been replaced in modern split concrete blocks. Barrett (1993) states that there was a date-stone (which survive on the equivalent buildings on Steep and Flat Holm) here until replaced with a keystone to match the others but Mrs Martin's photographs do not appear to show this. They do show, however, that the door was converted to a window at this date (c. 1916), which is not the case in the (undated) SANHS photographs.

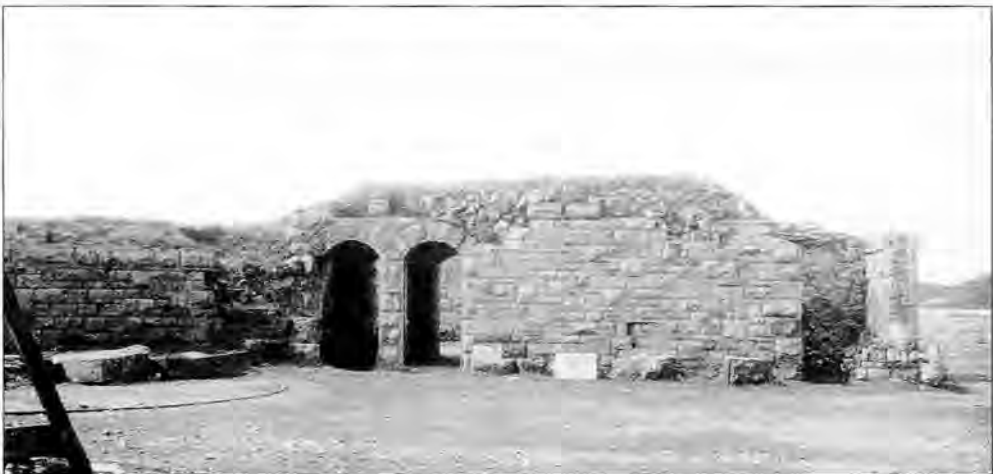
Fig. 10 The south side of the artillery store. The racer rail for the 'A' pivot G6 can be seen on the left; photo SANHS collection lantern slide

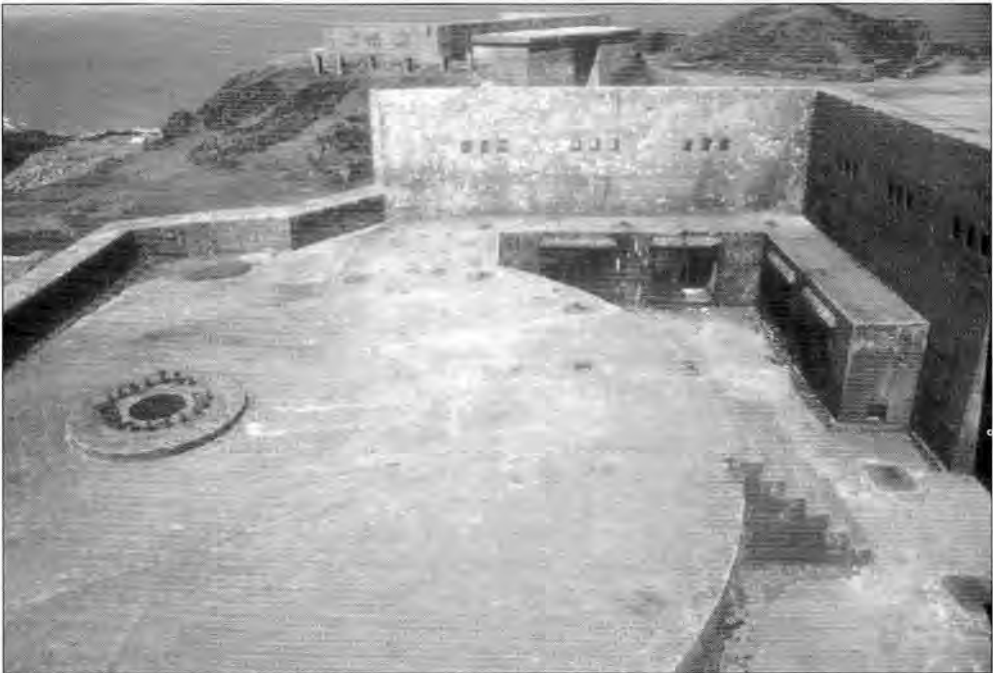
Fig. 11 Interior of Second World War gun house E2 showing the attachment for the naval 6-inch gun and ammunition lockers. The other gun house (E1) can be seen beyond with its crew rooms to the rear and the remains of the supports for the plastic armour roof; photo Somerset County Council

This is almost identical to E1 but the mounting for the gun is slightly different suggesting a different model of gun (Figs 4, 9 and 11). There was no room for the crew room at the rear and it was provided to one side (building I).

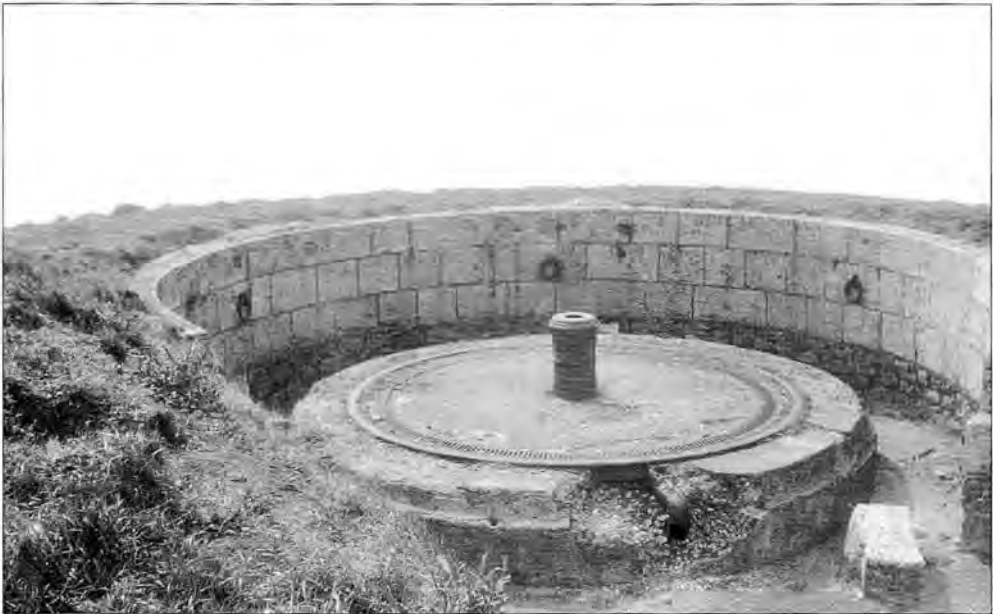
Fig. 12 Gun position G4 in the early 20th century showing the experimental alterations to the 'C' pivot. The ground has been lowered outside the racer rail, revealing the foundations of the parapet wall, and a toothed ring added for traversing the gun; photo SANHS collection

The Victorian plans show an emplacement for a 'C' pivot RML approached by a ramp from the rear (Fig. 5). Between this and the wall next to G3 there appears to be an addition to the plan showing an earth-covered stone structure containing 'Shell Recess No. 3'. Number 4 is shown in the wall behind it. From the configuration this must be the position shown in the SANHS lantern slide (Fig. 12). The slide shows a 'C' pivot with an internal geared track for traversing the gun – which was not used for 7-inch RMLs. The explanation for this appears to lie in experiments reported to have taken place on 14/8/1886 with a gun carriage arranged for depression under-cover loading. One of the points noted from this was that the use of iron-shod levers for traversing was clumsy and a gear would be better (WO 33/47). In reply to this point it was noted: 'Traversing gear would be desirable but up to the present it has never been fitted to 7-inch guns except experimentally' (WO 33/48) This suggests that the gearing may have been added for further experiments.
