MILBORNE PORT CHURCH

The Problematic Early Work at Milborne Port Church¹

BY F. J. ALLEN, M.A., M.D.

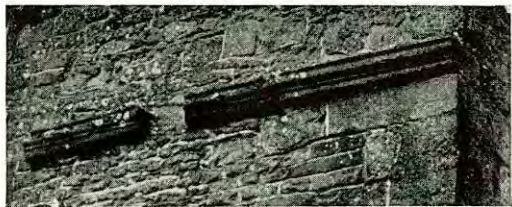
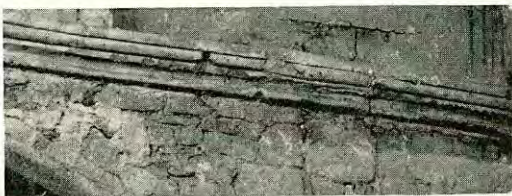
ABOVE: (a) String-course, Milborne Port;
(b) Early cornice, Shepton Mallet.

The string-courses on the outside, previously referred to, may be compared with the cornice in the nave at Shepton Mallet, which is of very early date and apparently carved with blunt tools (*see* Plate VII and the accompanying illustration).

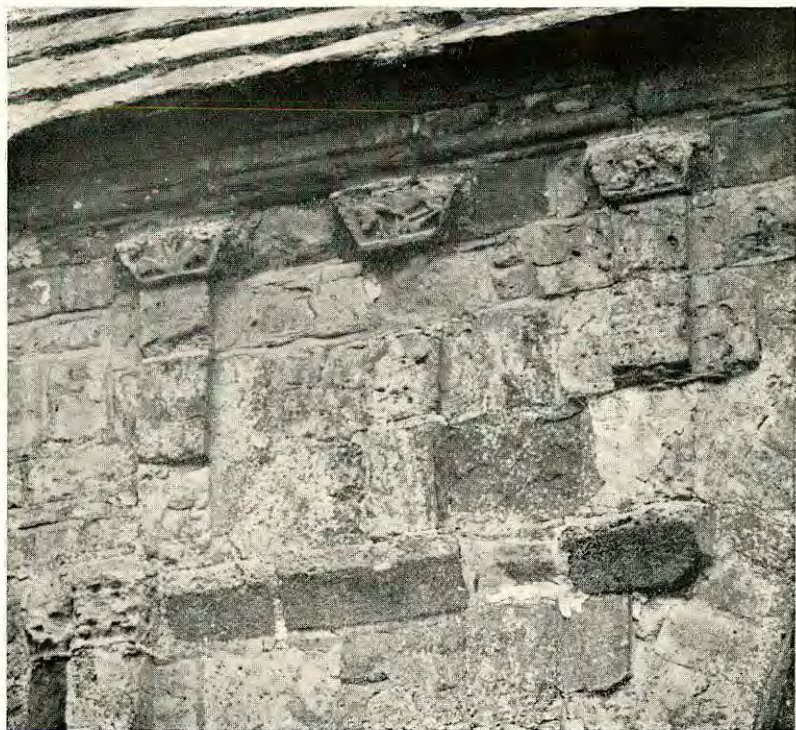
MILBORNE PORT CHURCH
Pilaster Work

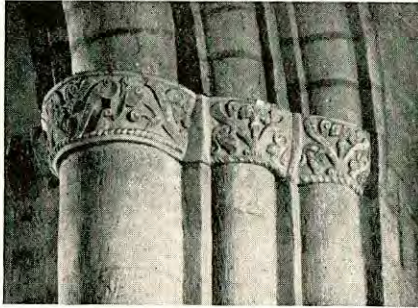
- a. Plaster capitals of south tower arch
- b. Stone capitals of west tower arch
- c. Bases of west tower arch

South arch, capitals entirely plaster.

This plaster work is so good that it looks like original work rather than restoration. If it is really restoration it is most cunningly executed, and must have required great skill and patience : the architect seems to have aimed at accuracy, real or specious. Very early plaster work is rare in England ; but there are fine examples on the Continent, for instance at Hildesheim.

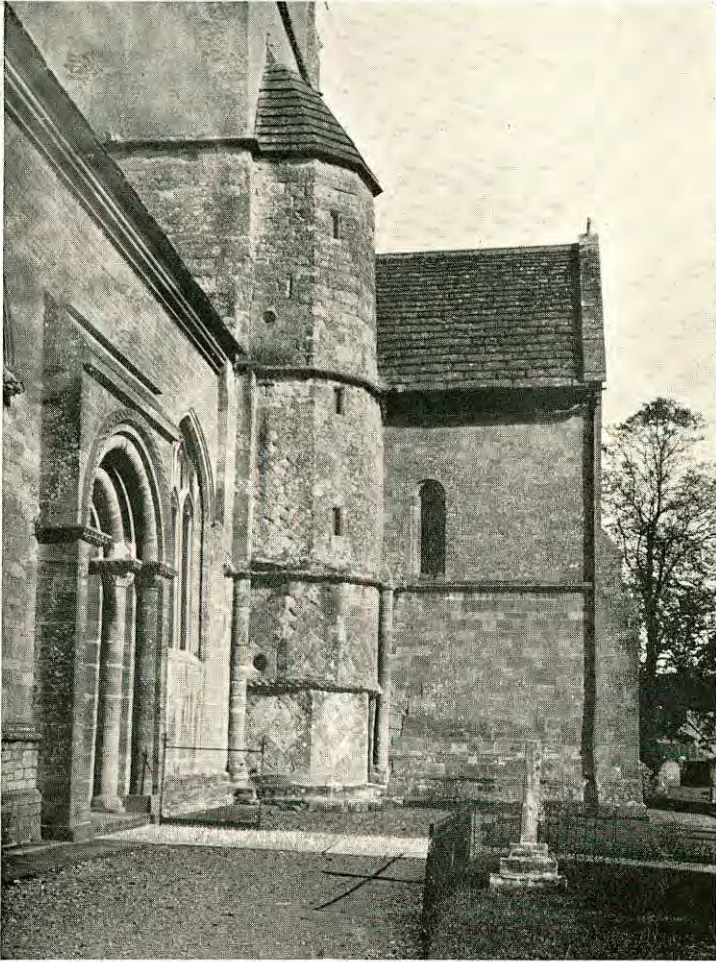
Junction of Nave and South Transept

This turret is a polygonal structure in the angle between the south transept and the nave (Plate X) and encloses the newel stair to the tower. The masonry of this structure is not continuous with that of the transept, and thus suggests that it is a later addition. The surface stones are set diagonally as far as the roof level, and horizontally above. There are three string-courses, the lowest with billet ornament, the upper two plain, not moulded like those of the transept with which they are continuous.
