## STEART BARN, TRULL

BY LIONEL F. J. WALROND, A.M.A.

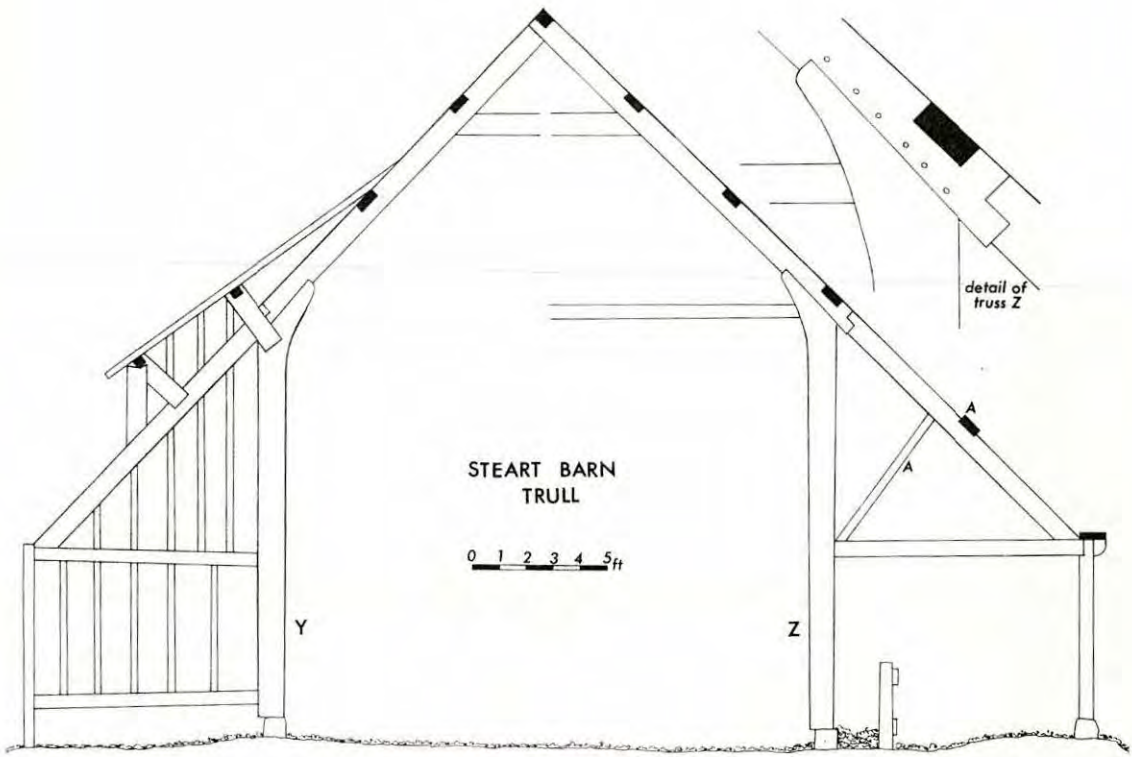
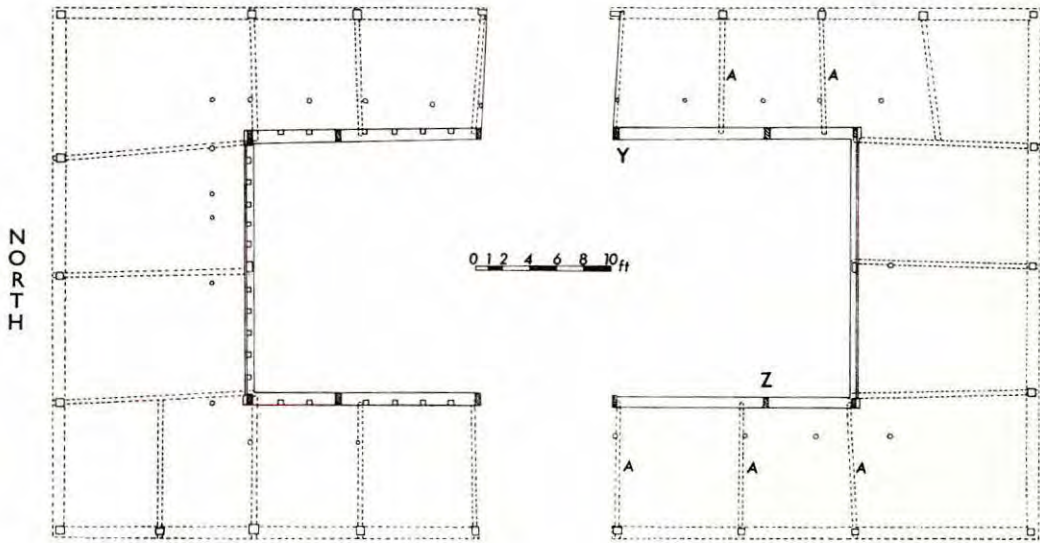
There were gaps over the end walls which were closed by fixing sloping joists with boarding, resting at one end on the cross beam, and at the other upon a rail fixed across the under side of the hipped roof.

The central part of the barn, 45 ft. 6 ins.  $\times$  21 ft., contained four exceptionally fine jointed cruck trusses supported by vertical members 11 ins.  $\times$  4 ins. in section and 17 ft. 5 ins. tall. These rested on, and were presumably mortised into, sill beams of rather more than 9 ins. square section laid direct upon the natural soil or upon a course of stone which was subsequently buried by accumulations of compacted hay and dust. The ridge piece was square in section and there were three unusually wide purlins notched into the back of the roof principals, the lowest being also in effect a wall plate. The outer trusses had only a collar beam set high in order not to inconvenience the handling of hay, but those adjoining the through passage had in addition a tie beam, regarded as original but nailed into position. The scarfing of the two members of the jointed cruck truss was abnormal in that the under surface was cut to form a rolled bracket instead of the more usual continuous curve,<sup>1</sup> and that the scarf joint was held by six pegs instead of the usual four. There was no reason to suspect a slip-tenon as was noted in a far earlier example at South Bradon.<sup>2</sup>

At each end of the barn were three uprights, set on a sill beam, supporting a cross beam. The corner posts were nailed to the lower purlin/wall plate of the side walls, and the diagonal hip ridges passed over this end framing without support.

The open shelter shed around the barn was supported by a series of posts resting on dressed stone bases. The top of each post was deeply mortised to take a tie beam, the full width of which projected beyond, where it was dressed to a quarter roll, and upon which rested a conventional wall plate. Principal rafters rose from above each post, eight of them being notched onto the lower ends of the jointed cruck trusses. The hip ridges were small in section, and served as trimmers for the purlins and common rafters rather than for their support. Their ends met those of the other hip end principals in a cluster, nailed together at the ridge, with no trace of a gablet. Along the sides, the principals of the shelter shed supported one purlin only, but with two purlins at each end where the sheds were much deeper. The inner ends of the tie beams were not mortised or otherwise fixed to the main posts of the central barn, but were nailed to the nearest wall stud. Along the barn wall were remains of a low feeding crib, some of the posts of which were still tall enough to be nailed to the tie beams. Hay had been fed to the stock through holes in the boarded walls, but this feature does not appear to have been part of the original design.
