# THE CHAPEL OF ST COLUMBANUS AT CHEDDAR

PHILIP RAHTZ and SUSAN M. HIRST

The chapel of St Columbanus at Cheddar is now a conserved ruin in the grounds of the Kings of Wessex School. Archaeological excavation in 1960–62 showed it had its origin as the royal chapel of the palace complex in the 10th century. In spite of its early-sounding dedication it did not succeed any earlier religious structure, but was in fact built over a hall of an earlier period (Rahtz 1979, 52–67, 193–223, 374–9).

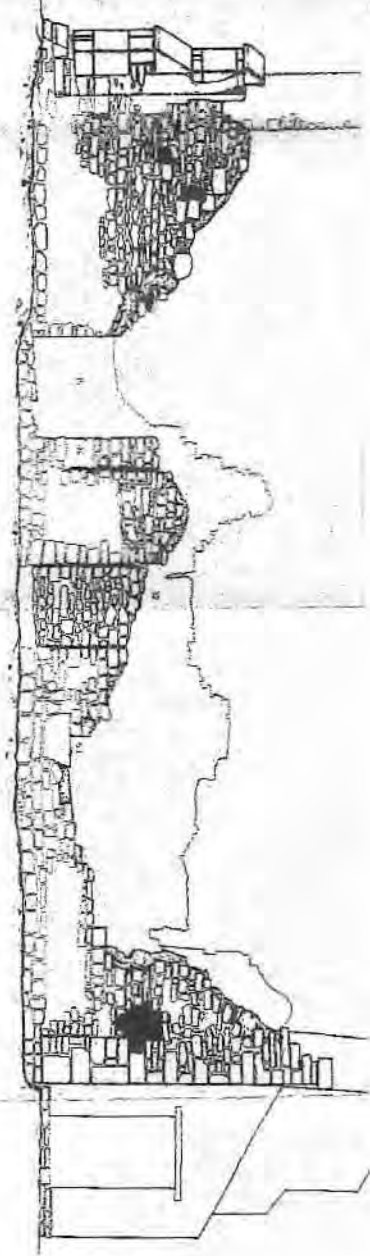
Fig. 2 South elevation.

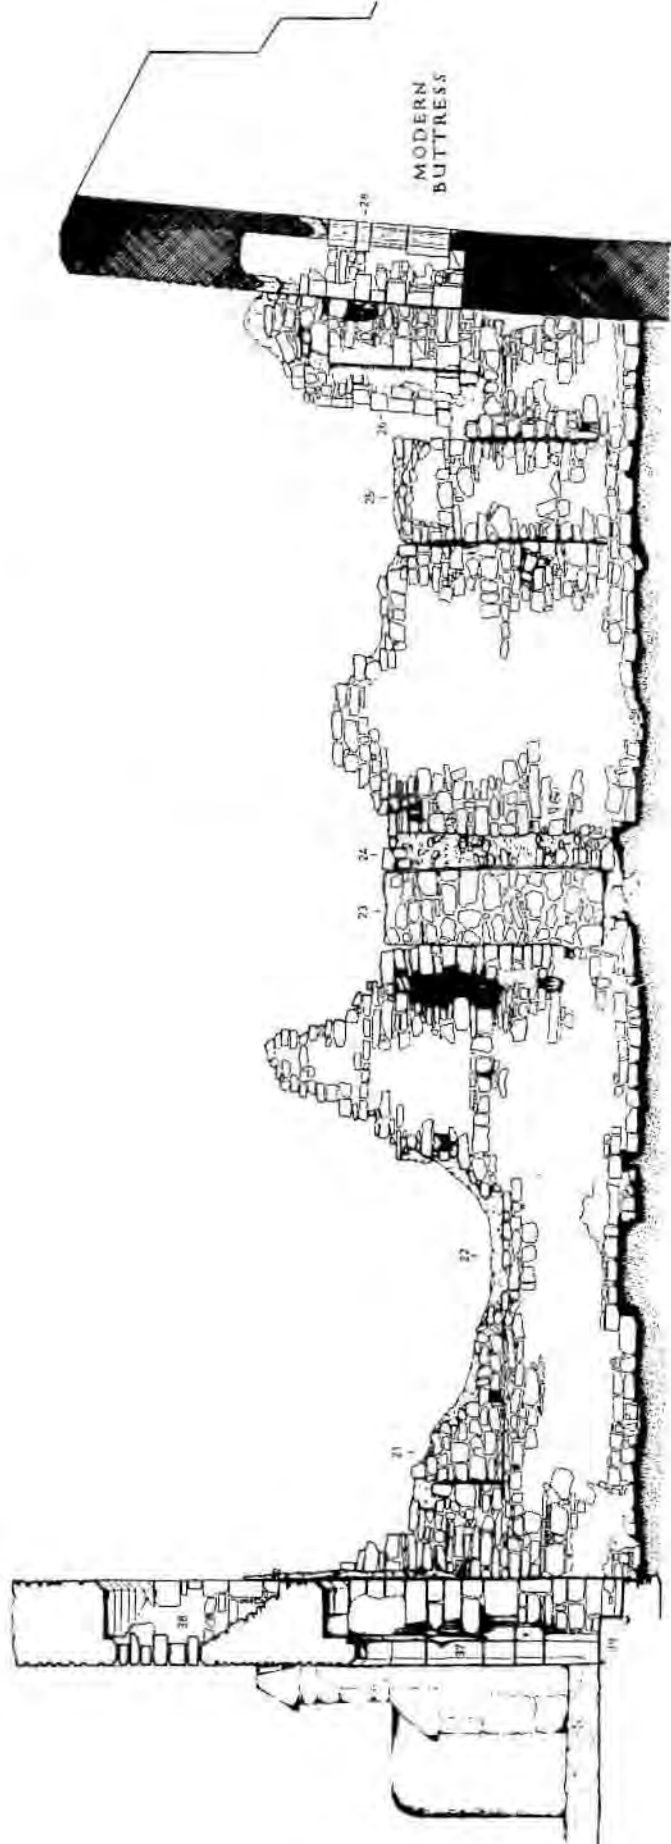
Fig. 7 Internal elevation of north wall.

38. Window in centre of west wall (Figs. 4, 5, 6 and 7). Single light lancet with two-stone double chamfer; flattened pointed arch inside single chamfer voussoirs; wide internal splay to 40° jambs. Blocked in Chapel IIIB.

26. Window at east end of north wall (Figs. 7 and 8). East side only survives, west side destroyed by IIIB door 25 (see below). Plain chamfer jamb and simple mullion.
29. Window at east end of south wall (Fig. 4). Only survives as fragment of simple chamfered jamb. Blocked later.  
(N.B. For below-ground foundations at east end see Rahtz 1979, 210 and Fig. 75).

22. Window in western end of north wall (Fig. 2). Destroyed before elevation (Fig. 7) drawn. Some fragments of single chamfer jamb set in IIIB mortar (see above) had survived.

23. Doorway and ?window in middle of north wall (Fig. 2). The doorway is certain, as blocked masonry between two straight joints set in IIIB mortar (Fig. 7). The blocking was only down to the level of the lowest post-medieval floor levels of the 17th century; some IIIB mortar here suggested a robbed threshold. The existence of a window above this door is attested only by the drawing of 1829 (see Rahtz 1979, Fig. 77).

25. Doorway and ?window as 23 at east end of north wall (Figs. 2 and 7). Doorway has straight joints, with jambs set with IIIB mortar (see above) which block IIIA window 26. Doorway blocked later. A possible threshold outside (60 in Rahtz 1979, Fig. 75) is represented by three large pieces of window-head from Chapel I re-used here (ST. 75 and 76 in Rahtz 1979, Figs. 79 and 80).

28. Window in the middle of east wall (Figs. 2, 7 and 8). Exterior has two-light ogee cusped tracery, interior arabesque hood moulding; *c.* 1330 in style (inf. Dr. C.A. Raleigh Radford).

21. Blocked ?window at west end of north wall (Figs. 2 and 7). May be only a recess.
53. Window in east end of south wall (Figs. 2-4). East side IIIA masonry, west side rebuilt in IIID; probably glazed with leaded lights.
- 34 & 35. Doorway in middle of south wall (Figs. 2-4). 34 is a later rebuild of the original east side of 35 in harder mortar. There may originally have been a window here, later changed to a doorway; later still blocked (see Fig. 4).
24. L-shaped wall (Figs. 2 and 6) running south from middle of interior north wall.
