NOTES

A COB DOVECOTE AT DURLEIGH

Somerset Archaeology and Natural History, 1968

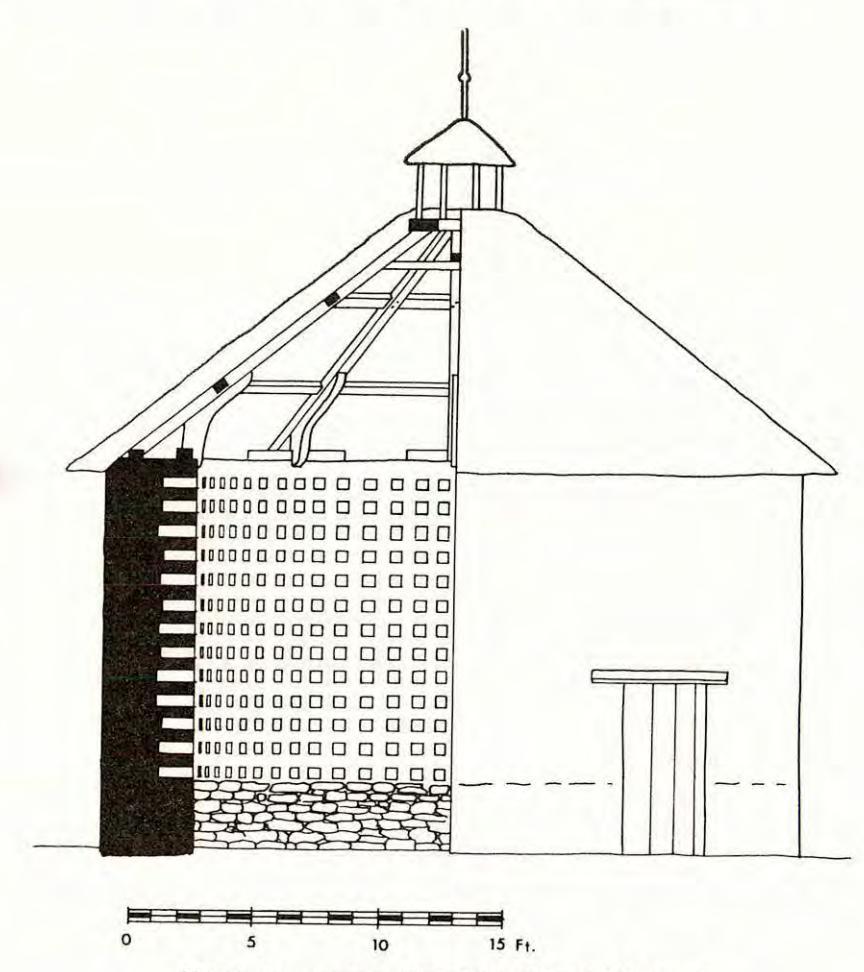
FIG. 1 DOVECOTE AT WEST BOWER FARM, DURLEIGH

The Durleigh dovecote is at ST 265363 near the site of West Bower manor house, to which it belonged. Both the timber-work of the roof and the weathercock which formerly surmounted it are of 17th century character, and the cob walls are probably of this date as well. The dovecote is circular, $20\frac{1}{2}$ feet in internal diameter, with a stone plinth and thatched roof, but has deteriorated markedly in the last 45 years¹. During this time the lantern and weathervane have collapsed, the wall has cracked, and the floor has been raised along with the level of the surrounding farm yard when the Durleigh Reservoir was built.

The sandstone footings are about 3 feet high, though only 15 inches are now visible; on them stands the cob wall, 13 feet 4 inches high and 3 feet 10 inches thick. Probably the unusual height of this plinth was intended to discourage vermin. There is a complete absence of stones in the cob, which consists of red clay with a small quantity of chopped straw, built in six courses or risers each between 18 and 30 inches high. In Devon a progressive reduction in the height of the risers has been claimed,² but the reverse is the case at Durleigh, where the courses are respectively 22, 18, 28, 30, 30 and 30 inches high. After each riser had been completed, it would have been left for a short while to compact before the next course was laid on top. When the wall had been completed and the cob had consolidated, but apparently before it had entirely dried out and become hard, the inner face was trimmed and the nesting holes were cut out. Each hole is wedgeshaped and about 6 inches high, having an opening 6 inches square and widening out to 10 or 11 inches at the back; they vary in depth from 15 to 18 inches. The sides, top and bottom of each hole are smooth, with a few lines scored by the tool used, but the ends are rough where the stiff clay has broken away. The tool used was a cob-paring iron, a small spade-like flat iron blade, in this case 5 inches wide, mounted on a long straight handle. This iron was used normally to pare away the rough surface of a newly-built cob wall. To cut the nesting-holes, it was simply driven into the wall with the handle held horizontally.³ This technique of cutting the nesting holes accounts for the absence

Originally there were about 730 nesting holes arranged in 13 rows or tiers, each complete tier containing 60 holes. Each hole is placed exactly over the one below, at 12 inch centres, the vertical intervals being very regular. On the other hand, the horizontal intervals between the columns vary considerably, with a norm of 6 to 7 inches, reducing to barely 5 inches in the south-east sector of the dovecote. From this it can be inferred that the holes were cut, not tier by tier but column by column with the help of some form of vertical guide, and that the work of cutting the holes probably began and ended in the south-east sector, where the spacing of the holes is suggestive of confusion.

The door is on the north-west, and has been greatly enlarged at the expense of the nesting-holes, probably in connection with a secondary use of the building. The curved lintel with its slightly hollow unstopped chamfer may be the original one re-used. Almost opposite the door is a window for ventilation, placed at the top of the wall. Though mutilated, the splayed jambs and steeply sloping sill remain and suggest an opening 21 feet square.

Conical roofs have received scant attention in the past, so that a discussion of the present roof must await further work in this field. There are 8 principal rafters which support the circular wooden frame which forms the exit-hole at the apex of the roof. They are linked by two sets of curved purlins which are canted to the pitch of the roof and mortised and pegged into the sides of the principals. The weight of the roof is spread over the top of the cob wall by a wall-plate at the base of the principals; and by curved brackets which are mortised into the principals and rest on baulks of timber on the inner face of the wall. These brackets convey some of the thrust of the roof downwards in an effort to reduce the horizontal stress on a cob wall already weakened by the cutting of the nesting holes. Between the upper purlins and the apex are four ties which link opposing principals. Immediately below the upper purlins are four similar ties, but these are secondary and have been omitted from the drawing. The glover has now collapsed, but consisted of 6 posts standing on the framework of the exit-hole, supporting a conical thatched roof surmounted by a weathervane. R. F. TAYLOR

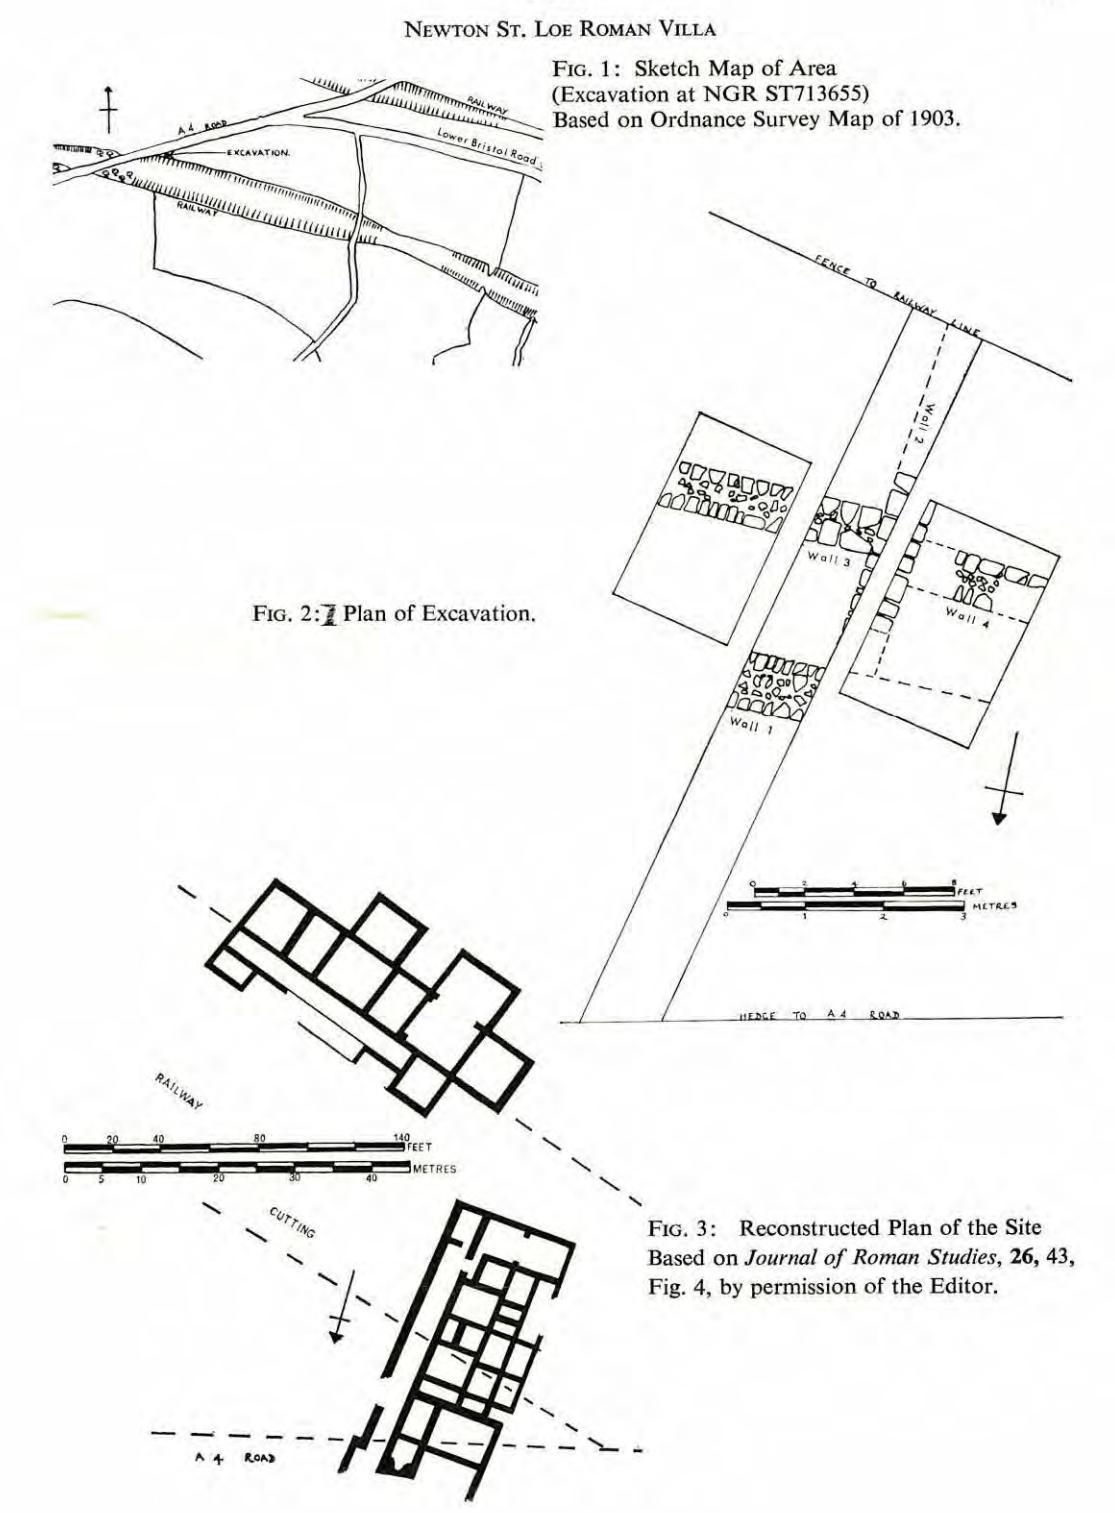
This excavation, with the aid of the nineteenth century plans, made it possible to plot the position of the Villa (Fig. 3).

The earliest wall on the site must be wall 1 which was far deeper than any of the others. Then followed wall 2 at right angles to wall 1. Because of the lack of evidence, it is impossible to say whether there was a bonded or a butt joint at the point of intersection. There is, however, no question that both walls 3 and 4 butted on to, and are therefore later than, wall 2; but how much later they are, or whether 3 and 4 are contemporary with each other, it is impossible to say.

Time being at a premium, a trench three feet wide and over thirty feet long was laid out across the probable site (Fig. 2) and at right angles to the railway.

The nineteenth century investigators apparently failed to recognise any distinct periods, but as can be seen (Figs. 2 and 4) the story is rather more complicated than they suggested.
