DATING OF THE SMALLER SOMERSET HOUSES FROM EXTERNAL APPEARANCE

BY CDR. E. H. D. WILLIAMS, O.B.E., R.N. (RET.) AND R. G. GILSON

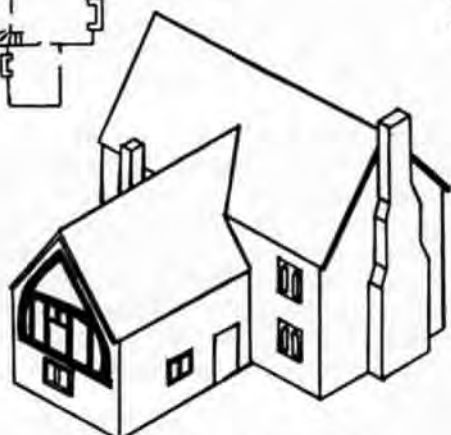
V. Medieval cruck house partly
replaced by 16C building.

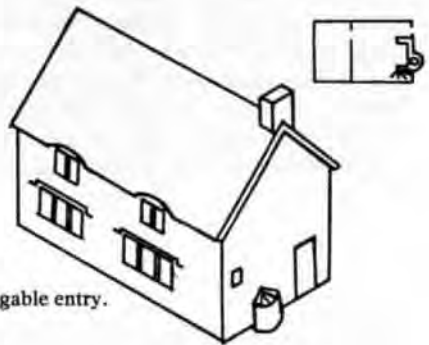
X. 17C gable entry.

Many houses of two-room plan of the later 17th century have a door sited centrally (or nearly so) into a lobby, sometimes with a staircase in it or in a turret at the rear, and the rooms on both sides have gable-end fireplaces (Fig. IX; Pl. 3). An alternative plan of the 17th century has an entry in the gable-end wall beside a fireplace and stair into the larger of two rooms, the smaller being unheated (Fig. X). Stairs in houses newly built in the 16/17th centuries are contained within the overall width beside the hall stack and sometimes also beside a gable stack, their positions indicated by small windows, but in medieval houses modernized at this time they are often in an external turret.

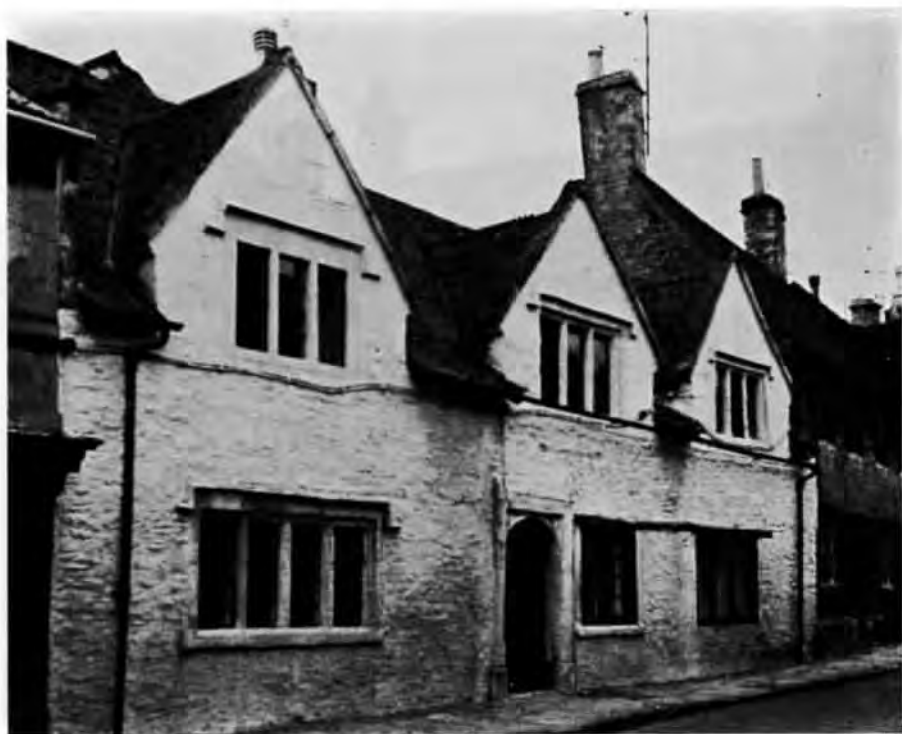
Plate 1. White House, Norton St. Philip. Medieval house modernized mid 17C; square-headed ovolo moulded windows under angled drip moulds, upper windows in dormers.

Exterior decoration in and prior to the 17th century was confined to the mouldings of doorways and window frames which are described and illustrated below. Drip moulds, primarily a utilitarian adjunct to these, also provided scope for decorative treatment (Pl. 1) and in the late 17th century individual drip moulds with angled ends developed into continuous string courses (Pl. 3). Relieving arches, although basically structural, also add interest to otherwise bare expanses of rubble walling—these are more common in the north east of the county. Occasionally dormer gables have carved barge boards. Pediments and other Renaissance features appeared widely in the 18th century by which time moulding was largely confined to the relatively unobtrusive bead (Pl. 3).

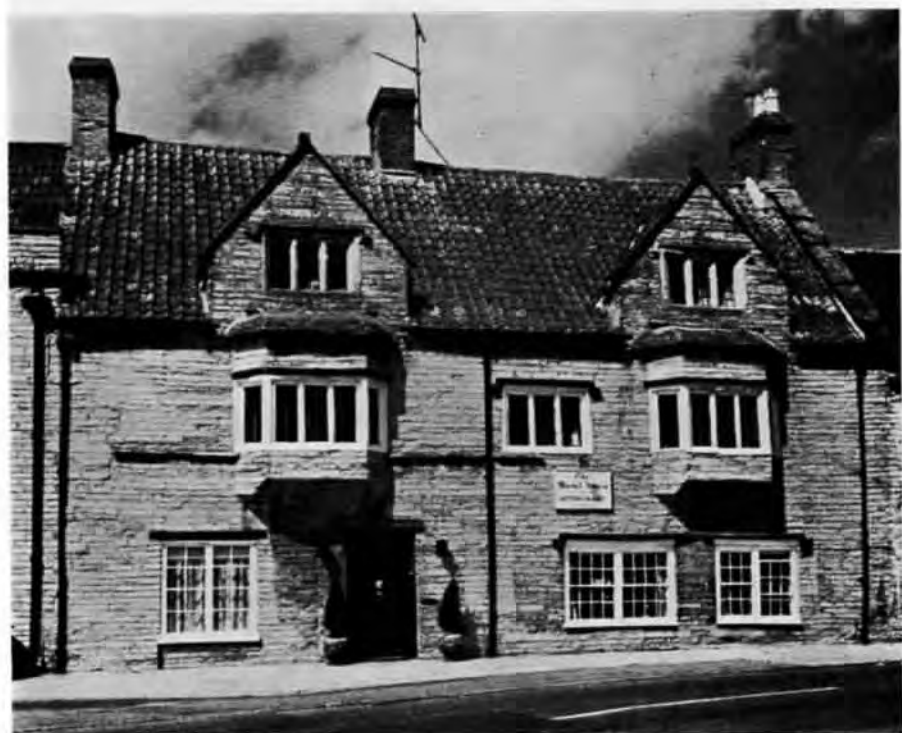
Plate 2. Market House, Somerton. 17C town house, 18C sash windows replacing some of the square-headed ovolo moulded windows. Oriel first floor windows.

Sash windows appeared in the early 18th century, replacing the earlier mullioned windows (Pls. 2 & 3). These early sashes have thick glazing bars and the boxes are set flush with the walls, but legislation of the mid-18th century required the boxes to be inset, and later glazing bars became thinner. Blocked windows often result from the introduction of the window tax in 1697 (lasting until 1851), but they may also be due to internal re-arrangement of rooms and can even be dummy openings intended only to give external symmetry. Bay windows, found in grander houses from medieval times, appear in houses of manorial status in the 16th century and are often gabled, but in lesser houses are likely to be of the 17th century. Oriel windows lighting superior rooms on the first floor are of the same period (Pl. 2). Bow windows are of the late 18th to 19th centuries.

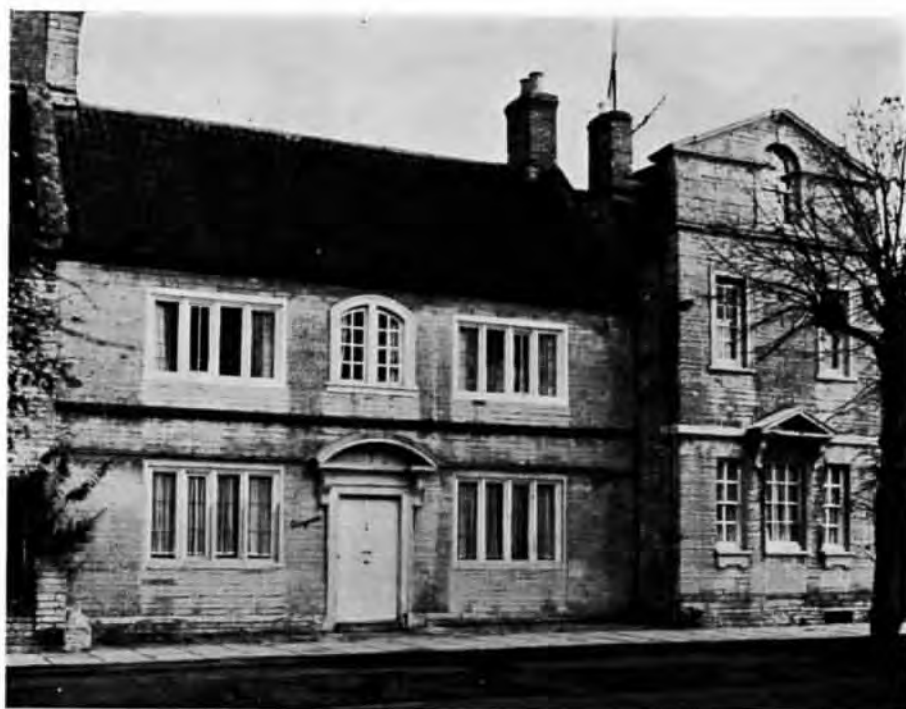
Plate 3. Craigmore, Somerton. Late 17C house with square-headed hollow mullioned windows under a stringcourse and added tall 18C wing; pediments are 18C, that on the left being an addition.

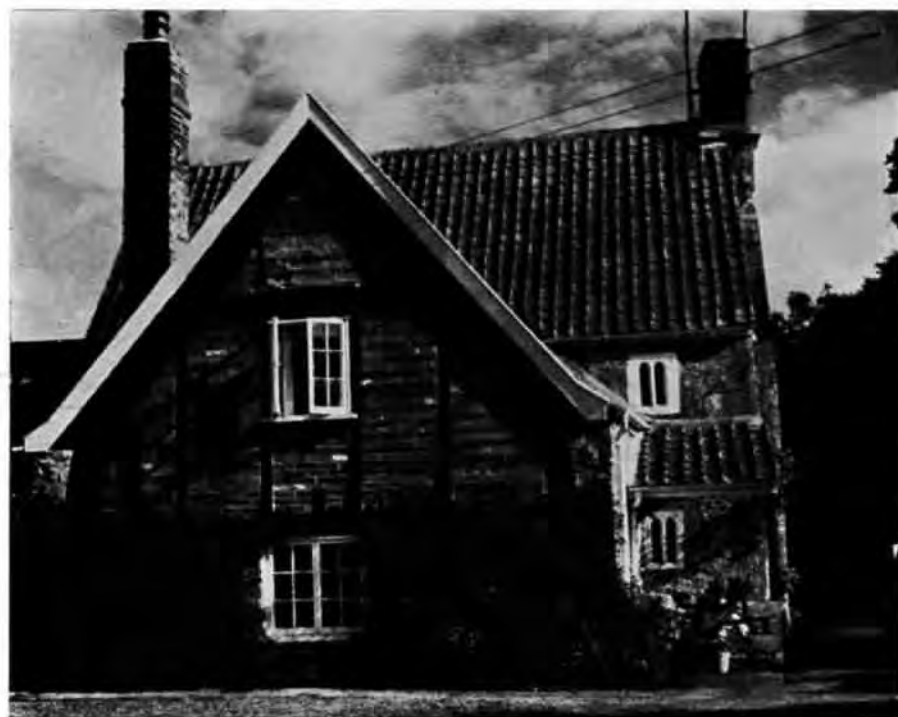
Plate 4. Redbridge Cottage, Standerwick, Berkley. Medieval cruck house partly replaced by early 16C wing forming a T plan. The only exposed cruck known in Somerset.

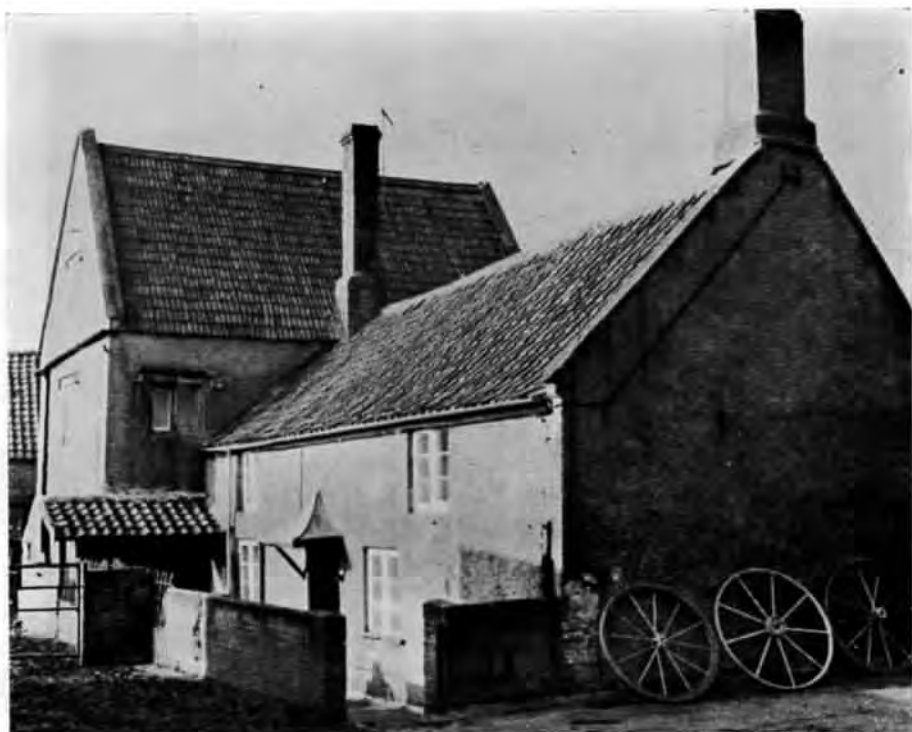
Plate 5. Burcott Manor Farmhouse, St. Cuthbert Out, Wells. Inner room of a medieval house replaced by a 17C wing giving a T plan.

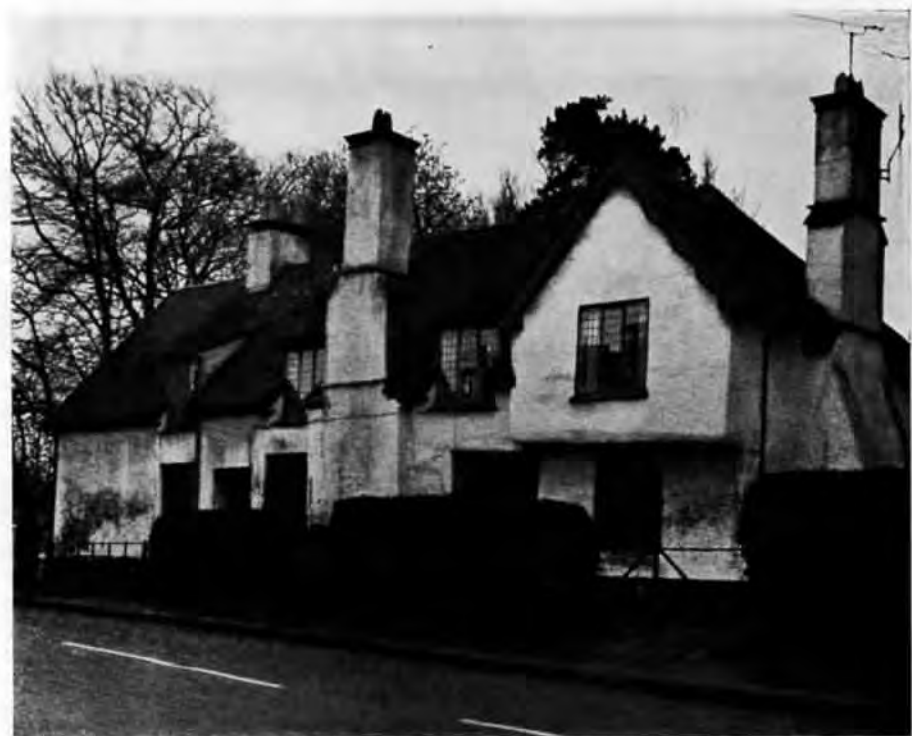
Plate 6. Gatchell Cottage, Trull. Early 16C lateral stack, later lower end stack and an addition beyond the upper end where a second door has been inserted. Lower end rendered over timber framing.

With certain exceptions mostly in towns, notably Taunton and Axbridge and to a lesser extent Bruton, timber construction is not now seen: an outstanding example is the George Inn at Norton St. Philip. Sometimes timber-built houses are recognizable under later rendering (Pl. 6) and these are mostly of the 15th and 16th centuries;

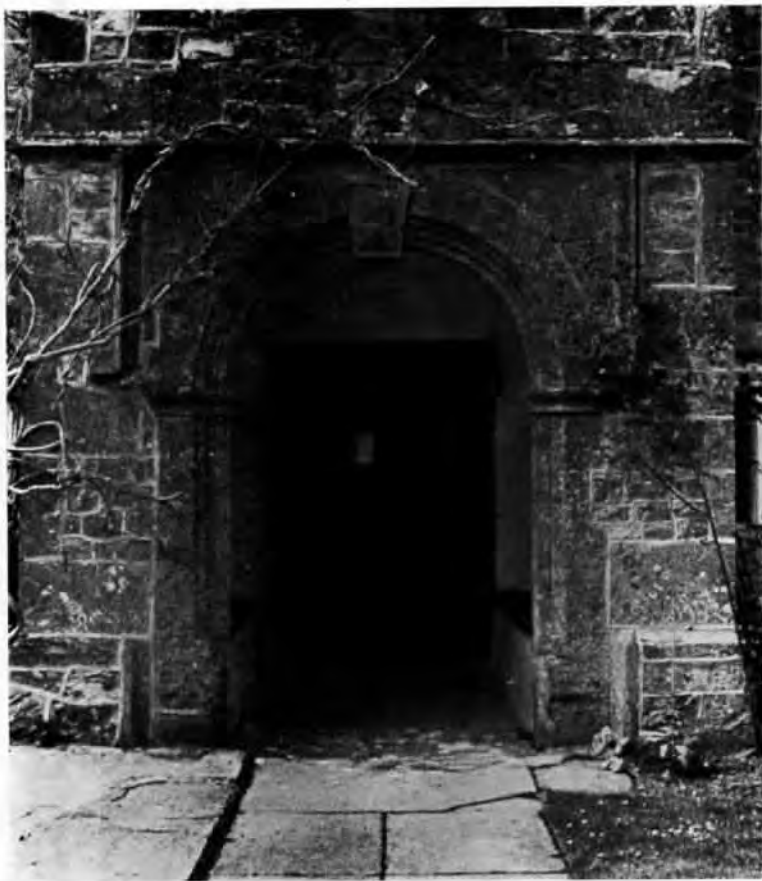
Plate 7. Weston Farmhouse, Combe St. Nicholas. 17C porch entrance with semi-circular head and dropped keystone.

- Fig. 10. Stone arch, semi-circular with projecting keystone, in porch openings of late 17th century (Pl. 7).
- Fig. 11. Square head, later 17th century or 18th century.

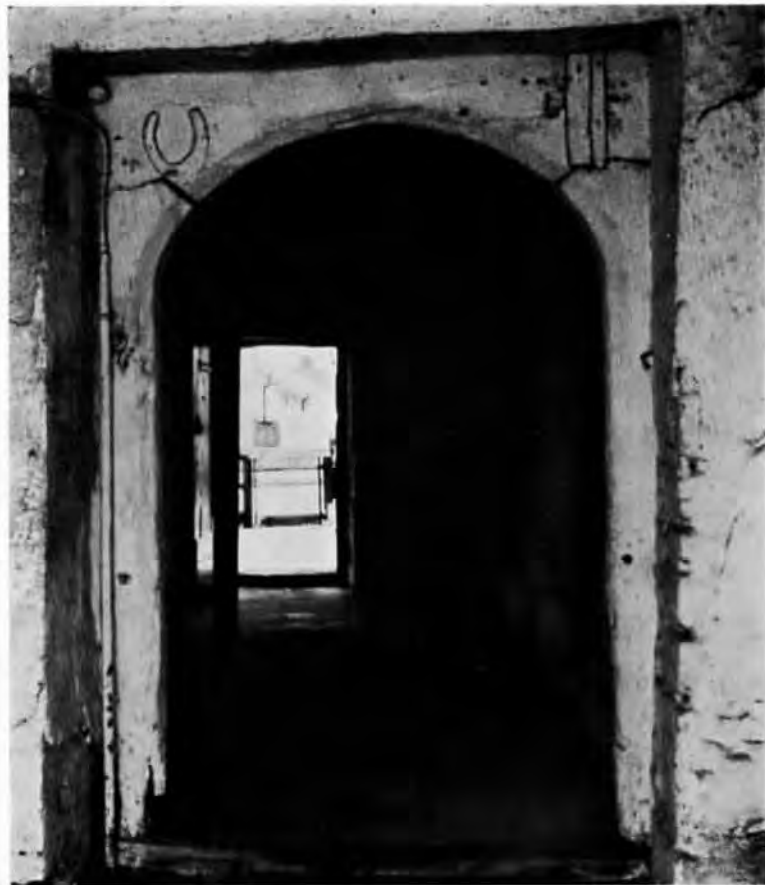
Plate 11. 115-117 Galmington Road, Taunton. Medieval three-centred doorway of the cross passage. (The house is now divided into three cottages).

- Fig. 1. Two-centred head typical throughout the medieval period (Pls. 8 & 9).
- Fig. 2. Ogee head (Pl. 10): late medieval.
- Fig. 3. Three-centred head (Pl. 11): late medieval.

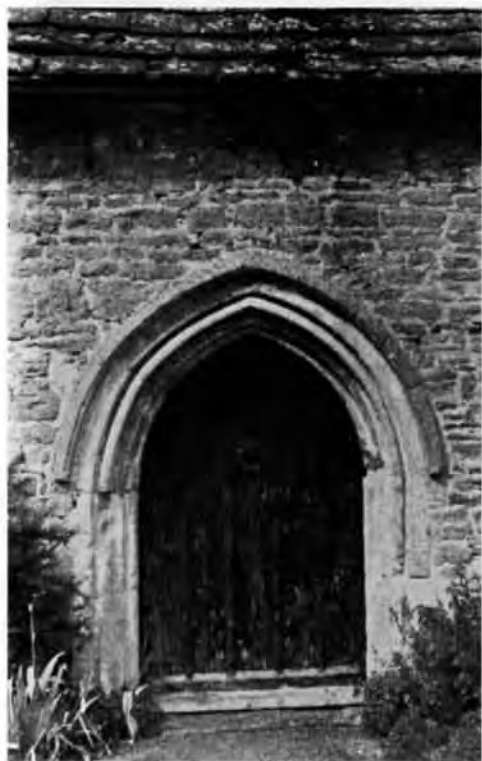
Plate 8. Wick Farmhouse, Norton St. Philip. Cross entry doorway of c.1300 with wave moulding and bulbous dripmould over two-centred head.

- Fig. 12. Medieval moulding was usually a simple hollow or flat chamfer but occasionally a more complex form is found, this one of the early 14th century (Pl. 8).

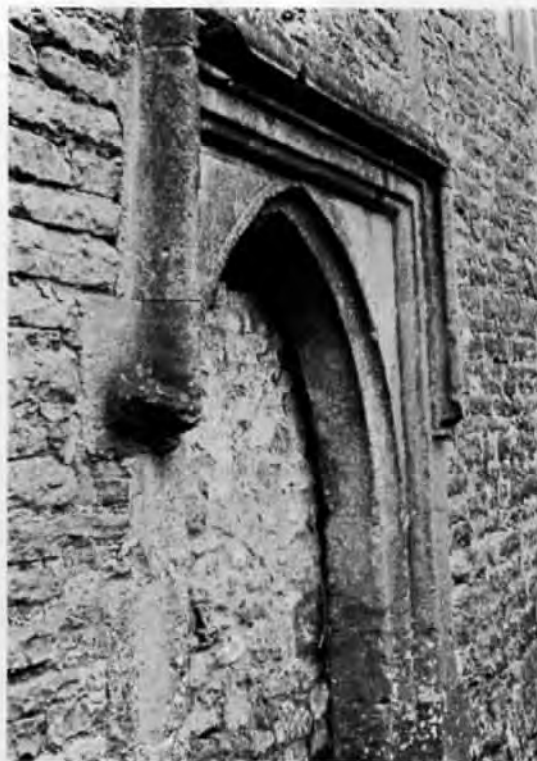
Plate 9. Manor House, Crocombe. Cross entry doorway of c.1400, hollow moulded two-centred head under angled dripmould.

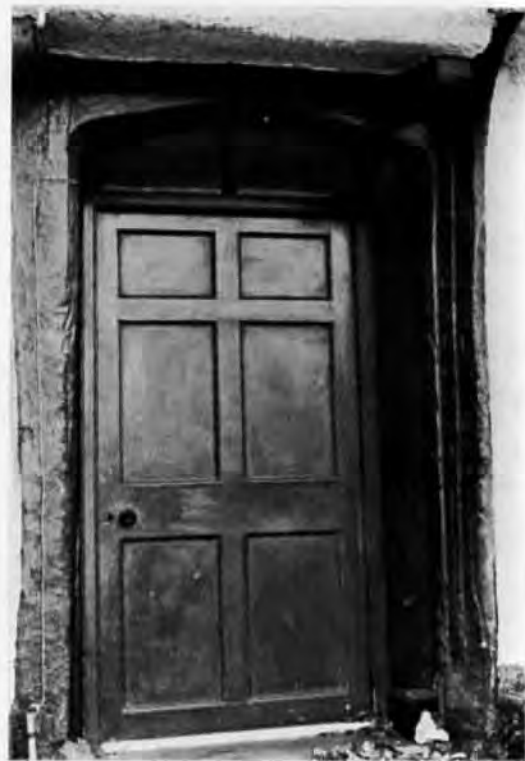
Plate 10. Gatchell Cottage, Trull. Late medieval ogee-headed doorway.

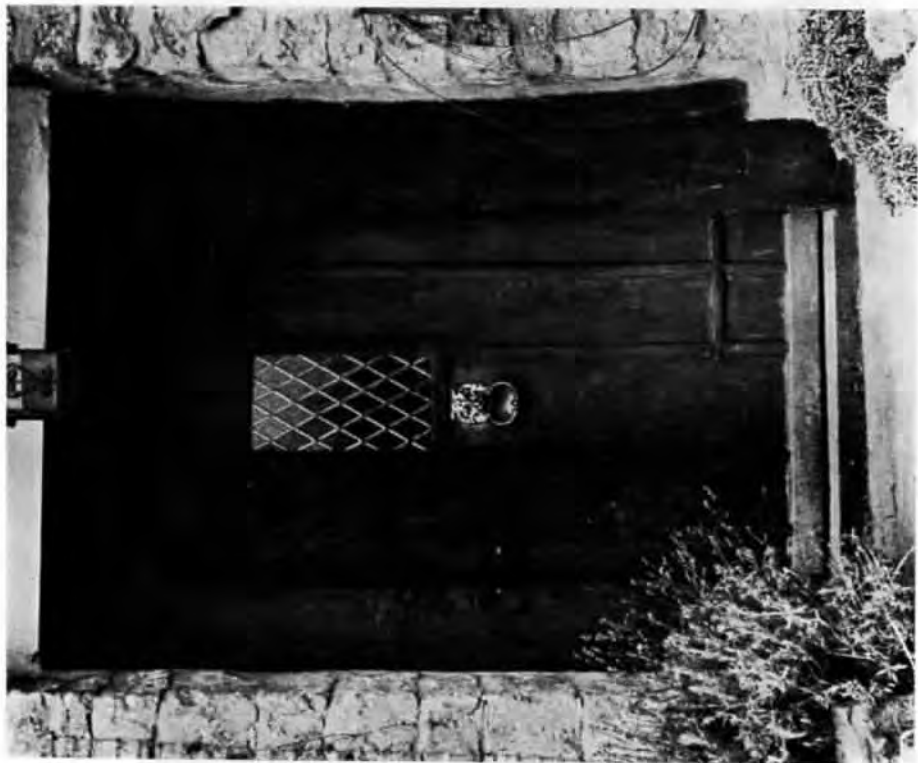
Plate 12. Farndon Thatch, Puckington. 15C shouldered doorway.

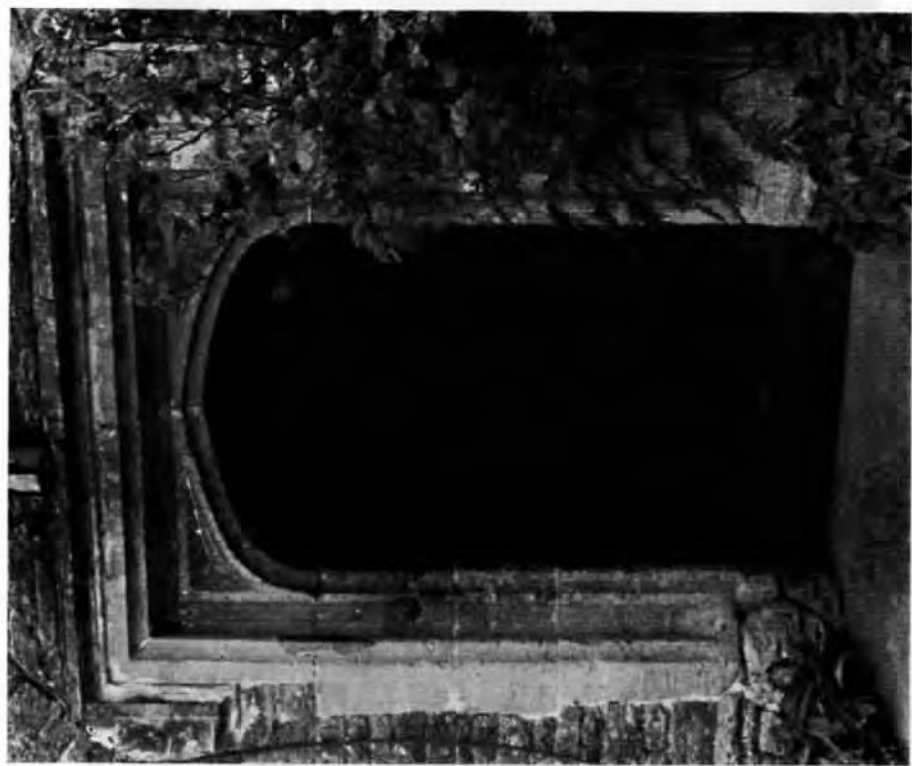
Plate 13. Highchurch Farmhouse, Hemington. Early Tudor four-centred doorway.

- Fig. 4. Shouldered posts and straight lintels in wood — 15th century (Pl. 2).
- Fig. 5. Typical Tudor four-centred head of the late 15th/early 16th centuries (Pl. 13).

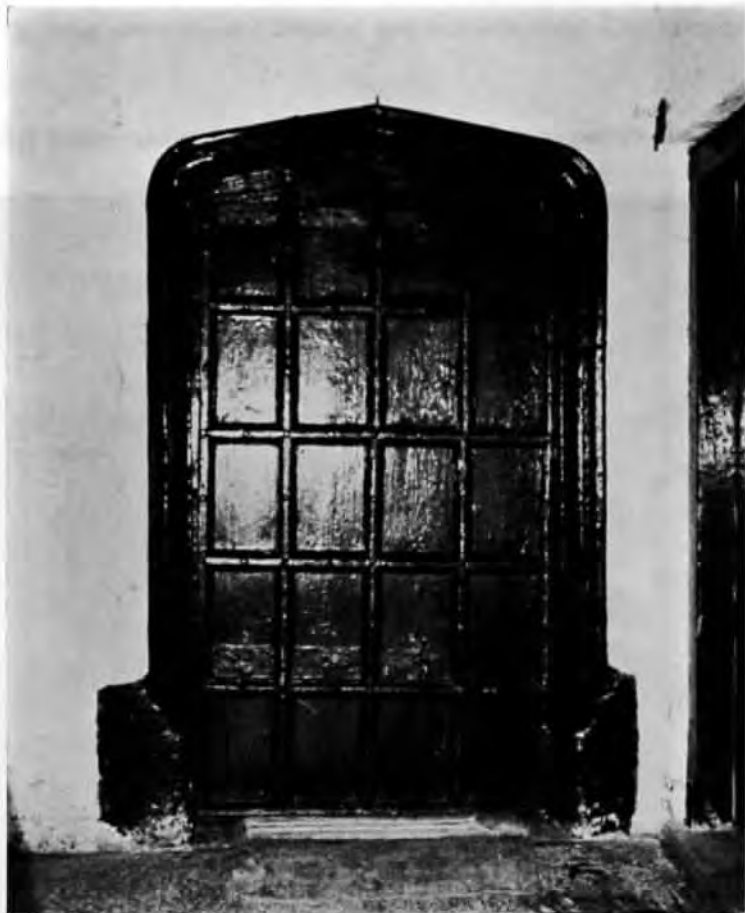
Plate 14. Hamwood Farmhouse, Trull. 17C depressed four-centred head, ovolo moulding and scroll stops.

- Fig. 6. Depressed four-centred head — late 16th/17th centuries (Pl. 14).
- Fig. 7. 'False four-centred' occurring in late medieval contexts in wood (Pl. 15).

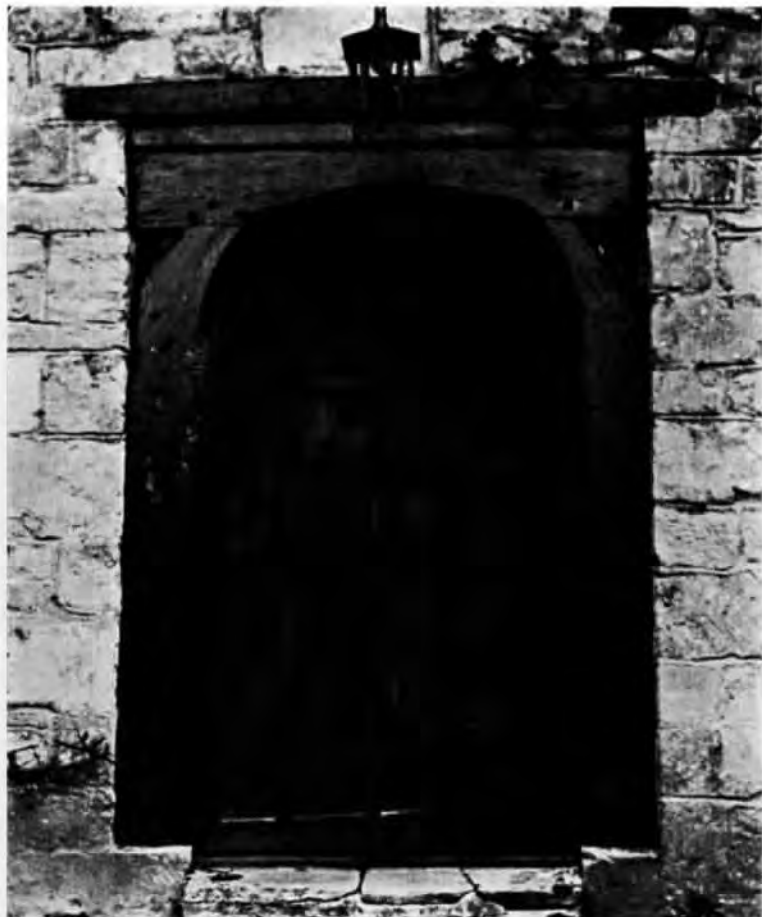
Plate 15. Old Cider House, Ilton. Late medieval false four-centred doorway.

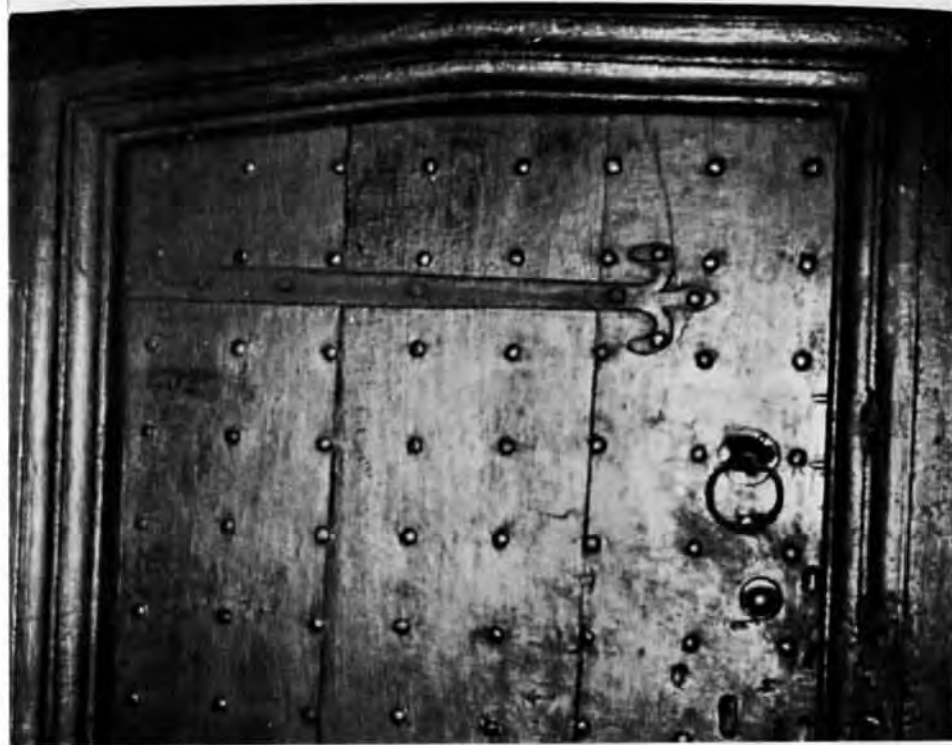
Plate 16. Broom's Farmhouse, Isle Abbots. 17C peaked-headed doorway with double ovolo moulding.

- Fig. 8. Peaked head (Pl. 16): occurring in the late 16th and 17th centuries in wood.
- Fig. 9. Segmental head: occurring in the late 16th and 17th centuries in wood.

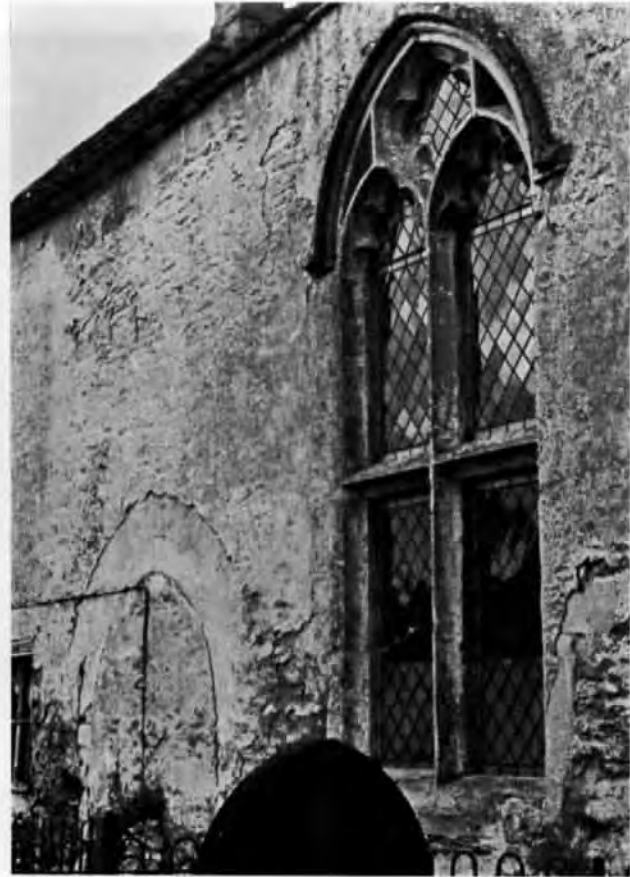
Plate 17. (right) Manor House, Croscombe. Hall window of c.1400. (Note blocked door at opposite end of cross entry to that shown in plate 9.)
