LOW SIDE WINDOWS IN SOMERSET CHURCHES

BY R. D. REID, B.Sc., D.Phil.

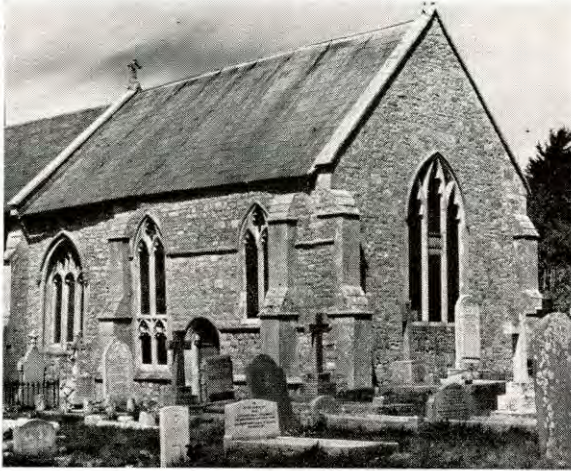
Top Left: Low Side Windows.
Plate VIa. Bleadon: East half of Chancel destroyed.

(7) *Bleadon* (Plate VIa). Here the window appears in a unique position in the middle of the south side of the chancel. In other respects too it is an interesting example. The chancel is lit on the south side near the altar with a typical 2-light 14th century window. Another, similar, is found further west. At about sill height, however, there is a transom. Below this and reaching down to the wall plinth are the two lights of the Low Side Window each with a trefoiled head. This forms the most elaborate example to be found in Somerset and perhaps elsewhere. Unfortunately the masonry has been renewed where the hinges would have come for the door. Further west in the chancel is a normal 3-light perpendicular window. These facts clearly show that the old chancel had its western termination with the Low Side Window and priest's seat just inside the chancel arch. It was extended westwards in the perpendicular period after an old central tower had been taken down. Thus the position of this Low Side Window contributes to an understanding of the history of the church.

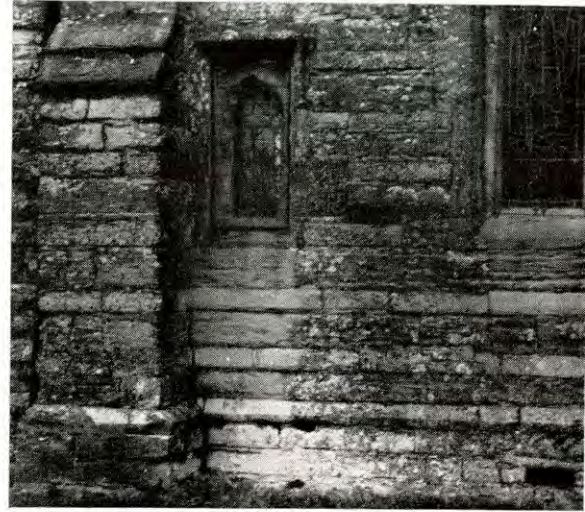
Top Right: Low Side Windows.
Plate VIb. Middlezoy: Window to Aisle altar.

(4) *Middlezoy* (the next parish) (Plate VIb). South aisle of *nave*. This nice example is generally

interesting because it is adjoining an altar in the south aisle of the nave. There is no such window in the chancel.

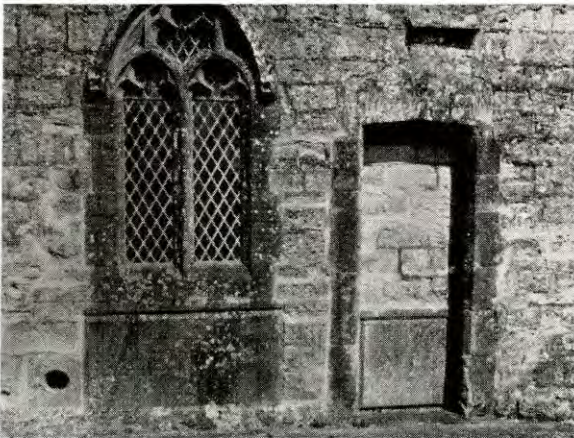
Left: Low Side Windows.
Plate VIc. Weston Bampfylde: Unusual position.

(11) *Weston Bampfylde* (Plate VIc). Here the "window" is quite near the floor but within easy reach of the seated priest. It strongly supports the ventilation theory.
