BUILDING RECORDING IN 2006

SOMERSET VERNACULAR BUILDING RESEARCH GROUP

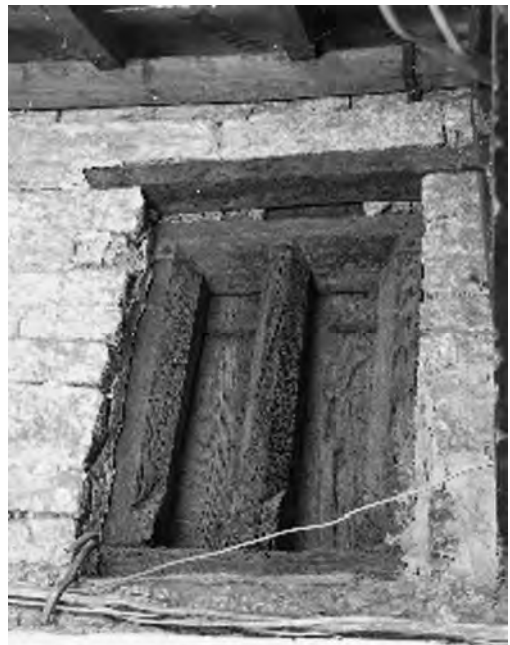
being the hall and the northern half the ‘low-end’ service room. On the evidence of the arch-braced jointed-cruck trusses, a date in the 15th century is indicated (based on similar tree ring-dated structures elsewhere in Somerset). The smoke-blackened roof extends over the northern (service) end and a fascinating detail is the survival of wind-eyes, which helped to disperse the smoke (Fig. 1). SVBRG has not previously recorded examples of these in Somerset and three survive here, two having their

*Fig. 1 Blackberry Farmhouse, Baltonsborough,
‘wind-eye’*

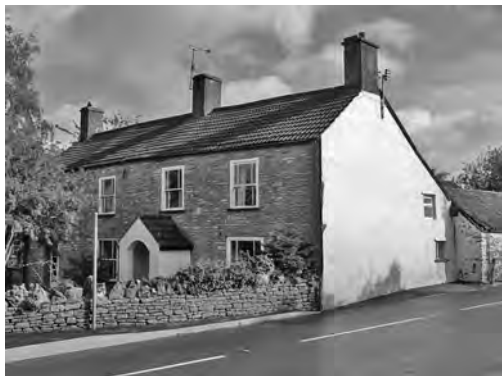
Fig. 2 Gilcombe House, Blagdon

The house comprises a two-storey main part with two one-and-a-half storey lean-to additions on the east and a single storey on the north gable (Fig. 2). Originally, the house was a two-unit gable entry plan, one room being an unheated service room, dating from the 16th century. The house had an upper floor from the outset and would then have been one-and-a-half storey. In the early/mid 17th century the house

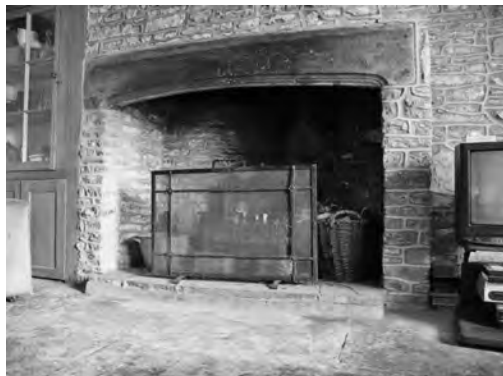
Fig. 3 Gilcombe House, Blagdon, fireplace with moulded bressumer

was upgraded with a room with an elaborate ceiling and a fireplace with a moulded bressumer (Fig. 3), added at the south end. However, for reasons that are unclear, the west wall is misaligned with the existing building. The whole house was upgraded in the 18th century. Stairs were inserted and the upper floor was rearranged and the eaves and roof raised. The service rooms on the east side were probably added at this time as a kitchen, perhaps a bakery, and separate access to the servant quarters. (This house was also surveyed by E.H.D. Williams in 1982, who came to slightly different conclusions, but at that time did not have access to the roof.)

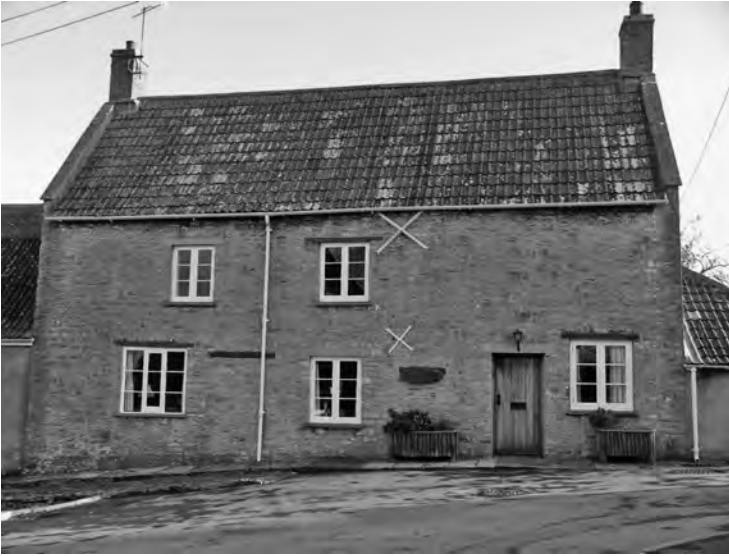
Fig. 4 Walnut Tree Cottage, Blagdon

The house is two storeys, four units with additions (Fig. 4). It was originally based on a two-unit plan with entry directly into the living room, and two unusually large service rooms. The stair is of solid baulk construction and its position is uncommon, but known from a few other examples in Somerset (Fig. 5). The details suggest a date in the 17th

century. The north extension was probably a stable built in the 18th century. In the 19th century, the house was divided into two and further alterations and additions made at that time. (This house was also surveyed by E.H.D. Williams in 1990.)

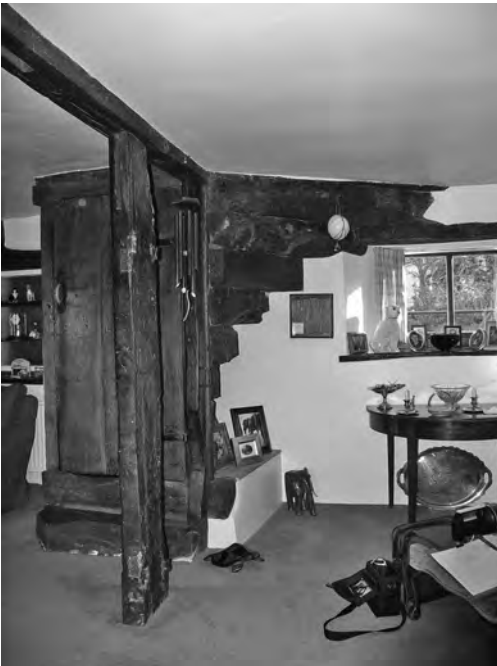
Fig. 5 Walnut Tree Cottage, Blagdon, staircase

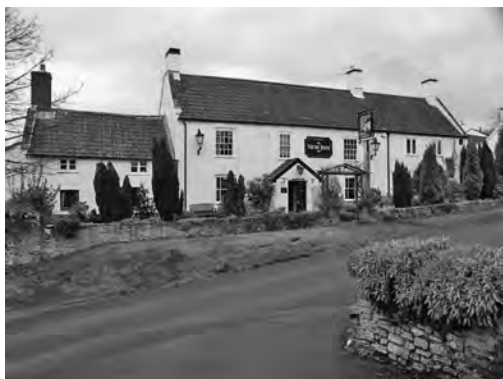
Fig. 6 New Inn, Blagdon

The building comprises three in-line elements, divided by chimney stacks, to which have been added various outbuildings and extensions (Fig. 6). The original unit at the north end appears to have been a simple one-and-a-half storey dwelling with a single ground-floor room. On the limited evidence it seems to date from the early 17th century. The next part appears to have been built as two storeys from the outset, with two ground-floor rooms. Although much altered, this appears to date from the mid/late 17th century. The last main part at the southern end was built as a two-storey single-room cottage, probably dating from the 18th century. Owing to so many later changes, it is not entirely clear what the function and interrelation of each unit was.

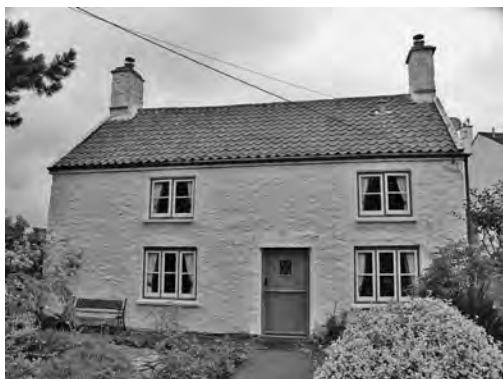
Fig. 7 The Old Saddlery, Blagdon

The house has an almost square plan of double-pile form (Fig. 7). The thickness of the west wall and the slightly wider west range suggests that it is the earlier part, probably of the late 17th or early 18th century. Originally this would have comprised two units divided by a partition. The door opened directly into the living room and the smaller part would have been an unheated service room. Possibly in the mid 18th century, the east range was added, perhaps replacing a lean-to extension. The date stone of 1727

on the south-west chimney stack cannot be *in situ* as the original building was unheated at that end. It may have been relocated when the house was enlarged.

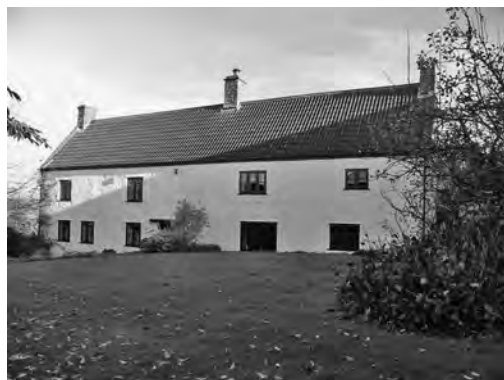
Fig. 8 Court Farmhouse, Blagdon

The house is two storeys with four units in line together with a staircase turret and a part-storied east wing (Fig. 8). The original house was one-and-a-half storey comprising hall and inner room with two chambers over. The common-rafter roof and the details of framed ceiling, beams, etc. indicate an early 16th-century date. This plan form including a central stair turret has been found elsewhere in north Somerset (Fig. 9). The northern part, approximately the same size, was added in the mid 17th century. A large kitchen wing, including a curing chamber, was added late in the century, probably to provide extra service for the northern addition. The house is no longer a farm and the farm buildings have been converted into housing.

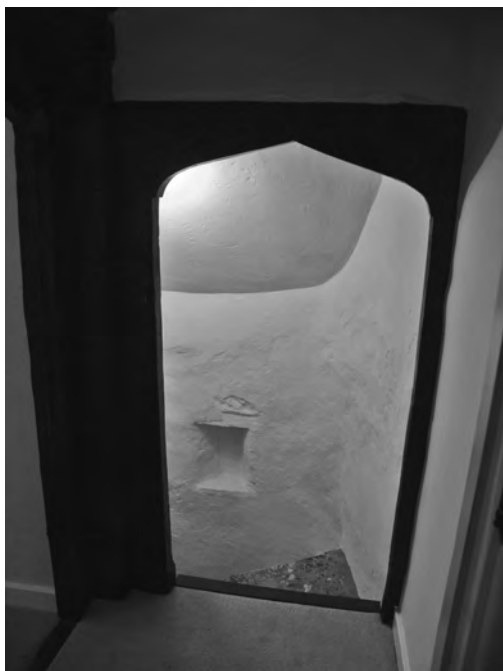
Fig. 9 Court Farmhouse, Blagdon, stair turret

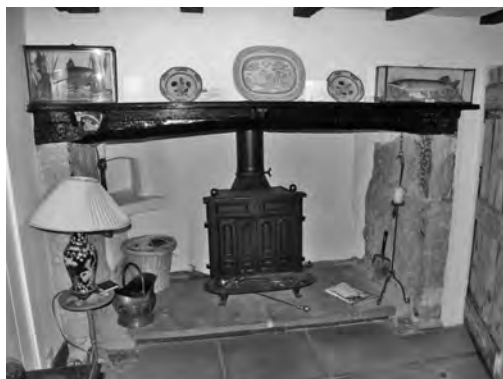
The plan is three rooms in line with an out-shut at the rear under a lean-to roof. On the evidence of construction details the core of the house dates from

Fig. 10 Dunn's Castle, Buckland St Mary, 17th-century fireplace

the early 17th century (Fig. 10). At that time there appears to have been no cross-passage or a substantial fireplace for a kitchen, so the house probably comprised a living room, parlour (perhaps unheated) and a stair turret in the out-shut giving access to the chambers over. In the late 18th century, a room to the north was added with adjoining service rooms. At this time it appears to have been divided into two dwellings.

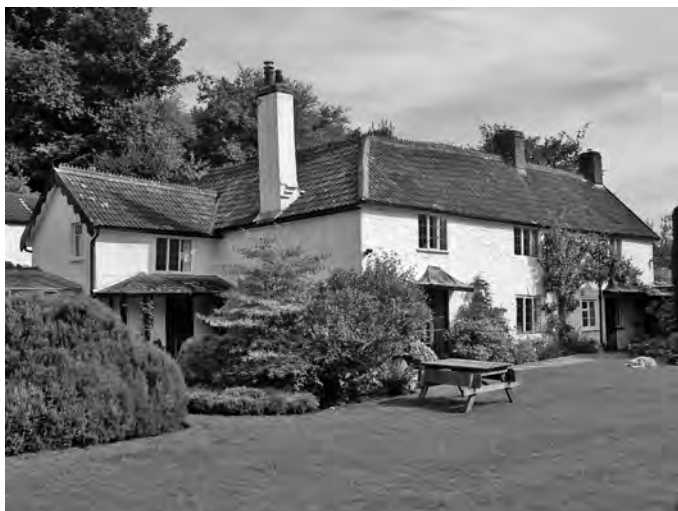
Fig. 11 Burnside, Combe St Nicholas

Originally this property was owned by the Dean and Chapter of Wells and sold in 1794. It stands adjacent to Wadeford Mill. The house is two storeys and the oldest part, the north–south range, appears to date from the 18th century (Fig. 11). Whether it was built as a dwelling or part of the mill complex is unclear. It lacks a large kitchen fireplace, but this might have been at the south end, which has been rebuilt. Later in the 18th century the east–west range was added. Part at the rear was probably enlarged in the early 19th century to incorporate a new flight of stairs – indicated by the gothic style of the window and stair. A further addition at the north-west was made in the late 19th or early 20th century.

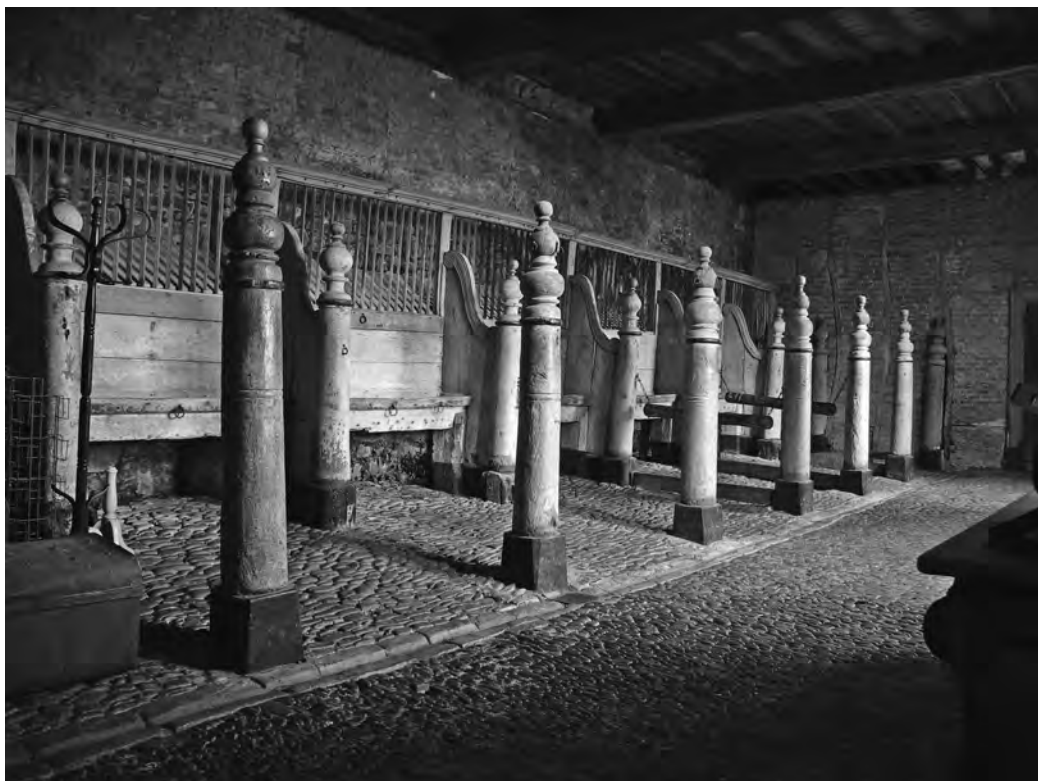
Fig. 12 Dunster Castle, stables

George Luttrell by William Arnold ... in about 1617'. However, this early date has been disputed by others. SVBRG were asked by the National Trust to survey this building, which is built of local rubble stone and the entire roof structure is comprised of collar-trusses. The outstanding feature is its complete interior with all the original stalls in place (Fig. 12). From the survey of the roof, windows and other details it was possible to confirm an early 17th century date.

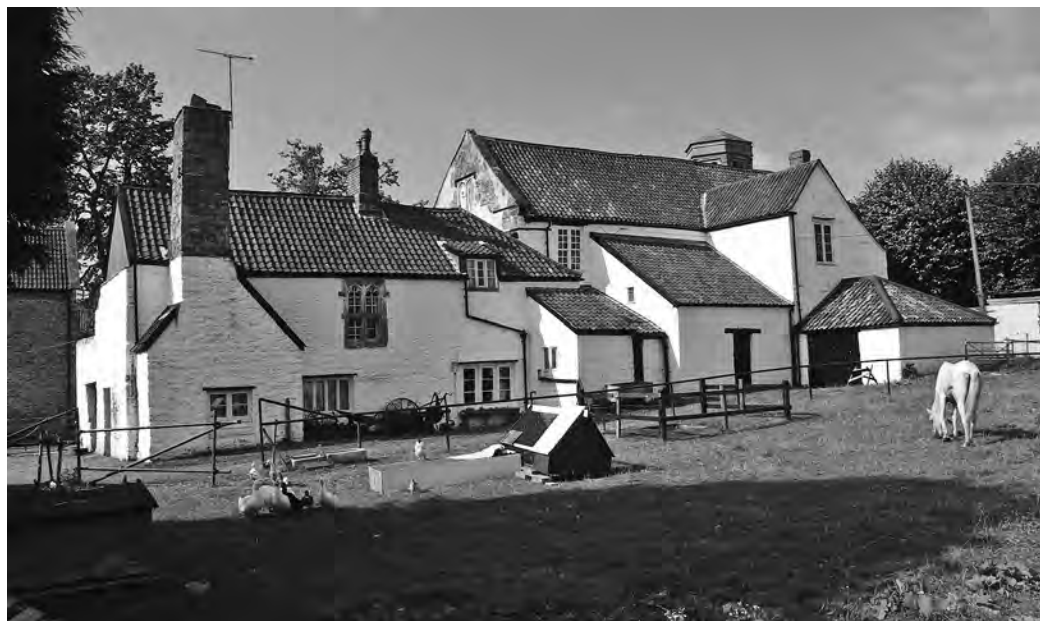
Fig. 13 Court Farm, Portishead, 15th-century range

court sittings in some style in 1624, possibly in this house. The plan comprises two main parts, to the east, an L-shaped unit of two storeys (Fig. 13) and, to the west, a larger unit of two storeys and attic, with a two-storey porch on the south elevation (Fig. 14). The eastern unit is almost certainly 15th century, originally perhaps three rooms with a cross-passage and a lateral stack. The absence of smoke-blackening of the decorative arch-braced collar roof with wind-braces and cornice suggest that the upper floor existed from the outset. Further alterations took place in the 16th and 17th centuries. Regarding the western unit, the style of the roof structure and the details suggest a date in the early 17th century. For example, the use of convergent stops on moulded beams is found in Gloucestershire from the early 17th century, but is not commonly found in Somerset. The proportions and details of this part, particularly the ceiling heights, suggest that it was not erected as a domestic dwelling. Thus it might be inferred that the builders were Bristol Corporation, who it is recorded had a grand opening in 1624. A hexagonal tower is attached to the south-west corner, built later in the 17th century. The date 1751 below the attic stairs indicates that alterations or repairs took place at that time.
