Building recording in 2016

Somerset Vernacular Building Group

BUILDING RECORDING IN 2016

SOMERSET VERNACULAR BUILDING RESEARCH GROUP

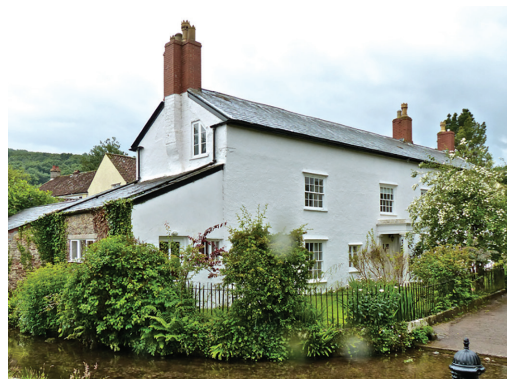
1. Burrington. Rickford, Brook House. ST4857 5952

Fig. 1 Burrington. Rickford, Brook House from NE

A listed property. The house is two storey with attic under a pitched, slate clad roof. The ground floor comprises four rooms in-line with a stair hall separating pairs of rooms. There are single room, single storey structures on the east gable and the south, rear, side. A Doric porch protects the six-panel front door that opens into the stair hall. Built of local rubble the exterior is rendered and painted. Wall thicknesses vary from 75cm to 49cm indicating several phases of build.

The shallow pitched roof is carried on softwood timbers. This over-sails and is supported by an earlier roof: six elm tie beam trusses linked by a single tier of off-set purlins, fixed into the principals with tusk tenoned joints, typical of late 18th-century construction.

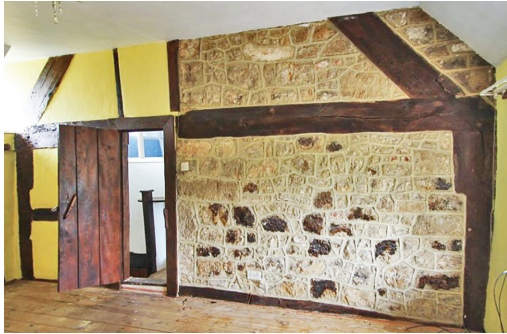
2. Donyatt, Chard Rd, Thatchers Pond. ST3401 1359

Fig. 2 Donyatt, Chard Rd, Thatchers Pond Frame FIII and truss with masonry replacing a possible fire hood of wattle and daub

The main roof is supported on elm structures; the major part by timber frames. Frame FIII, part infilled by stone, is a tie beam truss supported on jowl posts that form part of the plank and muntin partition in the cross passage below. The tapered principals are fixed to the tie and there are two tiers of in-line trenched purlins. The ridge is set diagonally on a raised and offset nailed yoke.

At FII the frame is based on a long tenon jointed cruck; the principals meet at a plain tenoned apex, and a high collar is tenoned into them. The ridge

piece is set diagonally in a V-notch. FI is now replaced by a stone wall. Frames at FII and FIII remain partially infilled with wattle & daub. The single stair is a 'winder' from the Hall.

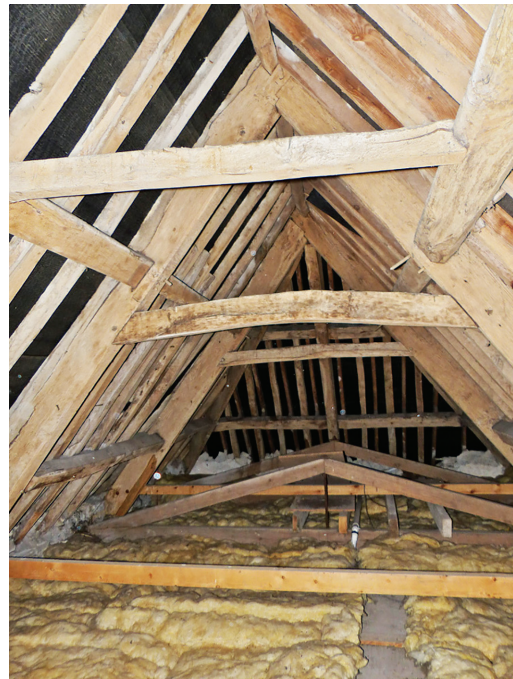
3. Doultong, King's Rd, Hurlingpot Farmhouse. ST6462 4407

Fig. 3 Doultong, King's Rd, Hurlingpot Farmhouse, the roof trusses and the shallow hoist truss

The slate clad roof is built of substantial oak timbers to a high quality and is hipped at the front and side elevations with an infill pitched roof above the stair hall. It is supported on four collar and tie beam trusses. Within the roof space, over a north rear room, are two shallow softwood trusses with an iron rod kingpost, probably part of a cheese hoist.

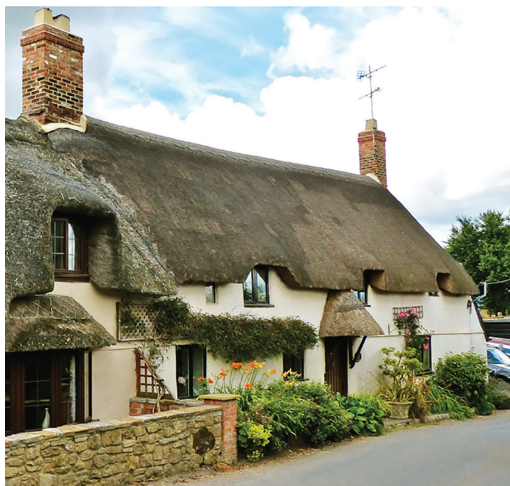
4. Kingsbury Episcopi. Burrow Hill, Troth Cottage. ST4137 1995

The house is one and a half storey under a thatched roof; a three-unit range with modern single storey extensions. A masonry base supports cob walls 53cm thick that are rendered and painted. The living space is divided by rod and daub partitions, the central unit being an unheated service room, now the location of a central stair.

Fig. 4 Kingsbury Episcopi. Burrow Hill, Troth Cottage, north elevation

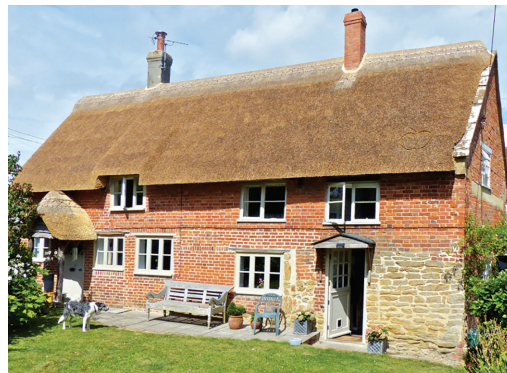
5. Kingsbury Episcopi, East Lambrook, Townsend Cottage. ST4311 1904

Fig. 5 Kingsbury Episcopi, East Lambrook, Townsend Cottage, south elevation

A listed property. The house is one and a half storey, four rooms in-line, under a thatched roof. It is largely built of brick laid in Flemish Bond some 40cm thick, but sections of masonry walling, 45-50cm thick, and cob are evident. A thatched bonnet porch protects the front door.

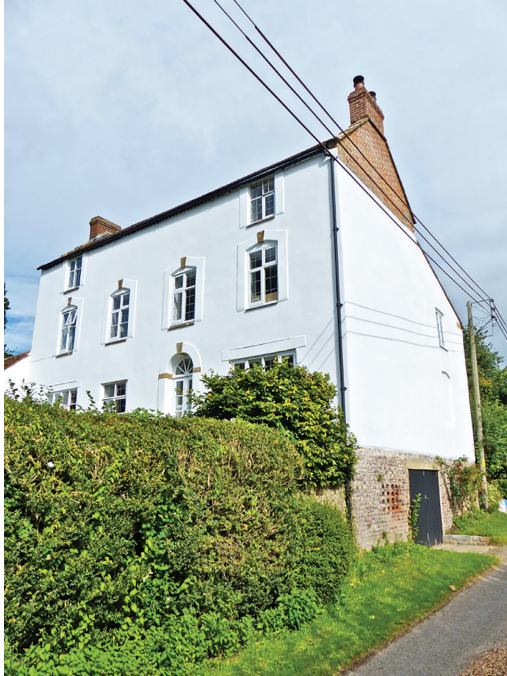
6. Kingsbury Episcopi, Mid Lambrook, The White House. ST4228 1853

Fig. 6 Kingsbury Episcopi, Mid Lambrook, The White House, south-east elevation

The house is brick built (Flemish Bond). The 40cm thick walls are rendered and painted on all elevations. The distinctive windows of the front elevation have a raised surrounds and keystone decorations. The roof is supported on four collar trusses. The principals meet at the apex in a notched tenon joint, a single tier of staggered purlins are fixed with tusk tenon joints. Stylistic evidence suggests that the house dates from the late 18th century or early 19th century.

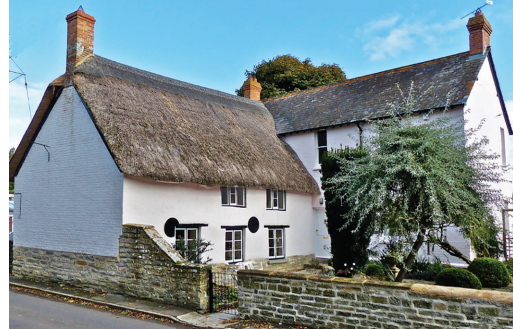
7. Kingsbury Episcopi, Thorney, The Old Rising Sun. ST4271 2278

A listed property. Once a public house and recorded as a Beerhouse in 1851, it is 'L' shaped and comprises two units. Initially it was a cob-built, one and a half storey two-room range under a thatched roof with gable end abutting the road and dating from the mid 17th century. The gable end is now built of brick in Flemish Bond on a masonry plinth. The cob walls

Fig. 7 Kingsbury Episcopi, Thorney, The Old Rising Sun, south-west elevation

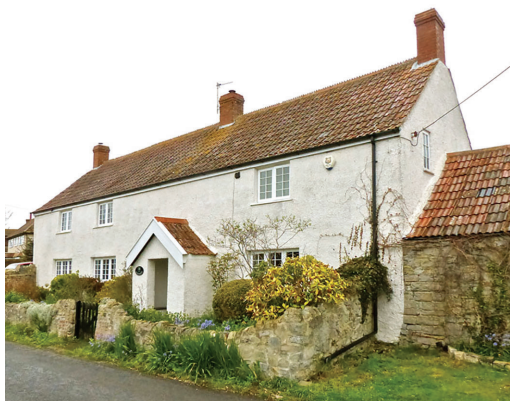
8. Pawlett, 14 Gaunts Rd, Doidges House. ST2990 4277

The house comprises a three room front range of one and a half storeys, with a single storey attached barn at the eastern end. At the rear is a single storey, two room range and a further domestic room under a catslide roof. A single stairway, behind the entry lobby, accesses the first floor. The elevations are rough rendered and painted with the exception of the local lias stone barn. The roofs are clad with double roman clay tiles and the front range has cocks-comb ridge tiles. A gabled porch protects the front door.

Fig. 8 Pawlett, 14 Gaunts Rd, Doidges House, south elevation

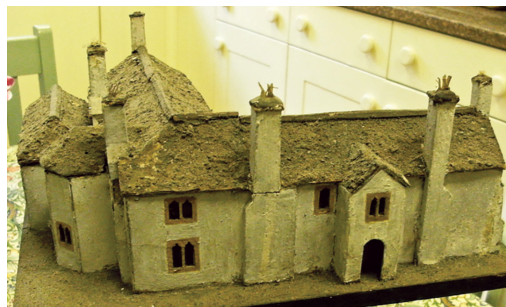
9. Selworthy, Crossacres. ST9188 4672

Crossacres is constructed from local mixed Devonian rubble, visible on the west gable, otherwise obscured by painted render. The long walls of this rectangular building and the west gable are 100cm thick, possibly dating from as early as the 14th century. The model shows a storied porch that may have dated from the 15th century. In the late 18th century the building was repaired and the current roof is of that period having five

Fig. 9 Selworthy, Crossacres the early 19th-century model of the house seen from the north

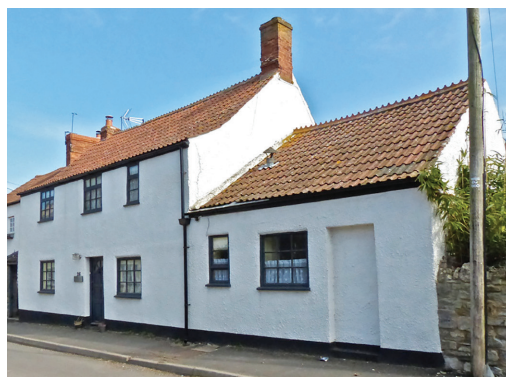
10. Stogursey, 26, Lime St. ST2032 4303

Fig. 10 Stogursey, 26, Lime St, west elevation

The main house is two-storey under a pitched roof. There is an in-line single storey former work-shop on the south gable and to the rear are rooms within a lean-to structure. The house is built of local rubble, rendered and painted. The roof is clad with double roman tiles capped with cocks-comb ridge tiles. There is a blocked doorway in the street wall of the single storey building.

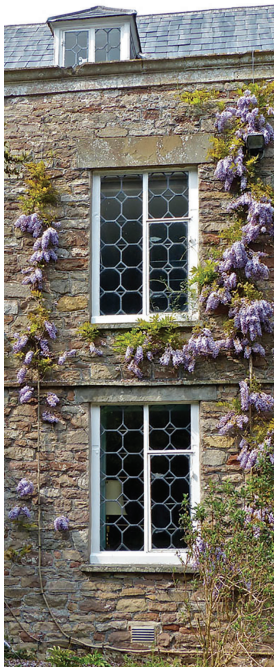
11. Walton in Gordano, The Manor House. ST4354 1681

Fig. 11 Walton in Gordano, The Manor House, octagonal glazing and parapet cornice

The house is largely built of local pennant sandstone with some ferriferous conglomerates. The masonry is exposed on the south and west elevations. A classic, but recent, Doric pillared porch protects the front entrance, complementing the symmetrical façade. The roofs are slate clad with chimney stacks in intermediate and gable locations. A plain string course lies above the lower window lintels; above the upper windows the wall rises to a shallow parapet with a cyma corniced coping.

Domestic activities were relocated to the new western extension of the house in the late 18th century or early 19th century and may have coincided with a reworking of the main roof and the introduction of the decorative glazings of the front windows. The range of domestic buildings at the west end shown on the Tithe map was significantly reduced in the mid 20th century.

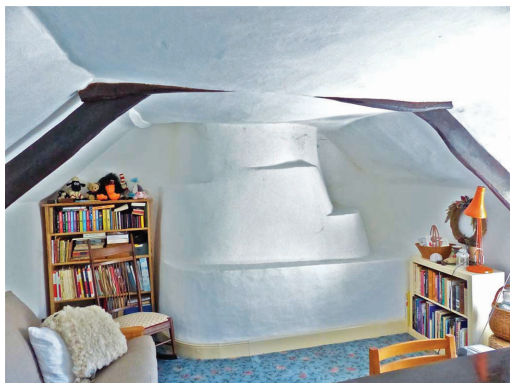
12. Wambrook, Beechwood. ST2764 0809

Fig. 12 Wambrook, Beechwood, rounded and stepped stack at first floor level

On the first floor the stack is rounded with stepped construction; this feature seems to be associated with the absence of regular shaped stone and has been noted in Mendip and Blackdown houses.

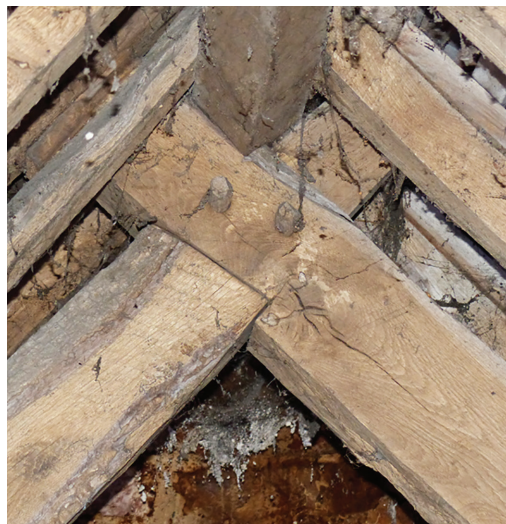
13. DEVON. Tytherleigh, Chard Rd, Penny Cottage & 2, Pinney Cottage. ST3185 0331

Fig. 13 Devon, Tytherleigh, Chard Rd, Penny Cottage & 2, Pinney Cottage, the halved and pegged truss apex

The main roof, half-hipped at the western end, is clad in bands of plain and fish-scale clay tiles. The primarily ash-timbered roof of the western two units is carried on four collar trusses, the halved and extended principals are pegged at the apex and carry the ridge. A single tier of trenched purlins supports the common rafters.
