# BUILDING RECORDING IN 2012

SOMERSET VERNACULAR BUILDING RESEARCH GROUP

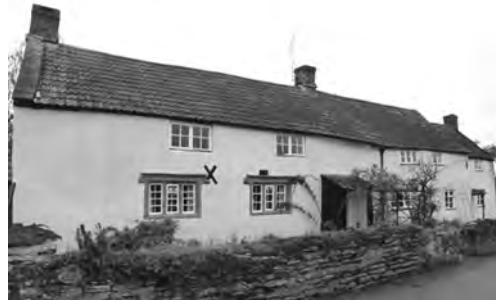
Plan: five rooms in line with a single storey lean-to along the entire rear (north) wall. The earliest elements are an inner room separated from the hall by a post and daub partition that supports a jettied floor within the hall. In line with the jetty beam is the residual foot of a true cruck recently

*Fig. 1 Curry Mallet, Colliers & Collier's Cottage (photo Ann Heeley)*

dendro-dated to 1474-1506, a much later dating than previous recorded examples. The house appears to have been extensively rebuilt in the early 17th-century as all the beams have 10cm flat chamfers and all terminate with step and run-out stops. To the west of the hall is an area that once comprised a cross passage and service rooms and to the west again is the kitchen with an inglenook fireplace incorporating a baking oven beneath an integral stone stair. Within the hall and backing onto the cross passage, a fireplace was created with a timber fire-hood, later replaced with a stone structure. Another room was created at this time to the east of the inner room. A pair of stone mullioned windows were introduced to give a balanced façade in the mid 17th-century and in the 18th-century the roof and upper windows were raised and the lean-to added. (Fig. 1) In the 19th-century the houses was divided into three dwellings.

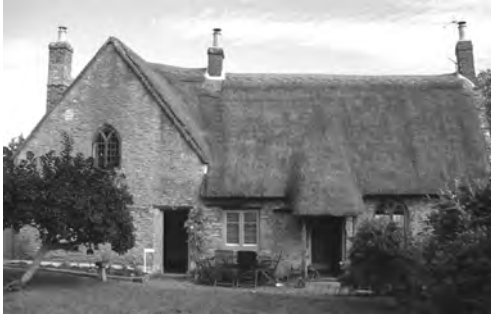
Fig. 2 East Coker. Moor Lane, Chapel Cottage & St. Roche Cottage (photo Mike Hargreaves)

Plan: Chapel Cottage comprises the three rooms in-line N-S front-range and the NE wing, formerly the Chapel. St. Roche Cottage comprises the two rooms of the NW wing. All walls are of local stone rubble with Hamstone quoins and dressings and rise to one and a half storey under a thatched roof set between coped gables. (Fig. 2) Dating from the early 17th-century both St Roche Cottage (Beam 2, concave chamfers with step & run out stops and Fireplace 1, wooden bressumer with 5cm chamfer and peaked-headed form) and Chapel Cottage (closed, side-pegged, long-tenoned jointed-cruck truss with notched apex) were possibly built as single unit one-and-a-half storey dwellings. In the mid 17th-century Roche Cottage was extended to the west (Beam 4, 6cm deep, flat chamfer & cyma stop). This latter extension and the core of Chapel Cottage were linked in 1713 (date stone). The one-and-a-half storey additions of both wings- one the Chapel in the 19<sup>th</sup>-century

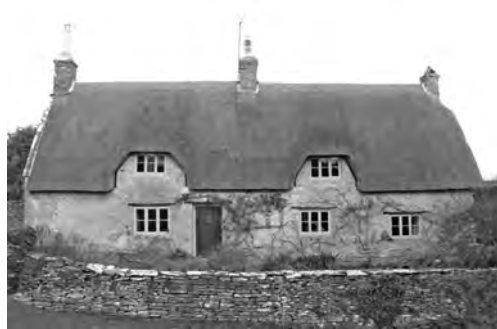
Plan: three-rooms in-line and one-and-a-half storeys with a 2-storey north wing. (Fig. 3) The rubble-stone (Forest Marble) walls have an internal inward-sloping batter. The thatched roof is supported by three long-tenoned side-pegged jointed-cruck trusses. The principals are joined by cambered collars with a straight-cut mortice-and-tenon apex joint. Curved wind-braces sit between the lower and upper purlins. All joints are wood pegged. A 15th-century date of build is suggested; smoke blackening and

Fig. 3 Longburton (Dorset), Spring House (photo Mike Hargreaves)

roof structure detail, particularly the jointed-cruck trusses. Single-storey, it comprised a hall with central hearth and a head height partition dividing it from an unheated inner room, itself partitioned axially to create a buttery and a parlour. A solar chamber, accessed by a ladder, had a jetty projection into the hall. In the west service-room (kitchen/brewhouse), the lack of smoke blackening suggested a substantial smoke-bay; late 16th-century this bay was replaced by a stone stack, stairs and curing chamber. A smoke-hood was installed in the hall against the cross-passage; an upper floor was installed throughout, lit by small windows. Early 19th-century the walls were raised and dormer windows inserted; the solar chamber may have been provided with a fireplace; new stairs were installed and a baking oven replaced the curing chamber. The inner room may have been used as a byre/milk house prior to the building of the substantial 2-storey stone NW wing, extant by 1843 (Tithe Map). The 1891 Census suggests that the farmstead may have been downgraded to 3 units of accommodation. In the early 20th-century it was sold from the Digby Estate as a 'Gentleman's Residence'.

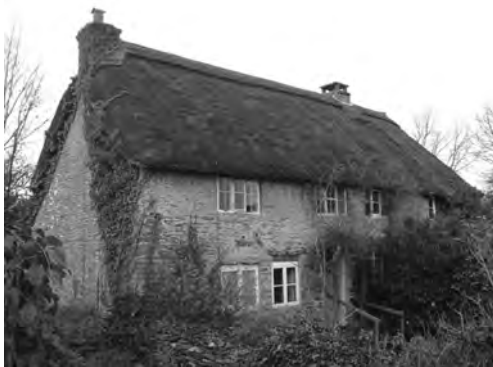
Plan: one and a half storey, two-room (hall and inner room) with gable entry. The depressed 4-centred head to this gable doorway is jointed to the jambs with an angled mortice and tenon joint (*ca.*1500); the door is double-planked, held with battens and supported on iron strap hinges and pintles. A post and panel partition (set on a rubble-stone plinth 16cm high), details of a jointed cruck

*Fig. 4 Longburton (Dorset), Well Cottage  
(photo Mike Hargreaves)*

truss with former trenched-purlins, two fireplaces with slightly cambered timber lintels and 4 -5 cm chamfers, the beams (6 - 8cm chamfers with run-out and/or shallow step and run out stops) and the 68-75cm thick rubble-stone walls under a thatched roof indicate an early 16th-century date. (Fig. 4) In the mid 19th-century the walls and roof were raised and the north end room and additional windows inserted creating accommodation for two households.

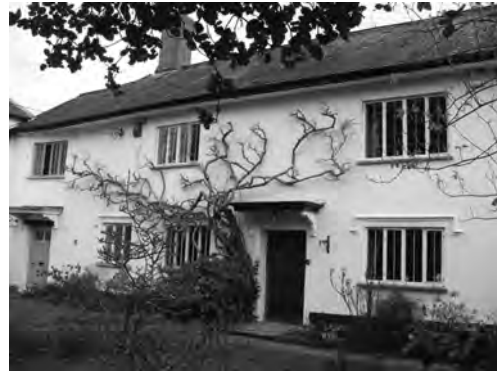
Plan: two rooms (kitchen/living room & parlour) divided by a central passage and rising to two storeys. To the rear are two wings (the NW may be part of the original build) with an enclosed passage way between them. The early phases of development are uncertain; wall thickness, a concave chamfered beam, two of the fireplaces (F1 cambered bressumer with hollow-step-ogee chamfer, anvil stop on the orthostatic jamb, F2 5 cm chamfer & run out stops to the bressumer and pyramid stops to the orthostatic jambs) plus hood moulds over the mullion windows suggest the early 17th-century. (Fig. 5) Similarity of

*Fig. 5 Lydeard St. Lawrence, Manor House  
(photo Mike Hargreaves)*

roof trusses in house and wings and beaded wooden mullions suggest that the property was refurbished mid 18th-century, at which time the SE wing was added, possibly as a farm building. Mid 19th-century the south east wing became domestic/was refurbished; a new roof, cast iron arched-top register grates in the chambers, sash windows, deep eaves and the present flight of stairs. Additionally the passage was extended to contain servant stairs leading to attic quarters in the south east wing.

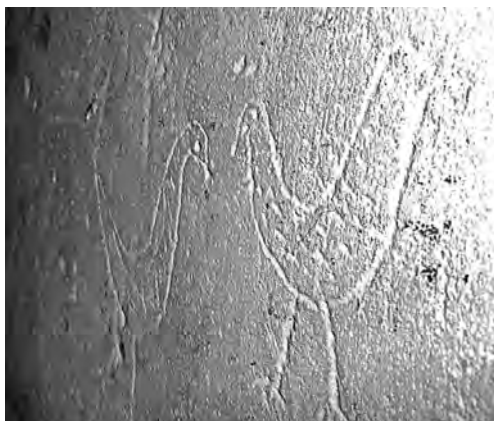
Original plan: three unit (hall, central entry & unheated service room, kitchen) with gable stacks, rising to two storeys with attics. Constructed from cut and squared local lias & Cary stone with Doulling stone dressings it has coped gables and a tie-and-collar truss roof (with former butt-purlins and a threaded ridge piece) clad with double Roman clay tiles. A date of build *ca.*1600 is suggested by the stylistic features (step and run-out or cyma stops and some concave chamfers on

*Fig. 7 North Cadbury, Brook Cottage, ritual mark on hall fireplace (photo Ann Heeley)*

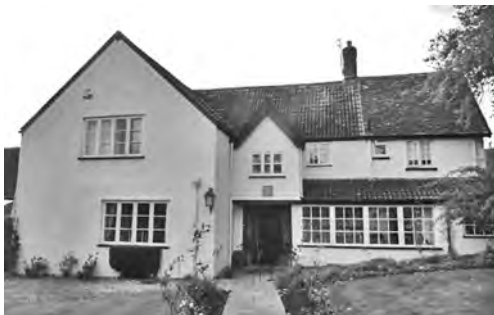
Plan: two-storey, with two original ground floor rooms and additions on three sides. The walls are roughcast and brick clad, over cob on the south front. (Fig. 8) A date of build *ca.*1600 is suggested. Then it was one-and-a-half storey, comprising kitchen and hall with a central dividing partition. The kitchen fireplace, curing chamber and winding stairs were extant. Substantial gentrification occurred in the late 17th-century; raising and

*Fig. 8 Taunton, Sherford House  
(photo Ann Heeley)*

cladding of the walls with brick; raising of the roof (collar-tie-beam trusses) and the formation of attics; installation of larger and taller windows, partitions and 'shell-style' cupboards; beams were plastered, using a Tudor Rose motif in the first floor rooms; the curing chamber was abandoned and a plaster overmantel, dated 1679 (fig. 9), inserted in the kitchen chamber. 18th-century documents indicate that the site contained a tan yard. Tanning processes probably necessitated the erection of 4 other attached 'production' rooms (one has a loft with 2 large brick 'honeycomb' vent-openings in the gable; tanned hides may have been stored here.). A date stone '1789 IW' fronts the two-storey porch. Maps from 1822 indicate a number of other dwellings and non-domestic buildings on site.

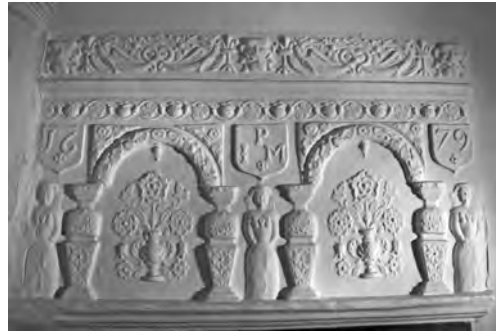
*Fig. 9 1679 overmantel, Sherford House  
(photo Knighton Berry)*

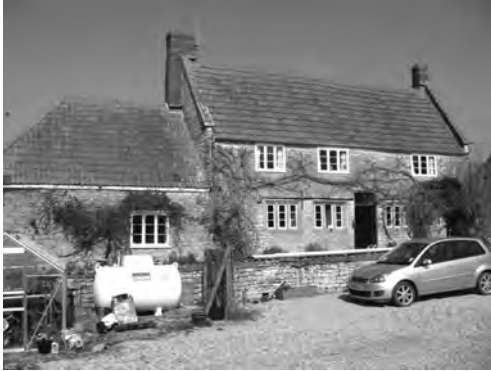
Plan: three rooms in line with an entry passage; dressed stone walls rising to two-storeys under a double-roman tiled roof. A mid/late 16th-century. date of build is suggested based on the mouldings (step-hollow-double-step and ovolo) and stops (variable floral patterns) on the beams; the four centred head and hollow-step-ogee moulding and flat and roll stop on the jambs of the hall fireplace. It then comprised a fully functioning kitchen (large fireplace with curing chamber), central entry with stairs and hall, all with chambers over. Early 17th-century the front elevation (fig. 10) was refenestrated to include the symmetrically sited, ovolo-moulded mullioned windows. The continuous drip mould was cut to allow for a taller entry door with fanlight. The two-storey

*Fig. 10 Adber, Batson's Farm  
(photo Mike Hargreaves)*

N wing was constructed with ground floor as buttery/cellar and rooms above. Attic areas were fenestrated for use as servant accommodation. Mid 17th-century a cheese room (accessed via the redundant curing chamber) with cheese loft over was built as an in-line extension; parts of the N wing now being used as a dairy or cider cellar. In the 19th-century the cheese room and loft were converted to domestic use.

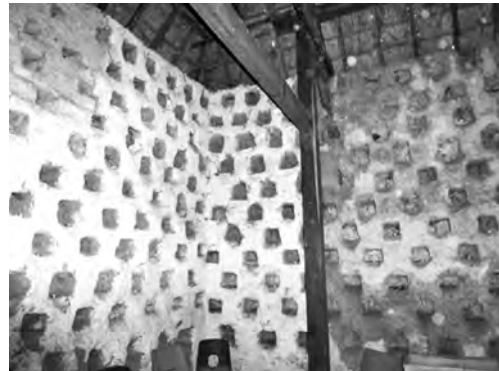
**The Dovecote** The only surviving cob dovecote in the historic county of Somerset and dating to the 17th-century. Rectangular in plan (26ft 3in long x 23ft 5in wide x 10ft 7in high), it sits on a limestone block plinth under a hipped, thatched roof. A lean-to abuts at the north end. The 550 nest holes, in chequer pattern, occupy 11 tiers on all 4 walls. (Fig. 11)

*Fig. 11 Trent, Church Farm dovecote  
(photo Ann Heeley)*

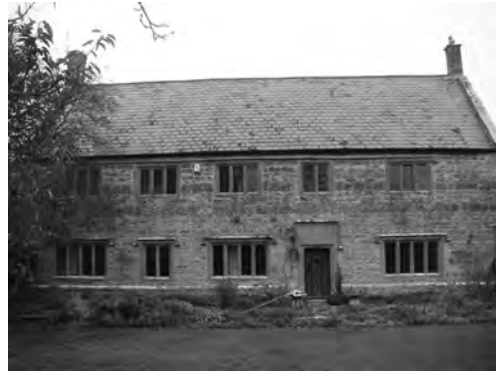
*Fig. 12 Trent, The Old School House  
(photo Mike Hargreaves)*

Plan: two rooms (formerly schoolroom and dining room) with a central stair hall rising to first floor and attics. The walls, some 60–65cms thick, are constructed of dressed and roughly coursed stone. A 2-storey kitchen wing extension at the rear of the property had evolved to create a double pile formation by 1840 (Tithe Map). The slated roof with stone gable copings is supported on four oak collar trusses notched at the apex with mortar and tenon joints. A king post truss is located in the rear wing. Features (Ham-stone ovolo-moulded mullions and door surrounds, depressed four-centre arch Ham-stone fireplaces with identical mouldings and incised spandrels and a double thickness door fitted with a lock case and strap hinges) support the documentary evidence for the date of build. (Fig. 12)

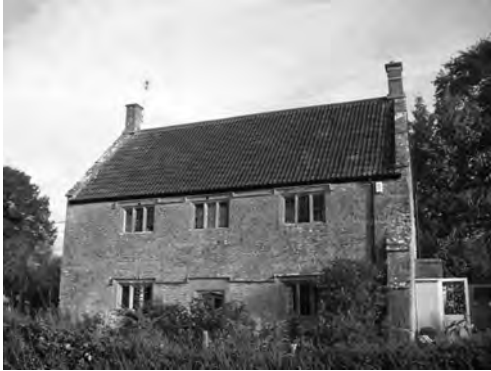
Plan: two-unit with central entry and stairs-passage, rising through two storeys and attics. (Fig. 13) An early 16th-century date of build is suggested by the wall thicknesses (70cm); the west gable window (cinquefoil lights with tracery in a square head); fireplace F2, a lateral stack (moulded surround and square head, herring bone stonework to the fireback, an 'ingle-seat'

*Fig. 13 Trent, The Dairy House  
(photo Mike Hargreaves)*

and an apotropaic mark on the lintel); doorway D2 (Ham-stone surround with ogee-step-hollow moulding terminating in a shallow stop). This early plan was hall, opposing doors indicating a crossway, and 2 service rooms divided by a lateral partition, all 2-storey. Late 16th-century the south elevation was re-fenestrated and the walls slightly raised necessitating new roof structure; a new partition defined the cross passage and a stair turret was inserted at the end of it. The hall became the kitchen, with a large baking oven. A gable fireplace was inserted in the former service area to create a parlour. Documents suggest that the property became a farmhouse during the late 18th-century and a 2-storey addition, now gone, built *ca*1800 provided a dairy and additional accommodation.

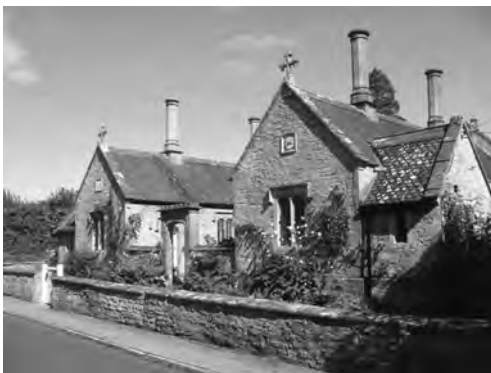
*Fig. 14 Trent, Mary Turner's Almshouses  
(photo Mike Hargreaves)*

Two ranges of almshouses built, under the patronage of the Rev. and Mrs. Turner of Trent (RCHM, Dorset 1, p. 256), of coursed rubble-stone walls with Hamstone dressings in 1846. Formerly four dwellings, each comprising a living room, bedroom and kitchen, the accommodation became two dwellings in 2005. (Fig. 14)

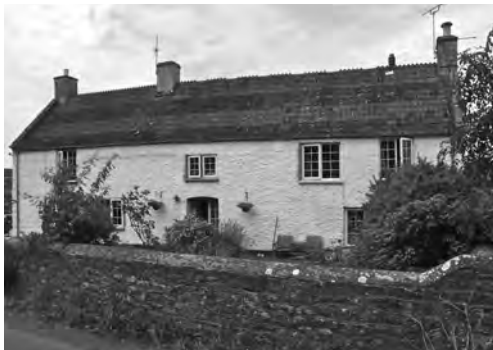
Plan: three rooms in line with two rear wings (late 19th- and mid 20th-century). The random rubble local stone walls, slobbered with white coating, rise to two storeys under a double roman clay tiled roof. Based on the wall thickness, 60cm, and truss construction (ridge piece jointed with a halved joint as has been noted at 3 other properties in the parish) it is suggested that the core is a mid 16th-century two bay, one and a half storey dwelling with a fireplace in the east gable. Mid/late 18th-century a westward extension included a new fireplace on the west gable, with a rounded 'D' shaped internal stack, this replaced that in the rebuilt east gable. About 1800, a further westward extension appears to have been constructed as separate accommodation (own entrance door and inglenook fireplace) but with a similar roof construction to the earlier extension. Later the 2 properties were integrated, the south eaves were raised and a new roof replaced the earlier structure. (Fig. 15)

*Fig. 15 Winscombe, Laurel Farm  
(photo John Rickard)*

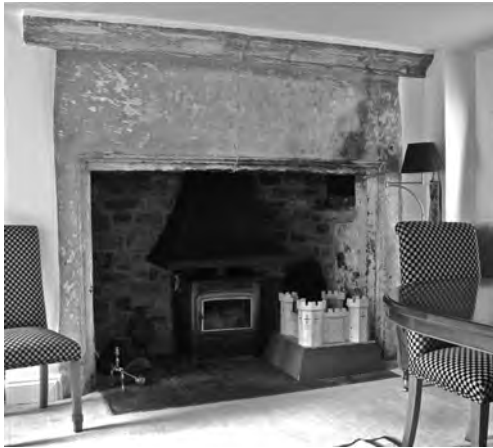
Plan: four rooms in line rising to one and a half storeys with a single storey addition. The walls, 50–70cm thick, are rendered and painted under a pan-tiled roof with a common ridge height but two different eaves levels. The open hall core of the house dates from around 1500; based on smoke blackening, truss construction, 3cm chamfers on the purlins and remnants of wind bracing. A closed (wattle & daub) truss indicates a solar over an inner room. Mid 16th-century fireplaces were inserted in the hall and inner room (fig. 16) and the ground floor was ceiled.

*Fig. 16 Winscombe, Wellage Cottage Court  
(photo John Rickard)*

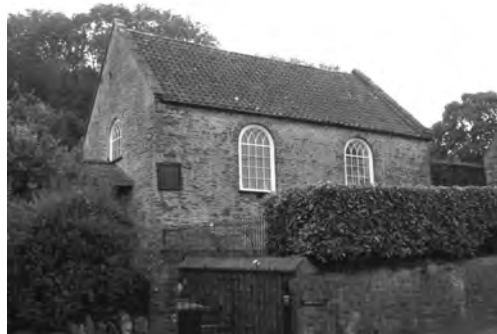
This building was originally a simple one-room plan and was built in 1798 on land recovered from “the waste”. Within the space there is a gallery that may formerly have been accessed by way of an outside stair. The tall round-headed windows with divided glazing bars are distinctive. (Fig. 17) The roof is constructed over three elm collar trusses, the collars being fixed with profiled half-dovetail joints. There are two tiers of purlins and the long tenon joint is rare in so far as the purlins are not off-set but

*Fig. 17 Winscombe, Old Wesleyan Chapel  
(photo John Rickard)*

remain in line. An additional timber descends below the collar to give mid-span support to the ceiling structure. After a century of use it was replaced by the present church and used for children’s classes. Over the years there have been several additions to the building to improve the facilities.

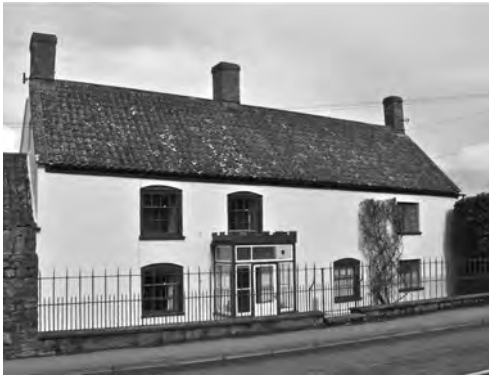
Plan: L shaped; the main (E-W) range is 2 storeys with attics and the rear (N-S) wing is of 1½ storeys. The 55cm thick walls are rendered and painted. The pan tiled roof, encompassing the original with 50° pitch, is set between coped gables indicating previous thatch. (Fig. 18) Original and very narrow newel stairs serve first floor and attic level; these and a bell system indicating previous servant accommodation. Built

*Fig. 18 Winscombe, Myrtle Farm  
(photo John Rickard)*

in the mid 18th-century (1792 'Dean & Chapter of Wells' Map) it presents as 3 rooms-in-line with cross passage; no evidence of a separate inner room remains suggesting a transitional phase of 2 rooms and cross passage with a smaller parlour separated from the main hall/living room, a large inglenook fireplace providing heat and cooking facilities. A 'back kitchen' wing was built soon afterwards with a large inglenook fireplace incorporating both bread and 'summer' ovens. Part of the property was 'up-graded' in the latter part of the 19th-century; some segmental headed (arched) windows with inserted sashes were installed and a front porch and rear wash-house built. Windows at the east of the front range were not replaced, suggesting dual occupancy at that time. Mid 20th-century the back kitchen gable wall was cut through to incorporate the adjacent barn to domestic use.

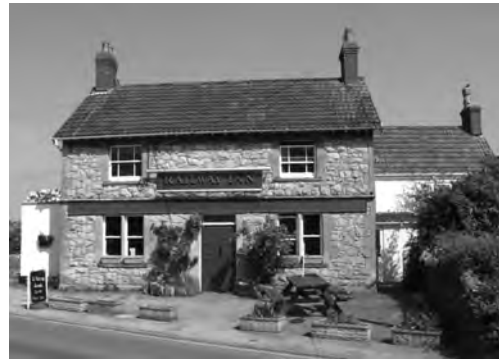
Plan: a two storey north range and single storey lean-to rear wing, possibly a scullery, is the prime focus of our survey. Dating from late 18th-century it comprises parlour, central stair entry, and kitchen/living room. The random rubble construction walls, 55cm thick, are rendered and painted. The roof, supported on three principal trusses (feet visible in the rooms below), with cut-back and tusk-tenoned purlins is clad in double roman clay tiles. The railway opened in 1869; lodging and beer provision was necessary for constructors and passengers. The present frontage was added in the early 20th century. (Fig. 19)

*Fig. 19 Winscombe, The Railway Inn  
(photo John Rickard)*

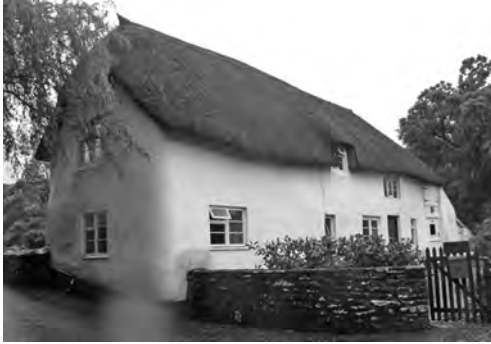
Plan: Two rooms in-line together with former stable additions rising to one-and-half storeys under a thatched roof. Early/mid 17th-century date is suggested by wall thickness (55cm,

*Fig. 21 Wootton Courtenay, Bridge Cottage  
(photo Mike Hargreaves)*

rendered over rubble stone and cob), 8 cm deep chamfers with cyma-stops on beams, remnants of jointed-cruck trusses. In the mid 19th-century it functioned as an Inn. (Fig. 21)
