# BUILDING RECORDING IN 2005

SOMERSET VERNACULAR BUILDING RESEARCH GROUP

## INTRODUCTION

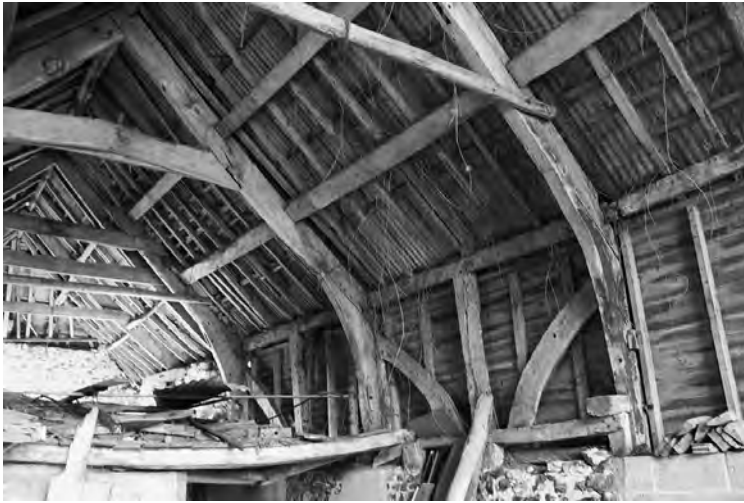
*Fig. 1 Barn at Whitehall Farm, Combe St Nicholas*

From the 16th century, Whitehall Farm formed part of the estate of the Dean and Chapter of Wells Cathedral. The main range originally comprised an inner room, hall, cross-passage and service room. The roof is of high status arch-braced trusses with a tier of curved wind-braces and may have been open to view. It has been dated to *c.* 1500 by comparison with tree-ring dated roofs elsewhere in the county. The stairs may have been housed in a turret. At the end of the 16th century, the low end was rebuilt with a wider span as a kitchen, incorporating a curing chamber (and possibly a baking oven). The house was upgraded in the early 19th century when a new fireplace and stack were inserted. A projecting bay was added in the hall and a lateral fireplace and stack built to serve the hall chamber. Additions to the rear at the same time included a dairy with cheese loft over. Subsequently the house was divided at the cross-passage into two dwellings, but reverted to one in the 20th century. Of the former sixteenth-century farm buildings, only a barn (Fig. 1) and a waggon and implement shed survive.

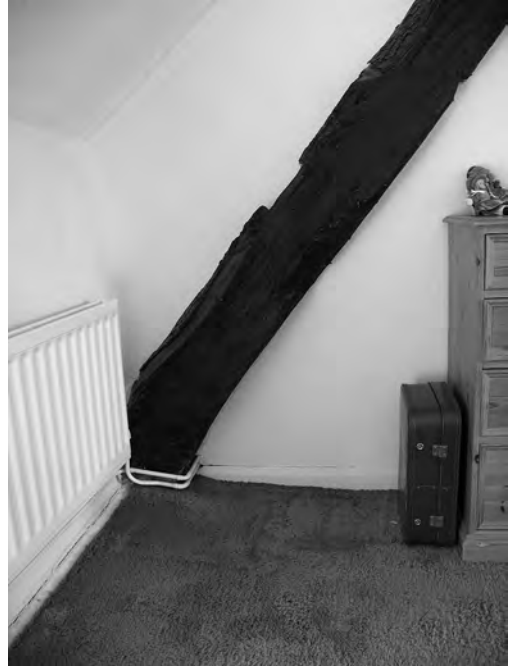
*Fig. 3 Willow Cottage, Alhampton, principal rafter*

Together the two houses now form an L-shaped plan. Willow Cottage comprises three ground-floor rooms on two levels and Canada House two rooms also on two levels. A room in each house dates from the 15th century (based on tree-ring dating of similar features elsewhere in Somerset) (Figs 2 & 3) and the smoke-blackening shows that they formed part of two open-hall houses. With the limited evidence available, it is not possible to establish the plan form of these medieval houses. In the second half of the 16th century, upper floors were inserted in one of the houses (now divided between the two cottages) and the other was ceiled late in the 16th century. The 1888 OS map indicates that the properties were then divided into three and extended further to the north and east.

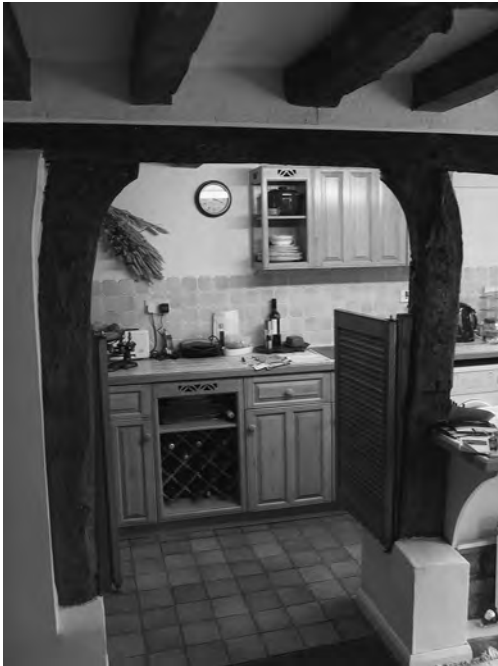
*Fig. 2 Willow Cottage, Alhampton, 15th-century doorframe*

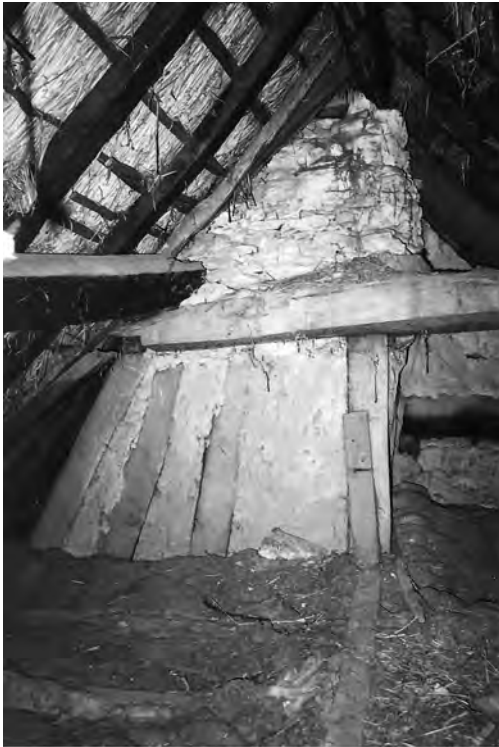
*Fig. 4 Bramble Cottage, Haselbury Plucknett, smoke-hood*

considered to be of one build. In the late 16th century, upper floors and a smoke-hood were inserted (Fig. 4). This appears to be the only surviving smoke-hood in the village. The kitchen fireplace and stack (and possibly the curing chamber) were also built at this time.

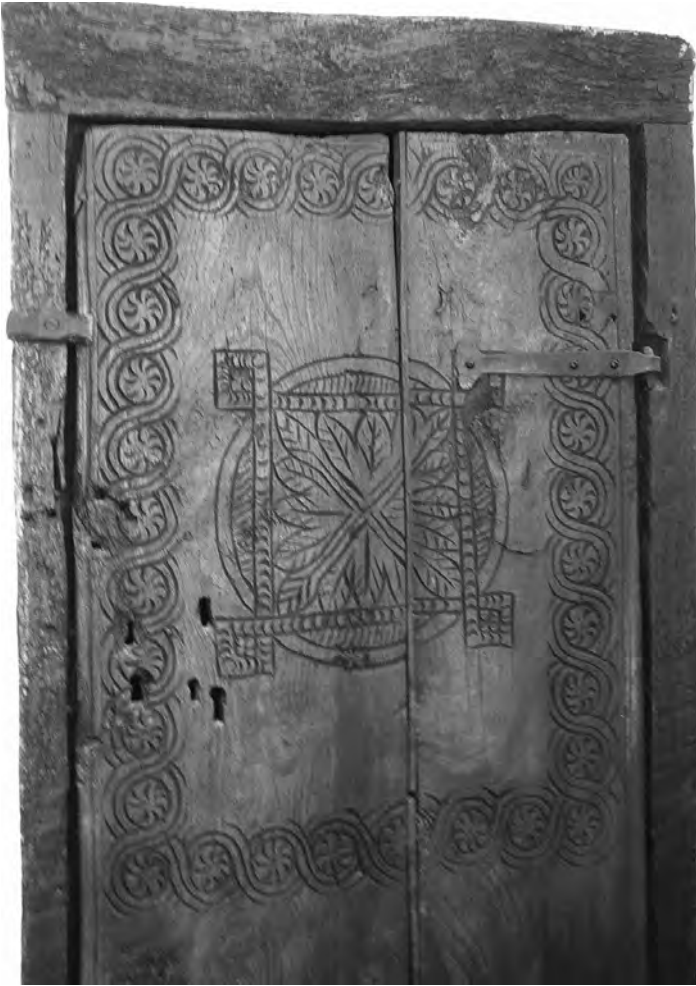
*Fig. 5 Eastfield Farm, Lydford on Fosse, decorated door on first floor*

The absence of the original roof structure makes interpretation difficult, but the plan appears to be a farmhouse of three rooms in line, comprising kitchen, hall and central unheated service room. Adjacent to the kitchen fireplace was a curing chamber (now gone) and access to the room above is by an elaborately carved door on the first floor (Fig. 5). Details of the beams indicate that the eastern half dates from the 16th century, but the other half has 17th-century characteristics. It is possible that when the house was built in the 16th century, the plan was transitional, that is, the hall and service area were still open without an upper floor. Alternatively the hall may have been damaged, for instance by fire, which necessitated rebuilding early in the 17th century. The existence of two contemporary staircases and two entrances suggest that the house was divided into two dwellings at an early date and was still divided at the time of the 1886 and 1903 OS maps.

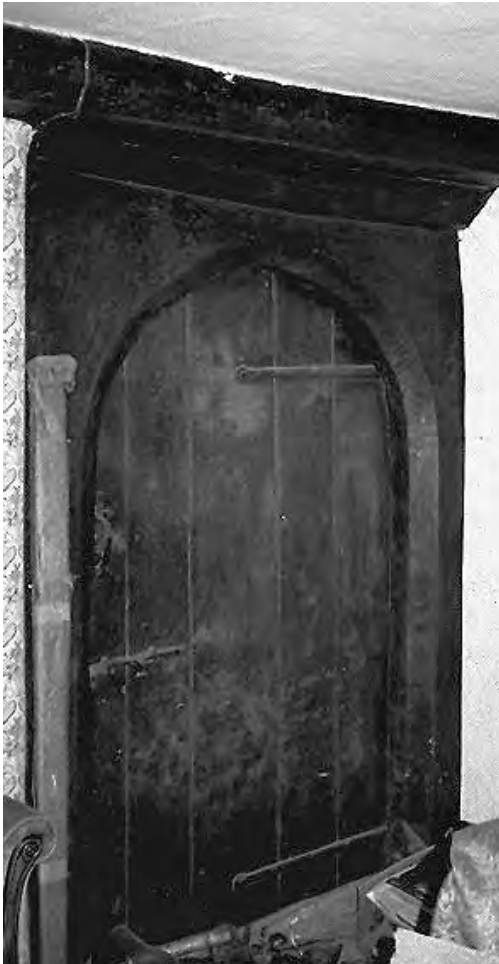
Fig. 6 Coombe Grange, Nailsea, 16th-century doorframe

16th century (Fig. 6), but the original layout remains uncertain. In the 17th century the house was remodelled and it appears that a cross-passage was created utilising part of a parlour and a new staircase was inserted. An addition, accessible from the house on the ground floor, may have been used as a dairy. The house was significantly enlarged in the early 19th century by the construction of the parallel south range, the entrance aligned with the former cross-passage. A later single-storey addition completed the rectangular plan.

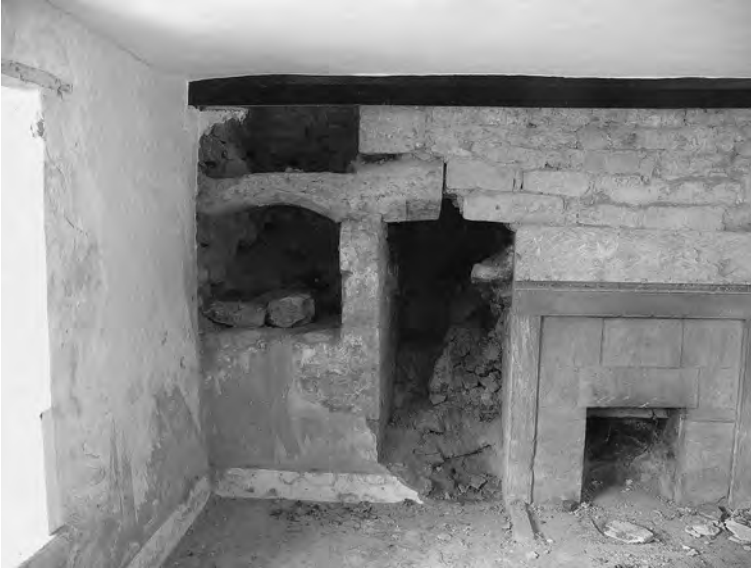
*Fig. 7 Old Harp House, Over Stratton, remains of bressumer and access to curing chamber*

The plan consists of three rooms in line with a cross-passage and stair turret. The original roof was destroyed by fire in the 19th century. The details of the beams and the stair turret suggest a date in the 16th century, and the proportions indicate that the room arrangement was much as now. Interestingly, the central hall is unheated so it does not accord with the traditional plan-form for that period, but two contemporary examples, both with stair turrets, have been recorded at Brompton Ralph and North Petherton. In the early 17th century the house was re-fronted, when the inner room became a parlour with a new fireplace inserted and the curing chamber in the kitchen was replaced by an oven (Fig. 7). By the 18th century the kitchen had been upgraded to a living room.

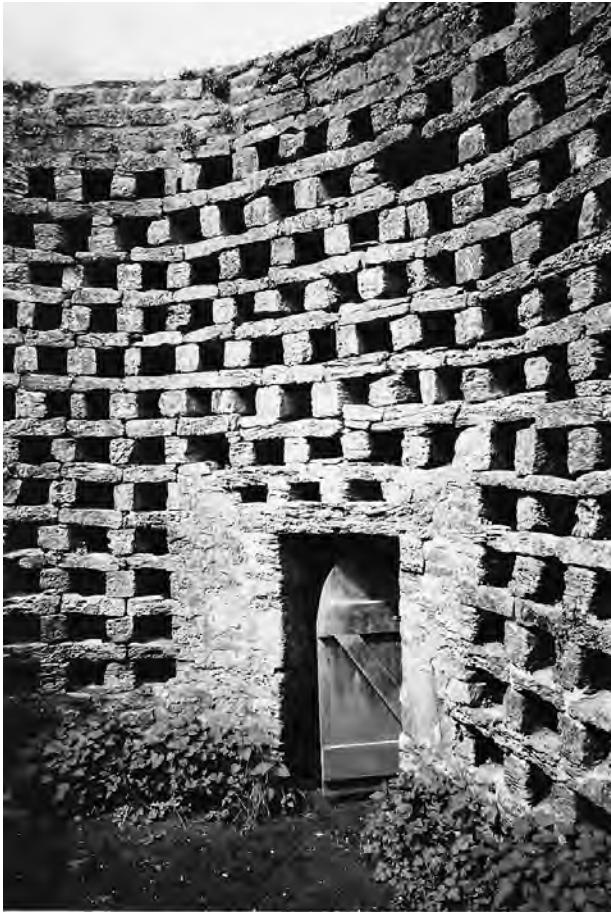
Fig. 8 Dovecote at Priory Farm, Stoke-sub-Hamdon

stables were originally of two rooms with a hay loft over, but were rearranged internally in the 19th century. A cart-shed with granary over, formerly with a lean-to, is also now roofless. Lastly, the medieval dovecote (Fig. 8) was fully described and illustrated in *The Dovecotes of Historical Somerset* by John and Pamela McCann, published by SVBRG in 2003.

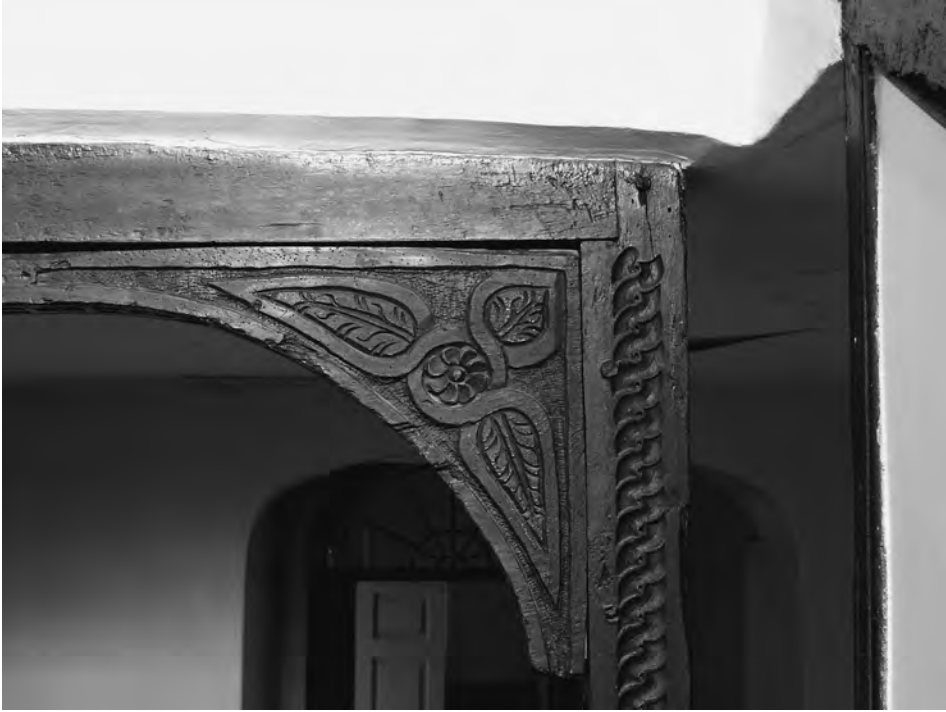
*Fig. 9 Tintinhull House, spandrel at foot of back stair*

The history of the estate is given in VCH, volume III (1974), and the house, listed Grade I, was described by Arthur Oswald in *Country Life* (19 April 1956). The parsonage estate, including Tintinhull Court and the Dower House (above), had been acquired by the Napper family in the mid-16th century and was in the possession of Thomas Napper from 1628. Owing to later changes it is difficult to determine the original plan-form of Tintinhull House. The inscription '1630 N' on the gable of the cross-wing is likely to represent the date of the earliest phase of building and the conjecture is that it was two storeys and L-shaped (Figs 9-11). The house was enlarged to a rectangular plan with the addition of the two-and-half

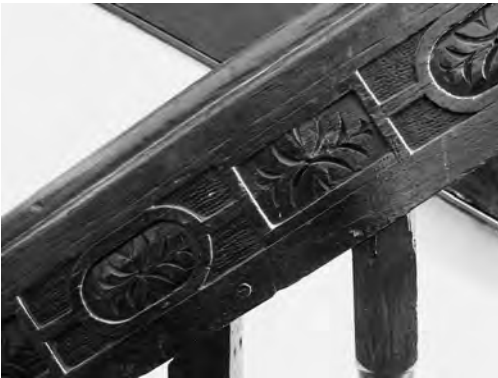
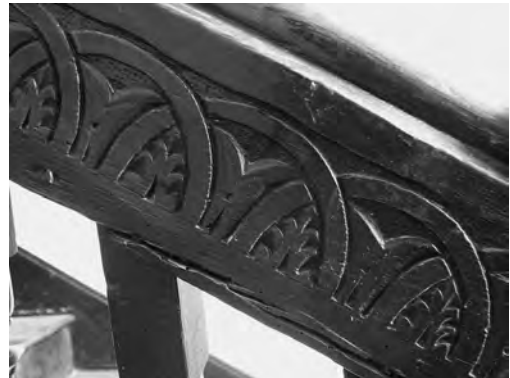
*Figs 10 and 11 Tintinhull House, details of handrail to back stair*

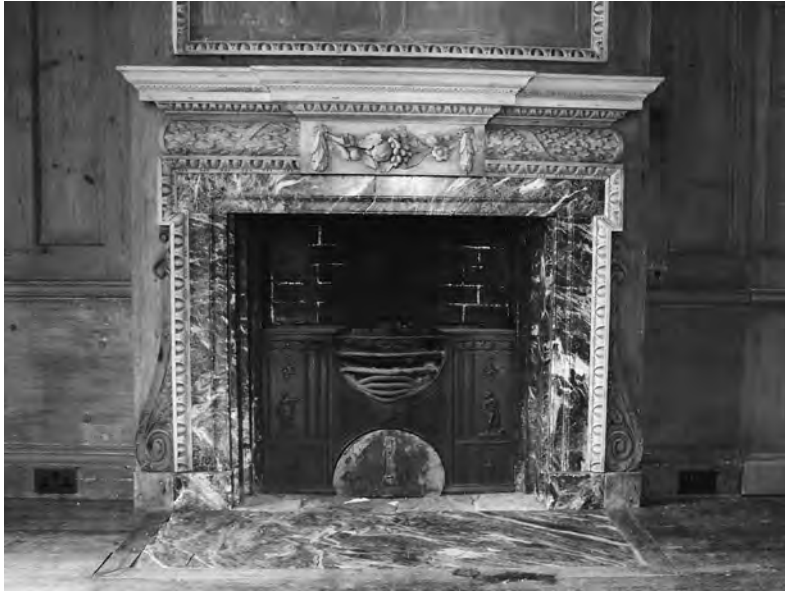
*Fig. 12 Tintinhull House, 18th-century chimney-piece*

storey west front in classical style – described by the VCH as 'an unusually perfect example of its period'. This work was probably undertaken for Andrew Napper, who acquired the property by 1722 (Fig. 12). Further alterations took place in the late 19th and early 20th centuries. It was bought in 1918 by Revd S. J. M. Price, a distinguished botanist, who redesigned the grounds and in 1933 it was sold to Edward and Phyllis Reiss. She transformed the gardens over nearly 30 years and in 1953 gave the property to the National Trust.
