## A ROMANO-BRITISH BUILDING AT QUEEN CAMEL

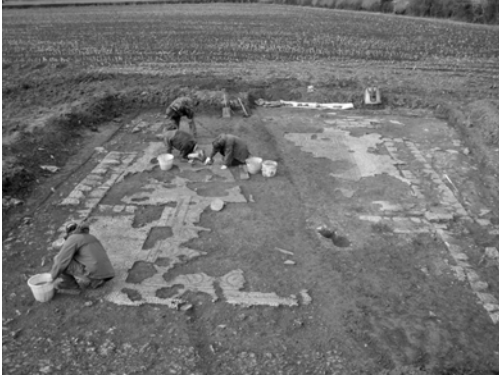
Fig. 3 Mosaic floor under excavation; view north

The work revealed a corridor-type villa building with its largest rooms at each end. Both probably had mosaic floors with the eastern room heated and the western a bipartite room. The scheme of the mosaic (Figs 2 and 3), its treatment and motifs are closely matched on mosaics from Halstock, Dorset (II, 170.2), Lopen, Somerset (II, 206.2) and Old Broad Street, London (III, 370.76) and is therefore another example of the work of the Ilchester subgroup of the Corinthian Saltire School, probably dating to the third quarter of the 4th century (Cosh and Neal 2010).
