Building Recording in 2020 and 2021

Somerset Vernacular Building Research Group

BUILDING RECORDING IN 2020 AND 2021

SOMERSET VERNACULAR BUILDING RESEARCH GROUP

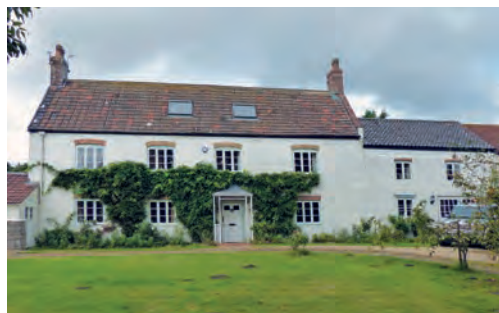
The main range of the house is two storeys with an attic floor under a clay-tiled roof. At the rear, a full height catslide extends over a two-storey range. The north gable has an additional two-storey unit attached under a lower pantiled roof. The walls are unpainted brickwork except for the front which is painted with unpainted heads over the windows (Fig. 1a). A large

Fig. 1a Chedzoy, Westfield Farm, Unpainted window heads enliven the brick frontage

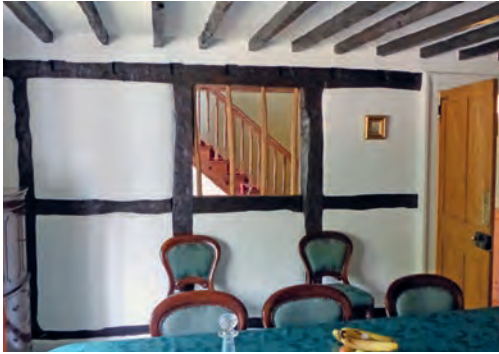
It was substantially rebuilt in the middle of the 18th century when a full upper floor was added; brick was extensively used in the rebuilding. An internal, perhaps original, wall of the main range is oak framed on a stone plinth with the head beam lower than the current ceiling and of wattle and daub construction (Fig. 1b). The principal staircase is a straight flight with decorative brackets, two tapered balusters at each open tread and a moulded handrail. The roof comprises four tie-beam trusses linked by two tiers of aligned purlins in an 18th-century construction manner. Beneath a Regency-style canopy porch is a six-panel door with the upper panes glazed. The door is double planked in a broad moulded architrave. The front windows are of three lights with opening casements and internal folding shutters on the ground floor.

Fig. 1b Chedzoy, Westfield Farm, Wattle and daub panels to an oak-framed partition

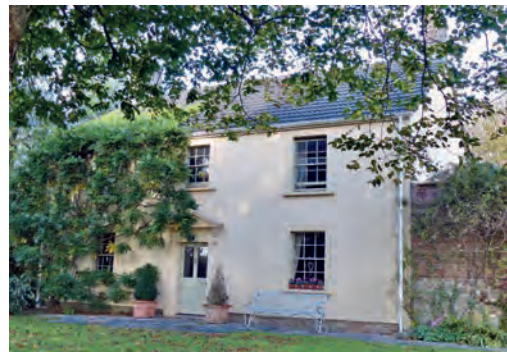
The two-storey house, linked to a single-storey north range, has a symmetrical arrangement of windows and a central pedimented entrance (Fig. 2), the north elevation being similar. The roof has modern, cement, double Roman tiles; brick stacks at the gables carry four flues. The house has a painted render finish except for a supplementary chimney at the west end. The house, window and door openings have stone quoins with walls of random rubble construction.

Fig. 2 Coleford, Lydford Farm, South elevation showing bracket and pedimented entrance

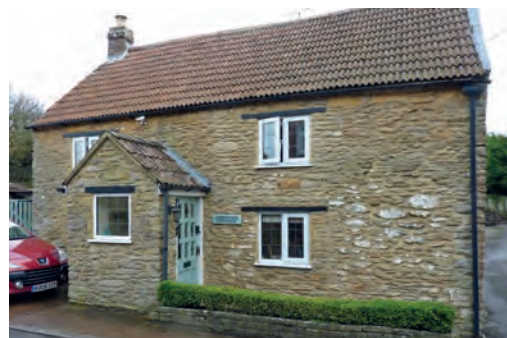
The cottage has its front, west, elevation almost on the street as depicted in the 1819 parish map. On this map, and on the 1840 Tithe Map, a rear range is shown running east from the north end. By 1886 this wing has been replaced by a new range behind the front range. The east side of this new range is a gable wall and the new ridge is at right angles to that of the front range. A further single-storey range now attaches at the north end. The front range appears to be the oldest part, originating perhaps in the mid to late 18th century (Fig. 3). The long walls of the front range have a distinct batter internally, diminishing from 0.7m thickness at ground level to 0.5m at ceiling height. Other walls are 0.5m. There is a wide fireplace in the south gable with evidence of a baking oven to the left side though the fireplace lintel and the right jamb are modern. The roof in the front range has two unmatched collar trusses and a single tier of purlins; the carpentry was modified using reclaimed timbers

Fig. 3 East Coker, Ebenezer Cottage, Front elevation with windows under timber lintels

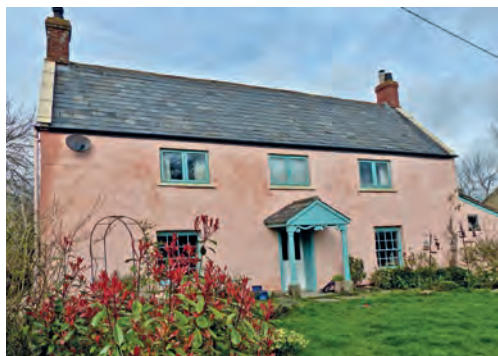
This two-storey house with its newly rendered elevations comprises two parallel ranges, both with separate slate roofs between coped gables and with a stack at each gable. The windows are replacements which, on the ground floor, imitate former multi-pane sashes (Fig. 4a). The south range is the older, dating to the late 18th century and contains two principal rooms separated by a wide stair hall in which there is a panelled and partially glazed store cupboard (Fig. 4b). The stair has open treads with bracket decoration. The north range similarly has two rooms and a through passage and both parts of the house have large, Lias, flagstone flooring. The Tithe Map of 1842 shows only the south range with two small additions on the north side, probably single-storey service rooms. By 1884, however, the north range is shown on the O.S. map. The difference between the ranges is evident in the wall thicknesses, the south range having 0.5m walls and a 0.6m south wall, the north range being only 0.3m and probably constructed of brick. The roof of the north range is a simple tie-beam roof of 45° pitch with softwood principals prepared from roughly hewn baulks, sawn in half to 20x8cm finished size. The 51° south roof is possibly of ash principals with elm rafters and, although now in a tie-beam configuration, was formerly a wind-braced collar truss roof, the threaded ridge and the butt purlins suggesting 16th-century origins.

Fig. 4a Godney, Lower Godney House, Rendered south elevation with replica sashes on ground floor

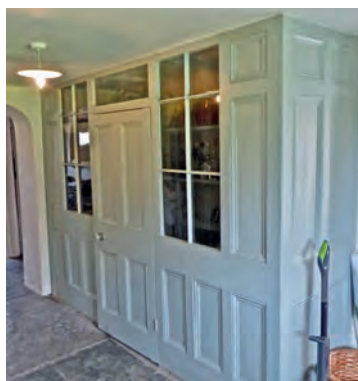
Fig. 4b Godney, Lower Godney House, Panelled and part-glazed cupboard in stair hall

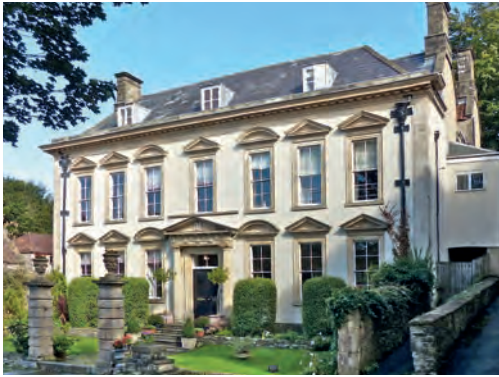
This listed house has a rendered Palladian-style west-facing frontage on two floors and dormers set in the slate-clad hipped roof (Fig. 5a). The entrance, below a triangular pediment, is supported on plain columns in the Tuscan style. To either side there are three windows in moulded architraves that have either a segmental or a triangular pediment above. Below the cornice a pair of cast lead rainwater heads are decorated with the Howe family crest and the date '1732' (Fig. 5b). The wide entrance hall gives access

Fig. 5a Shepton Mallet, Bowlsh House, Classical west front with dormers in the hipped roof

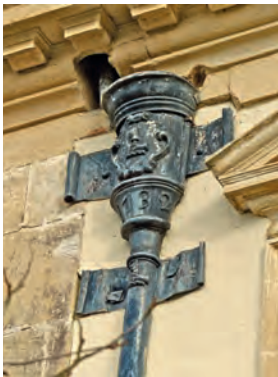
Fig. 5b Shepton Mallet, Bowlsh House, Rainhead dated 1732 and bearing the Howe crest

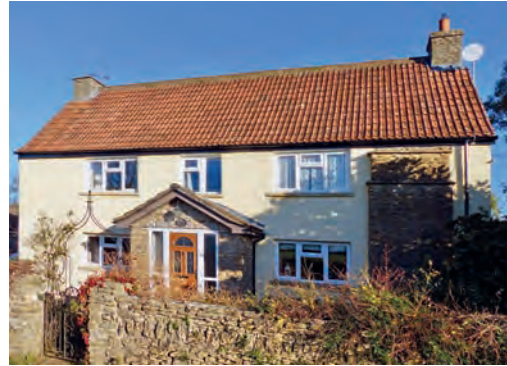
Fig. 6 Wanstrow, Brook House, Rendered front elevation with masonry buttress to right

The south room too originally had a (now blocked) inglenook, beside which was the original spiral wall staircase, still partially visible in the loft. The walls are of random rubble construction, rendered and painted externally, with a shallow buttress to stabilise the thin staircase wall (Fig. 6). The floors are solid, originally of differing levels.
